## SPECIAL REPORT: Generator inspection first step in avoiding failures attributed to dry stator-winding ties

Posted on [March 17, 2014](#) by [Team CCJ](#)

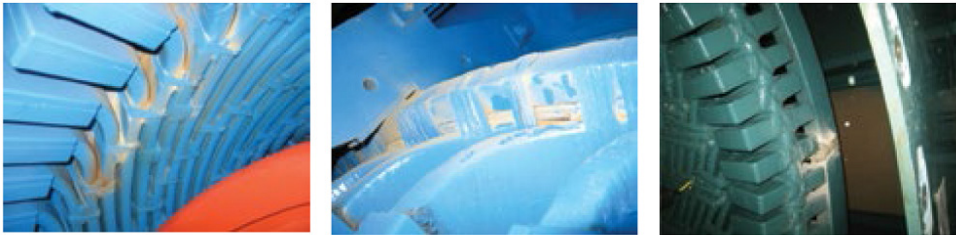
1, 2, 3. Dusting is indicative of early-stage vibration in endwinding

**Gallery.** Figs 1, 2, and 3 show dusting as evidence of early-stage vibration in an endwinding; Figs 4 and 5 reflect vibration of connection rings. Early-stage dry-tie vibration illustrated in these five photos is relatively simple to repair—that is, to remove the dry ties and replace them with wet ties as recommended by the OEM. Even where insulation wear is significant (Figs 6 and 7), depending on depth and location, it may be possible to repair and retie. An alternative is a stator rewind.

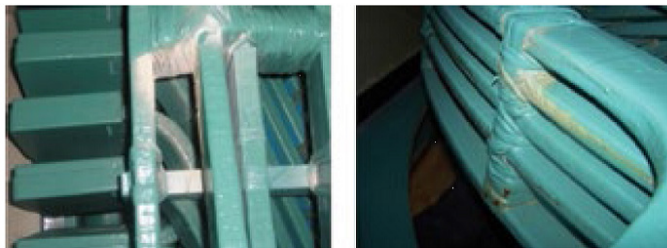
4, 5. Early-stage vibration of connection rings is identified by dusting

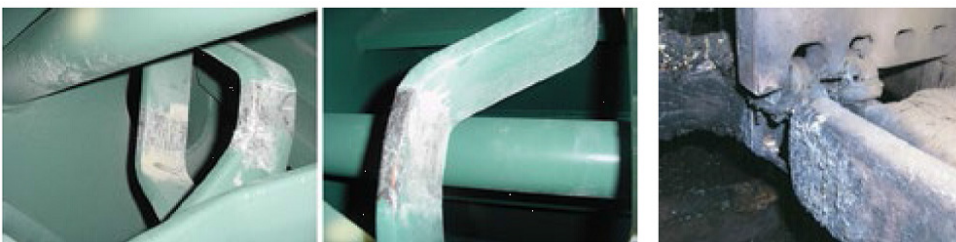
Fig 8 shows a failure location on connection rings. It illustrates the amount of physical damage that can be caused by a failure arc, which persists for several seconds after the breaker trips as field current decays. The photo also shows the relatively weak integration of the tie between ring and support: The ring is connected to the support only at an edge of the ring rather than on a wide face. If the tie and bond are not exceptionally strong, the bond will fail and vibrations and wear can begin.

6, 7. Insulation wear on two rings in different phases is clearly problematic 8. Arc damage was caused by failure of connection-ring insulation
