## Borescope Inspection Findings on Air-Cooled Generators with Spark Erosion and Partial Discharge

Bill Moore, P.E.  
Director, Product Line Development  
National Electric Coil  
bmoore@national-electric-coil.com

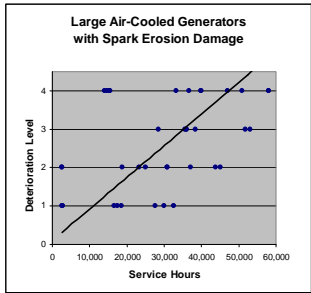
- 40 Borescope Inspection Results
- Deterioration Level
  0. No Deterioration
  1. Minimal
  2. Moderate
  3. Critical
  4. Failure/Rewind

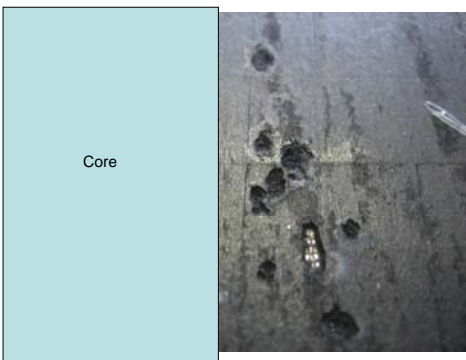
- Black circles near the edge of the vent duct spacer.

Dark spots – early stages of SE

### Level 1 SE Deterioration

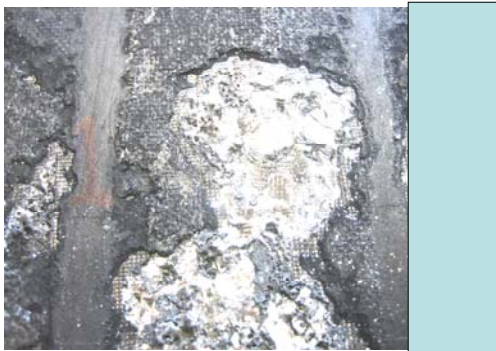
- Damage is more extensive near the vent duct edge
- Slag/Rough surfaces that have some depth

### Level 2 SE Deterioration

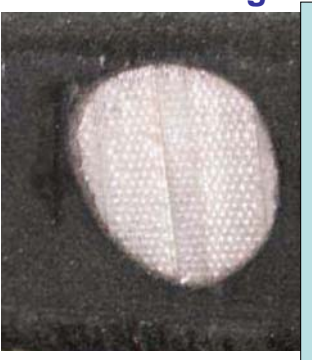
### Intermediate Stages of PD
