CORONA PROBE MEASUREMENTS TAKEN ON HYDRO MACHINES
AT
GRAND COULEE DAM

T. A. Goodwin
U. S. Bureau of Reclamation

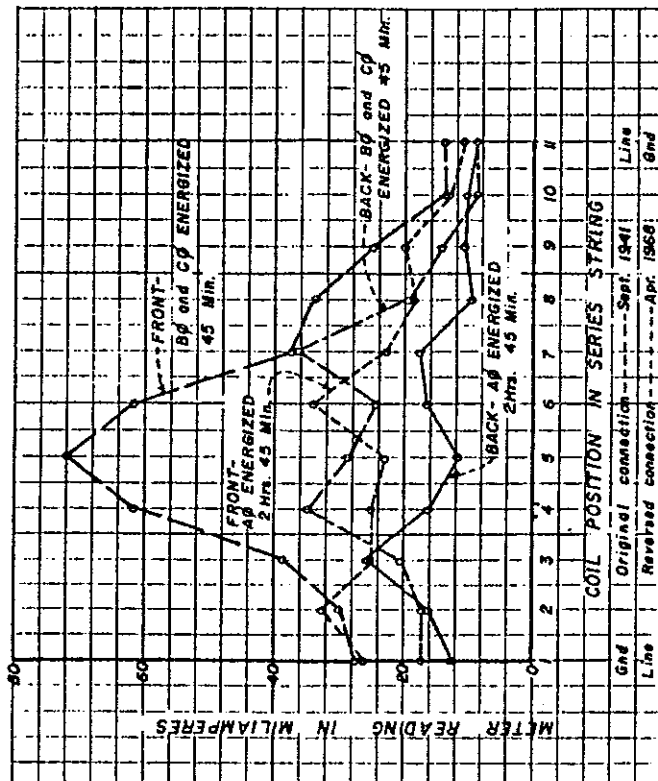
USBR, COULEE DAM
G-3 STATOR WINDING
 Asphalt Bonded Mica Insulation

PEAK-PULSE CORONA TEST MADE AT 7.5 KV USING 5 MEGAHERTZ PROBE
 3" BELOW TOP OF IRON IN AIR GAP ROTOR IN PLACE.
 THE PURPOSE OF AN INITIAL TEST AND A SECOND TEST AFTER THE
 WINDING WAS ENERGIZED FOR 2 HRS. WAS TO DETERMINE HOW THE
 CORONA READINGS VARY WITH TIME.

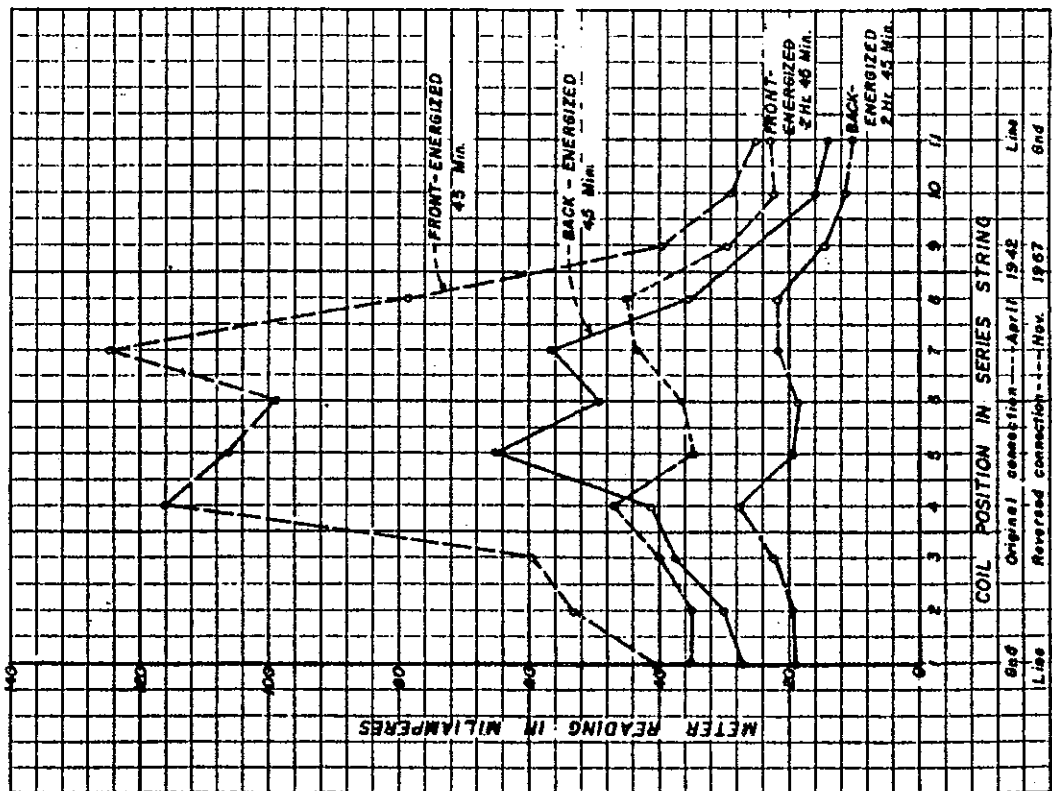
USBR, COULEE DAM
G-1 STATOR WINDING
 Asphalt Bonded Mica Insulation

PEAK-PULSE CORONA TEST MADE AT 7.5KV USING 5 MEGAHERTZ PROBE 3" BELOW
 TOP OF IRON IN AIR GAP ROTOR IN PLACE. THE PURPOSE OF AN INITIAL
 TEST AND A SECOND TEST AFTER THE WINDING WAS ENERGIZED FOR 2 HRS.
 WAS TO DETERMINE HOW THE CORONA READINGS VARY WITH TIME.

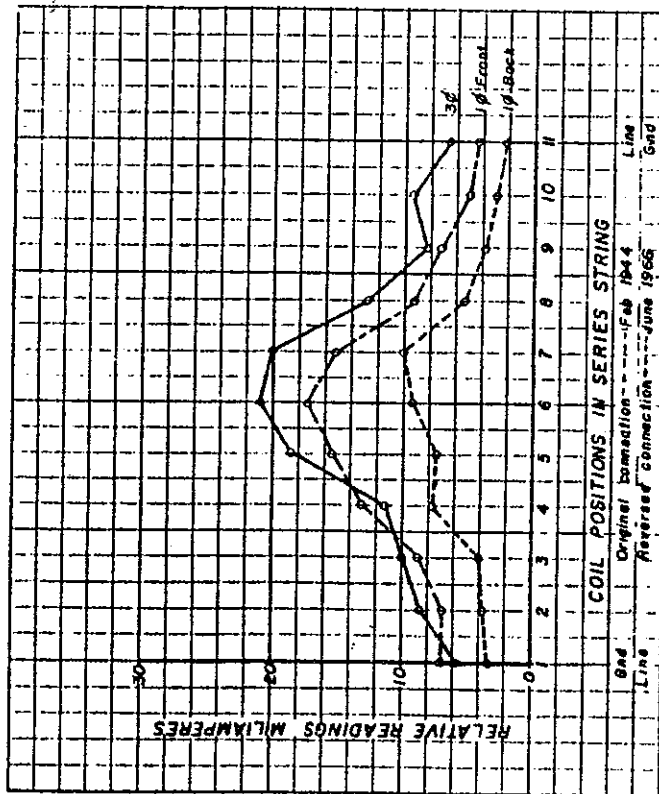
USBR, COULEE DAM
G-4 STATOR WINDING
Asphalt Bonded Mica Insulation

PEAK-PULSE CORONA TEST MADE AT 6 KV USING 5 MEGAHERTZ PROBE
3" BELOW TOP OF IRON IN AIR GAP ROTOR IN PLACE.

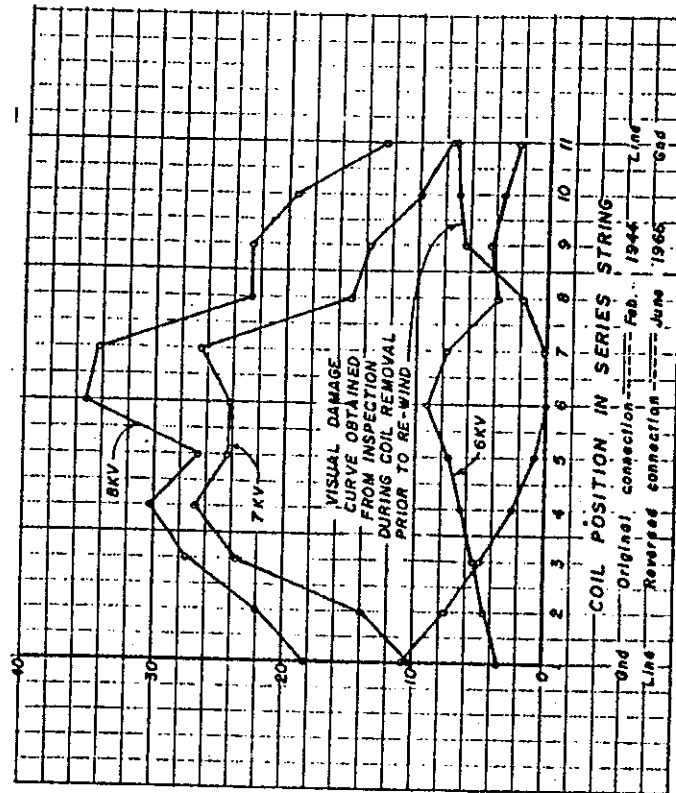
USBR, COULEE DAM
G-4 STATOR WINDING
Asphalt Bonded Mica Insulation

PEAK-PULSE CORONA TEST MADE AT 3 POINTS ON THE COIL, USING
5 MEGAHERTZ PROBE. ROTOR REMOVED.

The 6KV, 7KV and 8KV curves represent the "front leg" averaged values of three sets of readings taken at the following points:
(1) 3" below the top of the iron; (2) The center of the iron;
(3) 3" above the bottom of the iron.
The Visual Damage curve was obtained from inspection during coil removal. A "Damage Factor" was obtained by adding the following:
(1) "Area" of corona damage on a scale of 0 to 10. (2) Severity of damage at a scale of 0 to 3. The Corona Damage Factor figured for the curve below was Area + 5 times severity.

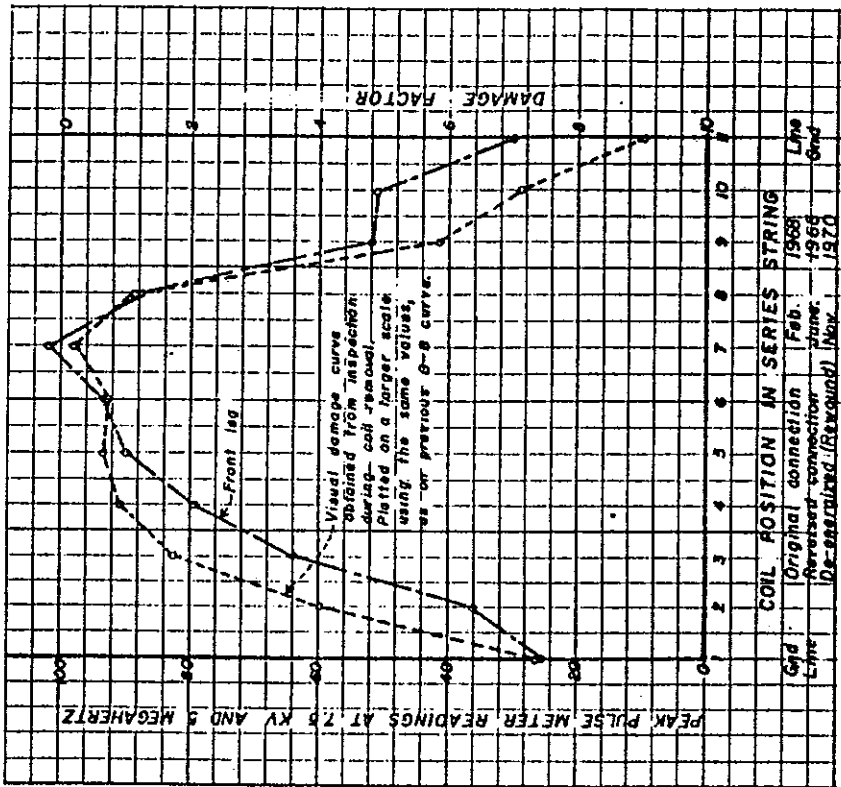
USBR, COULEE DAM
G-8 STATOR WINDING
Asphalt Bonded Mica Insulation

PEAK-PULSE CORONA TEST MADE AT 7.5 KV USING 5 MEGAHERTZ PROBE
3" BELOW TOP OF IRON IN AIR GAP ROTOR IN PLACE.
THIS CURVE SHOWS THE CLOSE SIMILARITY OF THE CORONA PROBE
CURVE AND THE "CORONA DAMAGE" CURVE WITH ITS ORDINATE
REVERSED.
