PWR2006-88030

DETERIORATION MECHANISMS

RECENT AIR COOLED TURBINE GENERATORS

W. Howard Moudy
National Electric Coil

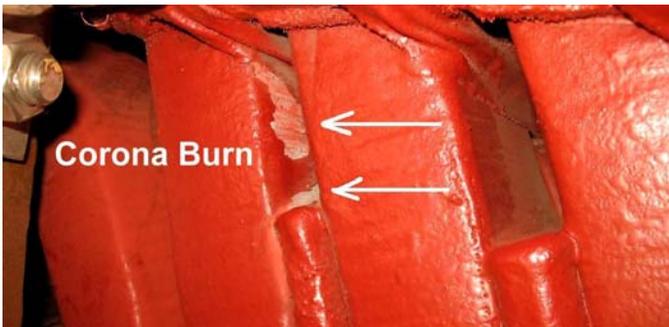
Figure 1: Corona and gap discharges on the stator endwinding after three years of service.

Within approximately three years, the generators developed minor end winding corona and gap discharges on the stator end windings. Figure 1 shows how ozone from the partial discharges eroded away the surface stress grading paints and the red protective coating. Figure 3 shows a burnt tie between stator bars and severe damage to the surface paints.

The original design of a generator stator may severely limit options for maintenance to extend service life. In some cases, recoating the damaged area shown in Figure 1 may be a way to lengthen service life. This is normally done with a process known as epoxy injection. However, repair of stator bar damage in the slots is difficult and in some designs impossible.

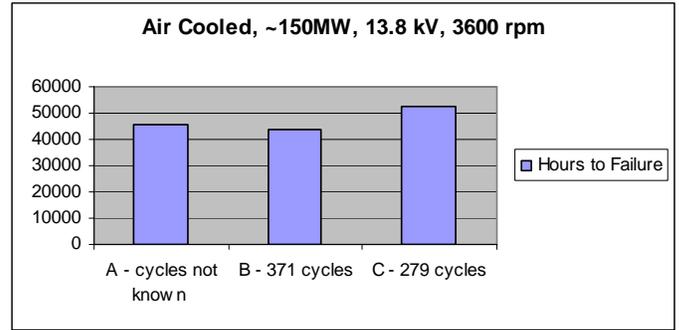
Figures 1 through 6 show the various effects of advanced PD on a group of three similar 3600 rpm, 13.8 kV generators with a nominal rating of 150 MW each. The design was identical for all three, and they were all manufactured by the same company. The machines all failed after experiencing similar operating hour durations; 43,500 hrs, 45,550 hrs and 52,401 hrs. Figure 2 gives a summary of operational data for the three units. Coils from failed machines were dissected and

it was determined that the designed volt per mill stress level of the ground wall insulation was approximately 72 volts per mil.

Figure 2: Average lifetime operational data for three identical generator units.

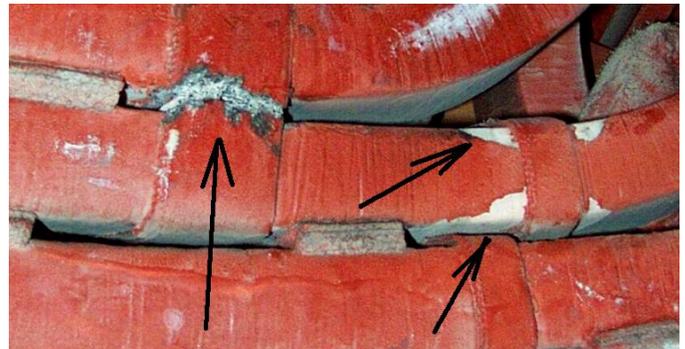
Figure 3: PD activity resulted in severe damage to surface paints and the burning of ties between stator bars.

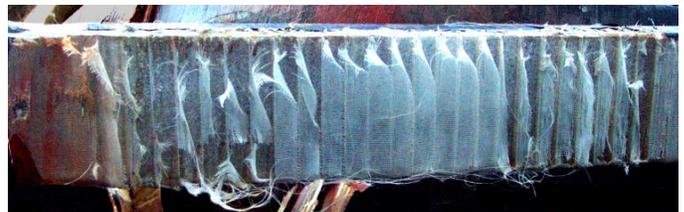
Figure 4: With binding resins eroded by ozone, only the glass armor tape remains.

In Figure 4, although the stator bars were tight in the slots, partial discharge activity on the high voltage top stator bars destroyed all the black conductive surface paints. Ozone had bleached away all the paints and binding resins leaving only the bare glass armor tape.

The stator bar shown in Figure 4 is the same as found in this generator before it was rewound. EMI Diagnostics made it possible to predict the remaining service life, and a stator winding replacement was scheduled before a failure occurred.

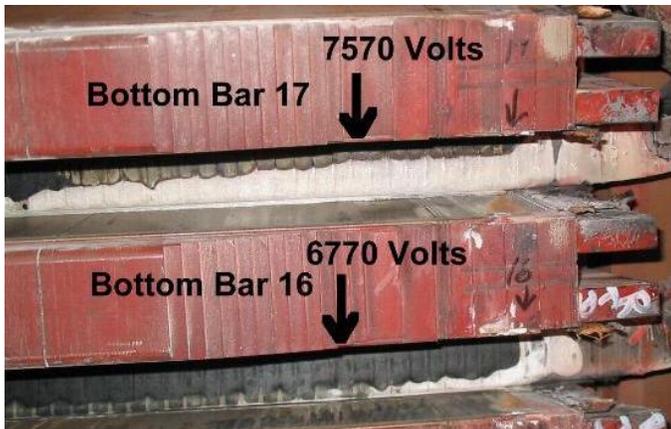
Figure 5: Bottom bars that experienced severe damage with operating voltages to ground indicated.

In addition to the top bar damage discussed earlier, which resulted in the unit's failure, the bottom bars also had severe damage. All of the bars operating at higher voltages experienced extensive erosion of the conductive coating after five years of service. Stator bars in the top of the core slots, which operate at higher temperatures, had the most damage. There was similar deterioration of bottom bars that operated at high voltages. In Figure 5 the operating voltages to ground are indicated next to the deterioration.

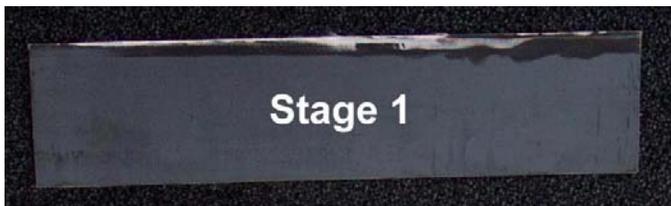
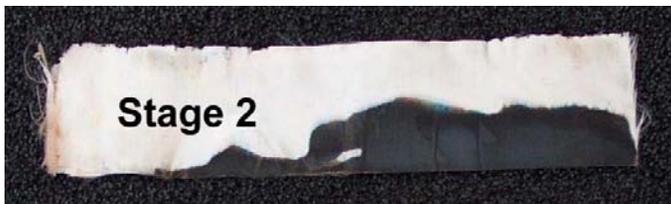
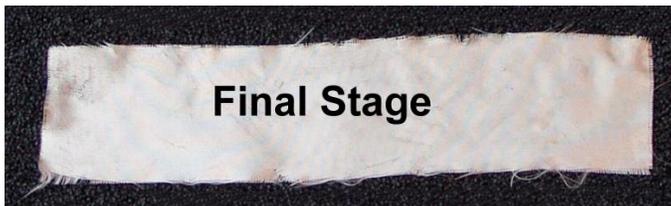
Figure 6: Progressive deterioration of slot side packing material.

Deterioration of slot side packing is likewise dependent on the operating voltage of the adjacent stator bar. Over time, as shown in Figure 6, severe slot discharges in this generator destroyed the side packing meant to hold the stator bars tight in

the core slots. In the final stage, all conductive material and binder disappeared and only a bleached glass cloth remained adjacent to the high-voltage bars. With no side packing, PD levels increase greatly and, eventually, the stator bars vibrate and fail.

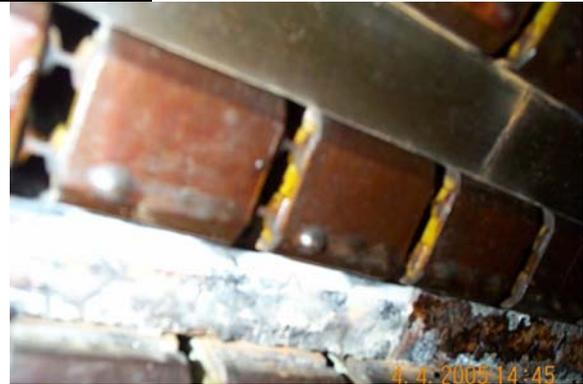
Figure 7: Stator slot with wedges burned along almost the length of the entire slot.

During a scheduled outage of the unit pictured in Figure 7, an inspection found one slot with wedges that were burned along nearly the entire length of the slot. At least one wedge appeared to be dangling out of the slot. The generator was disassembled and the rotor removed. Further inspection and disassembly found severe PD damage in the slot with the burned wedges. Signs of significant PD were also noted in other slots and areas of the stator.

Some generator designs do not utilize side packing in the slot area, as was the case with this unit. Despite the intent to essentially glue the coils into the slot, side vibration leads to mechanical abrasion of the coil insulation. The inability to establish a solid ground plane along the sides with the core iron, causes increased levels of PD activity. Together, the mechanical abrasion and PD activity eroded the coil insulation, fillers and even the slot wedges

Initially, the owner of the machine pictured in Figures 7 and 8, performed an epoxy injection procedure in the stator

slots, along with other efforts to “tighten up” the machine. Following completion of this work, the owner started the unit and began slowly applying load. Before reaching full load, less than 24 hours after starting the unit, it failed to ground in a different slot and phase than the previous one with the burned wedges. Following the second outage, the unit was successfully rewound with an optimized coil slot configuration.

Traditionally, the original manufacturers of the equipment have been considered the only ones technically competent to access and make appropriate changes. This is not necessarily factual in today’s market. A non-OEM company rewound the unit shown in Example #2, utilizing an optimized coil design and slot configuration along with up-to-date coil manufacturing techniques and materials, which were engineered in-house by the company and installed by their own field service team.

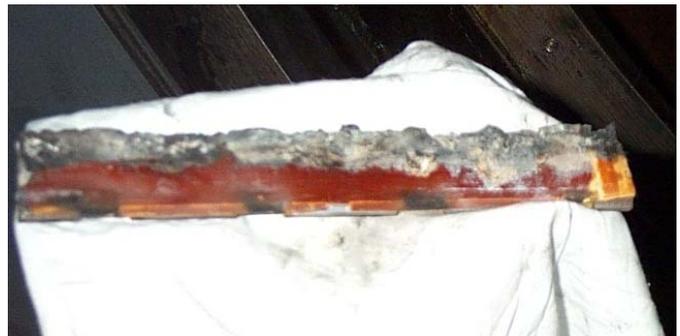
Figure 8: A wedge from the affected slot.

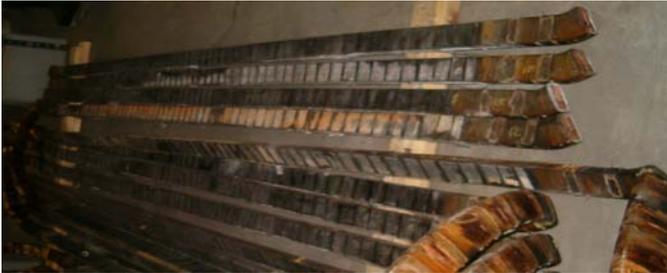
Figure 9: Bars removed from the unit by the non-OEM rewind contractor.

Figure 9 shows the condition of the bars removed during the rewind process. A difference can be noted in the degradation between the various bars. As mentioned with Example #1, corona damage was most predominant in the coils at the beginning of the coil groups that experience higher voltage levels.

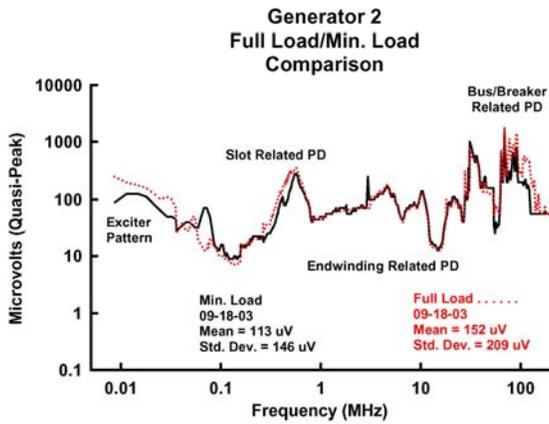
It is known that when stator bars are loose, the PD levels increase with machine load. The higher stator currents increase bar forces and vibration increase. With more stator bar vibration there is an increase in slot PD activity. The EMI signatures in Figure 10 show the slot related PD activity remains the same at two different loads.

The EMI mean and standard deviations change only slightly with load changes. There is a slight change in the exciter pattern around 0.01 MHz, due to the higher exciter currents. The part of the EMI spectrum that describes the generator from 0.1 MHz to 10 MHz did not change. The graph shows the machine had severe slot discharges, but the stator bars were tight in the core slots, as well as in the end-windings. This site has very high PD activity in the associated

generator breaker and isolated phase bus. There was a slight increase in bus/breaker related PD with a load change. This high noise level is shown on the curve from 20 MHz to 120 MHz.

Figure 10: Plot of slot-related PD and endwinding-related PD shows no increase in PD activity despite changes in load.

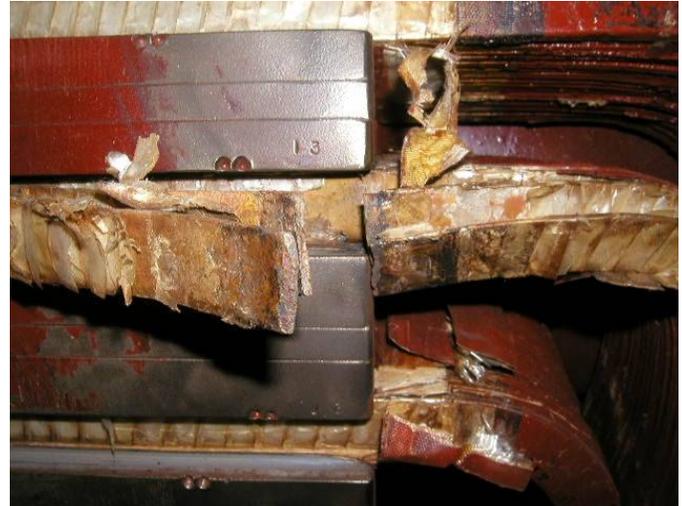
Figure 11 shows rotor conductor cracking of several top turns near the rotor body that caused a grounded rotor condition. Within the air cooled generator fleet, it is common for the units to be frequently cycled to follow demand. Cyclic operation can introduce low cycle fatigue stresses to the copper conductor, leading to cracking of the conductor.

Figure 11: Cracking of top turns near rotor body caused this rotor to go to ground.

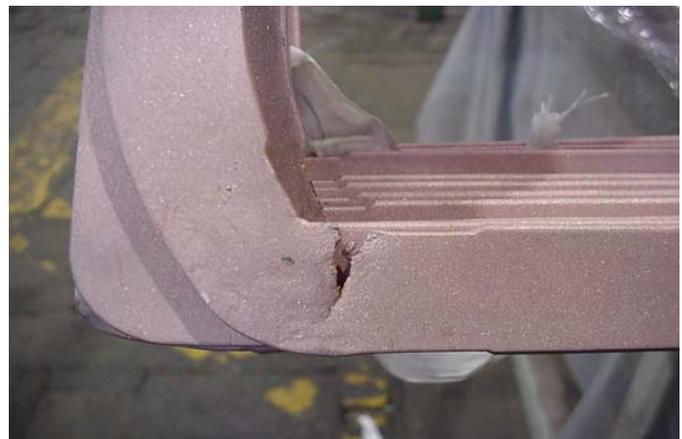
After removal from the rotor, this coil, shown in Figure 12, was cleaned by bead blasting. The cracked top turn is easily recognizable. The crack pictured was one of many found throughout the rotor winding. In all, more than ten percent of the total number of turns had cracks or indications of excessive conductor stress, requiring the replacement of the complete rotor winding.

Figure 12: Cleaning exposed the full extent of this rotor coil cracking.

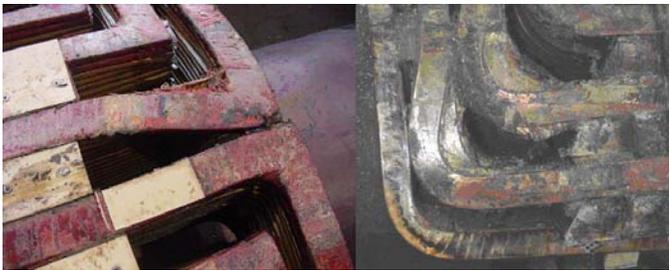
Figure 13 shows two examples of severe end winding distortions that have been caused by operational problems. Both square corner and edge bent configurations have been used effectively in many rotors. When coupled with the rest of the rotor components, in a well thought out and proven system, either can work well. However, instances of conductor cracking and distortion have been prevalent with the square corner coils, because of designs that provide inadequate relief of mechanical stress risers in the corner or because of manufacturing methods that result in inadequate corner braze joints.

Figure 13: End turn distortion, in square corner or picture frame type coils (left) and edge bent type coils (right).

Shorted turns in rotors can create significant operational issues, such as the severe vibration that follows load or swings in VAR loading. Major shorts are created if the copper conductor of a coil becomes deformed to the extent that it touches a neighboring coil as illustrated in Figure 13. Shorted turns can also arise from damaged or migrated turn insulation. Shorted turns caused by the migration of turn insulation was experienced on a number of machines of a similar design by one manufacturer. The root cause of the turn insulation migration was failure of the adhesive used to hold the strip turn insulation in the proper position, necessitating a rewind of the rotors to correct the problem.
