Deterioration of Stator Winding Insulation by Vibration Sparking

V. Warren & G.C. Stone
Iris Power
3110 American Dr.
Mississauga, ON L4V 1T2

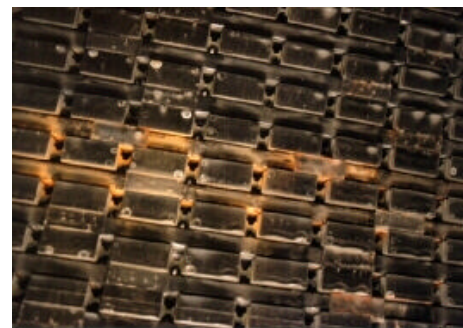
Figures 1-2 show photos of bars experiencing slot discharge considered as fairly serious and corrective action would be considered necessary.

Fig. 2. Wedges destroyed by slot PD.

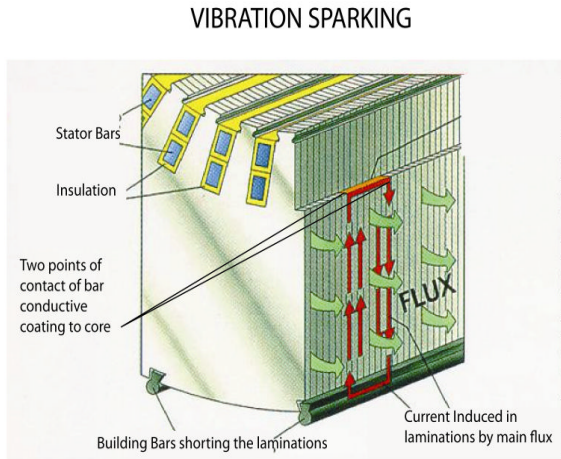
Figure 3: Mechanism of VS

The root cause of VS is too low a resistance of the slot conductive coating, together with vibration of the stator coil or bar. A current loop may exist axially along bar, radially through the core laminations, axial along the keybars at the back of the stator core, and radially back to the bar (Figure 3). If a bar is allowed to vibrate, the current in this loop will be interrupted at a contact point from the bar to the core iron. The interruption of this current will form an arc from the bar surface to the core. If the conductive coating resistance of a bar is low, this current will be of significant magnitude and the resulting arc can damage the groundwall insulation by an erosion process.

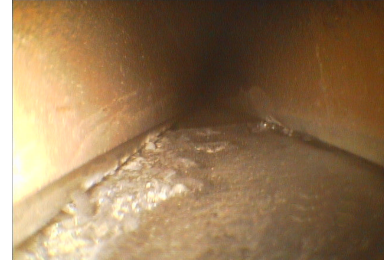
(a)

Vibration sparking is a relatively fast deterioration mechanism and has caused service failure in a relatively short time. Figure 4 shows borescope pictures of damage to a modern epoxy-mica groundwall insulation caused by vibration sparking. The stator winding of a generator of similar design failed in service after about 4 years of operation.

Fig. 4a. and b. borescope vibration sparking damage to stator bar insulation.

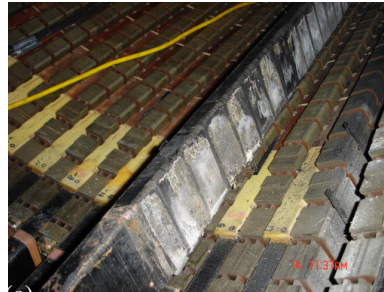
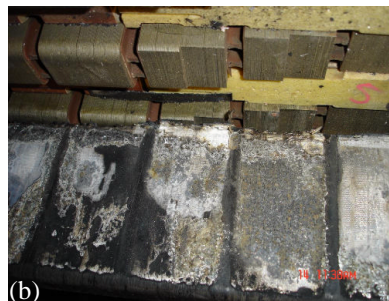
As previously stated, it may be difficult to distinguish the evidence of VS and slot discharge PD. If a bar is a high voltage bar, there may be no way to be certain, but if a deteriorated bar is from a low-voltage portion of the winding, it is certain to be VS. Figure 5 show bars that appear to have both VS and PD damage.

Fig. 5 a. and b. Bars removed from an air-cooled turbine generator suffering from both VS and the loose-coil form of slot discharge.
