EXAMPLES OF PREMATURE STATOR WINDING FAILURE IN RECENTLY MANUFACTURED MOTORS AND GENERATORS

G.C. Stone

Iris Power Engineering, Toronto, Canada

*from 10th Insucon International Conference Birmingham 2006
(pages 217–220)*

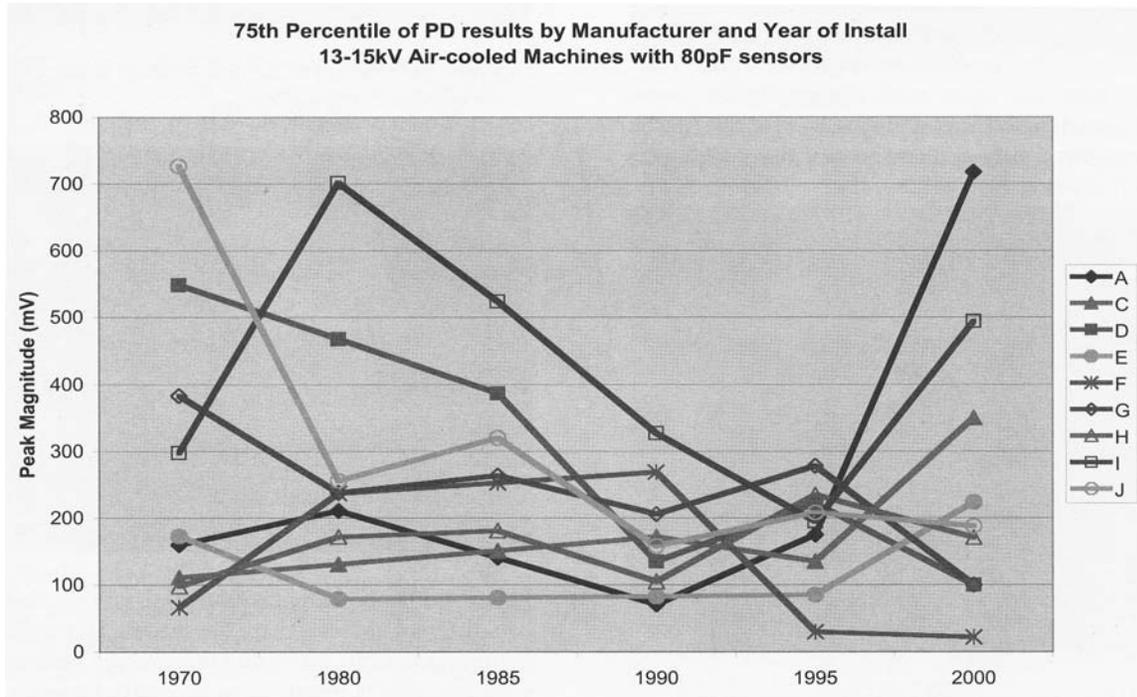
As part of the analysis of on-line partial discharge (PD) data performed on thousands of motors and generators, it has been noted that stators made by some manufacturers in the past decade have much higher PD than stators made by the same manufacturer more than 10 years ago [1]. For example, Figure 1 shows the peak PD activity vs. winding manufacturing date for 9 of the world's largest manufacturers of air-cooled motors and generators. This figure shows that for on-line PD readings measured in 2003, four manufacturers are exhibiting much higher PD on recently made stators, than they typically experienced on their machines made before 1995. Since high PD can be often associated with rapid aging of the stator winding insulation system, the high PD in recently manufactured stators is of concern.

Figure 1 Peak PD activity versus year of manufacture for 9 major manufacturers.

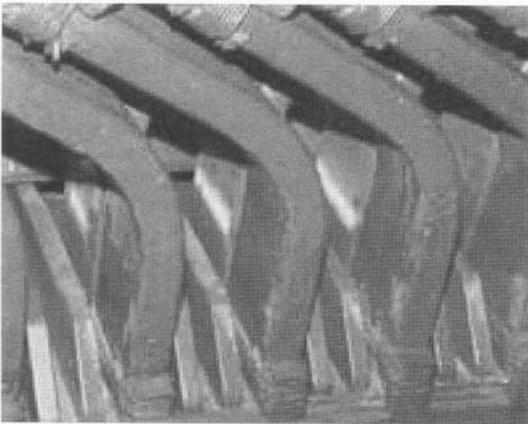
Figure 2 Semicon and grading coating overlap deterioration due to poorly applied or inadequate coatings.

Figure 2 shows a hydrogenerator stator where a very noticeable white band is visible at the junction of the semicon coating and the silicon carbide coating.

- The electric stress control problems may be caused by poorly applied coatings. The deterioration process is accelerated in winding designs that cause a class F insulation system to operate above about 120°C and/or with an average groundwall electric stress above 3 kV/mm.

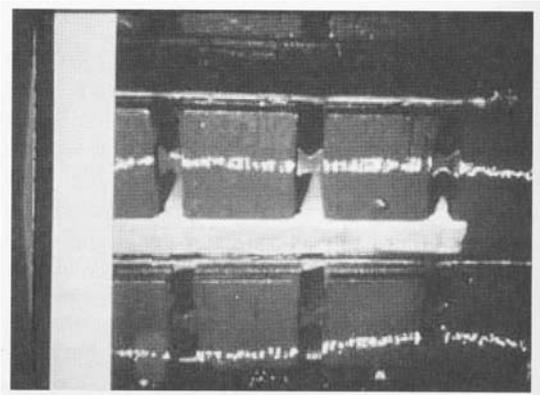
Figure 3 shows a winding where the semicon has virtually disappeared in the slot due to poor application of the semicon coating.

Figure 3 Destruction of the coil semicon coating in the stator slot due to PD and ozone.

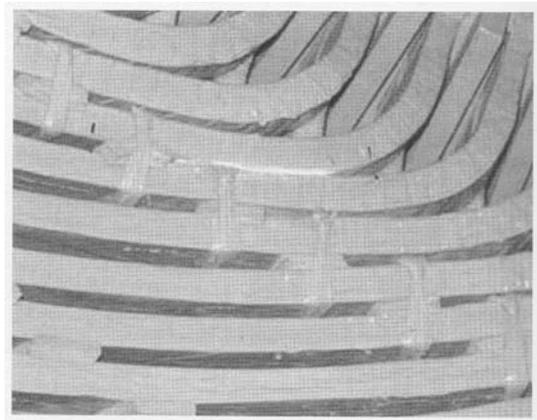
Unfortunately, in many motors and generators we have noted inadequate spacing, and consequently high PD (and ozone). Figure 4 shows the white residue caused by ozone resulting from PD between two coils in different phases that were installed too close to one-another.

Figure 4 PD occurring between high voltage coils in two different phases, where the spacing is insufficient to prevent the PD. Note that the spacing between adjacent coils is irregular, as a result of poor manufacturing processes.

- The endwinding PD is probably caused either by: (a) poor dimensional control of the coil and/or inconsistent alignment of adjacent coils in the slots; (b) too short an endwinding which does not allow enough circumference at the coil ends for sufficient air spacing between the connections; and/or (c) inattention to the air space and creepage distances needed when blocking and bracing are installed.

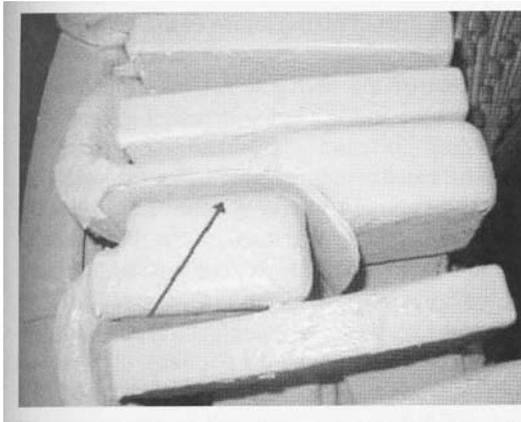
Figure 5 shows a stator where the close spacing has resulted in highly stressed air adjacent to where two phase end coils (in different phases) make connection to the circuit ring bus. The resulting partial discharge eventually bores a hole through the insulation, triggering a phase-to-phase or a phase-to-ground fault.

Figure 5 Partial discharges occurring in the inadequate space (here filled with an insulating board) between two phases where the high voltage bars are connected to the circuit ring busses. (Courtesy C. Maughan)

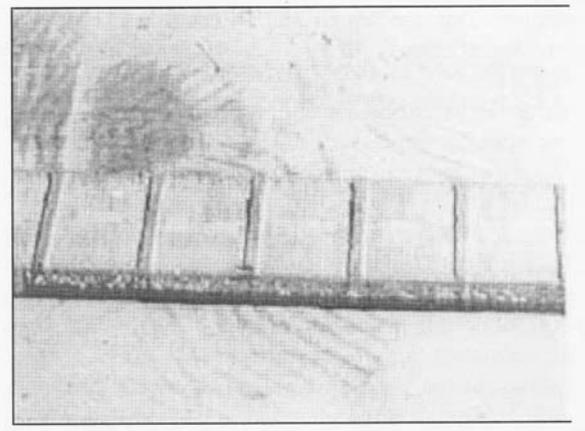
Figure 6 shows a coil that was removed from the slot of a hydrogenerator where the semicon and about 30% of the groundwall thickness has been abraded away. The manufacturer had not mechanically secured the coils in the slots by means such as sidepacking, ripple springs, two part wedges, conformable restraint in the slots, etc. Figure 7 shows a bar in the process of being removed from the stator slot that shows significant abrasion of the insulation in the slot, for the same reasons.

Figure 6 Photo of a coil removed from a hydrogenerator stator that failed due to slot discharge. The vertical stripes are where the insulation is not abraded, since the stator core ventilation ducts are at these locations.

- For non-global VPI stators, require the use of a wedging or sidepacking system that contains a follow-up restraint that ensures tightness as the slot contents shrink. This could include the use of two or three part wedges, ripple springs and/or conformable materials such as silicon rubber. Alternatively consider requiring a clearance between the side of the coil and the core to be no more than 0.1 mm or so.

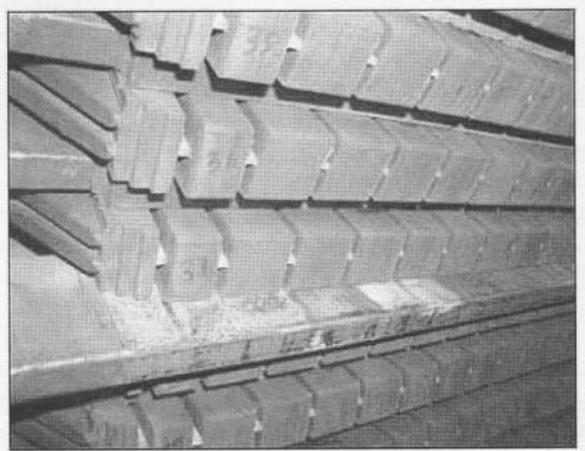
Figure 7 Bar abrasion due to loose windings in the slot of a turbo generator that did not have sufficient sidepacking or a radial follow-up wedging system.

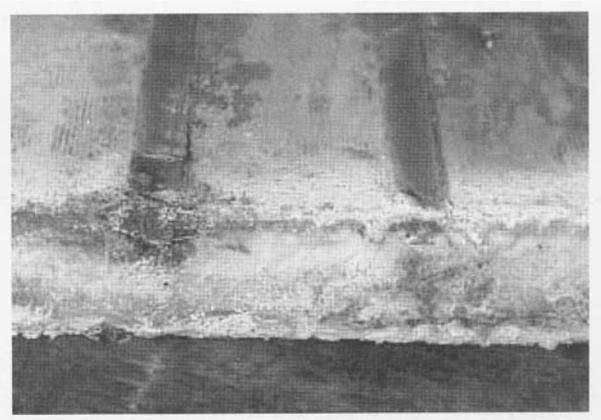
Normally one would not expect loose coils to be a problem in a global VPI stator, since the coils are effectively glued to the stator core. However, if the coils are made too small for the slot, and are subjected to load cycling that creates shear stresses between the coils and the stator core, then loose coils and slot discharge may occur in some designs (Figure 8).

Figure 8 Example of loose winding failure MVA global VPI generator stator.
