EXPERIENCE WITH DIAGNOSTIC TESTING TO EVALUATE THE REMAINING USEFUL LIFE OF A HYDROGEN-COOLED GENERATOR

Dan Huynh and Terry Hill
PacifiCorp

Hugh Zhu
Adwel International

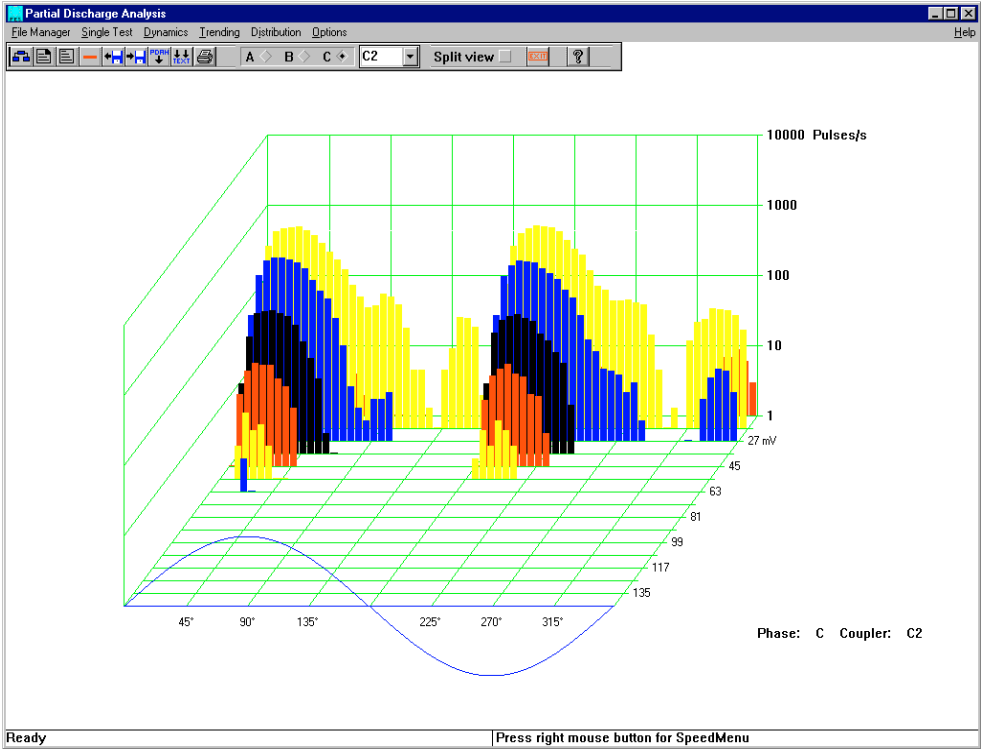
On-line partial discharge testing has been performed since 1995. A phase-resolved PD distribution in phase C from testing in 1999 is shown in Fig. 1. The three-dimension graph indicates the PD magnitude, PD pulses per second and the PD position against the 60 Hz sine wave. The PD activity in this generator was low due to effect of hydrogen gas pressure on the PD activity. The positive and negative pulse distribution has an equal distribution, this indicates that there were partial discharges within the groundwall insulation. The internal voids within groundwall insulation, created by poor impregnation during manufacture or by other aging mechanisms during machine operation, produced groundwall partial discharges under high voltage stress. Groundwall discharges can occur at delaminations or areas where bonding material is incompletely cured.

Fig. 1 Phase-resolved PD test results in 1999.

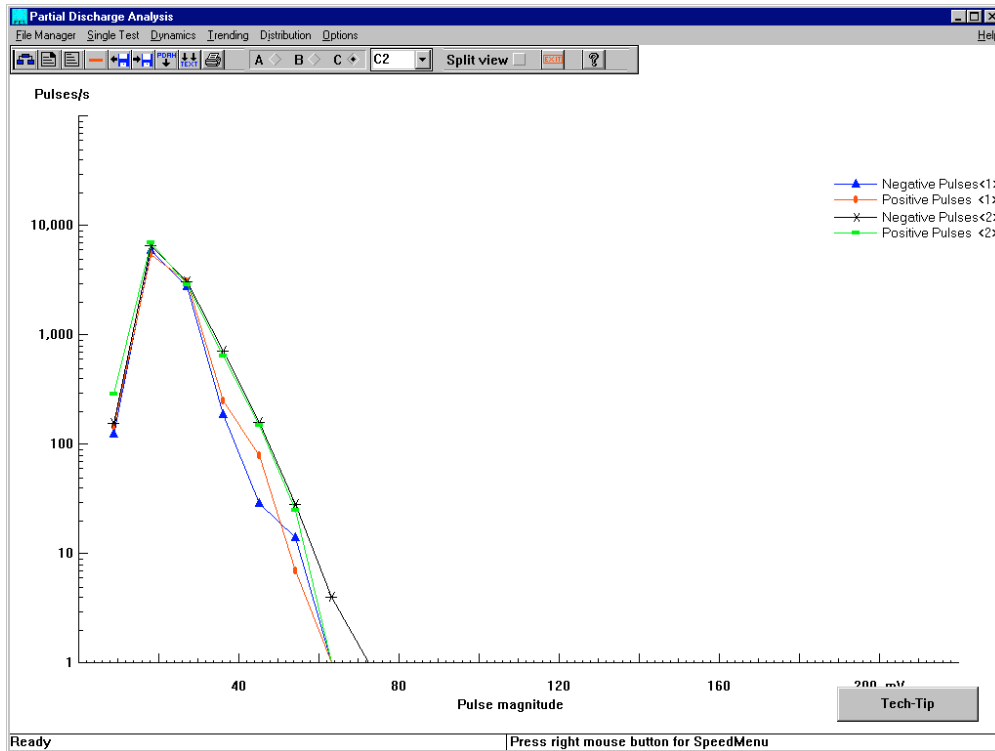
The PD measurement did not show sign of slot discharges, indicating that the stator re-wedge in 1992 tightened the winding and hence eliminated the slot discharges. The PD test results in 1995 and 1999 are compared in Fig. 2. which shows that the PD activity has been stable since 1995. There was no significant development of stator insulation deterioration.

Fig. 2 Comparison of the PD test result in 1995 and 1999.

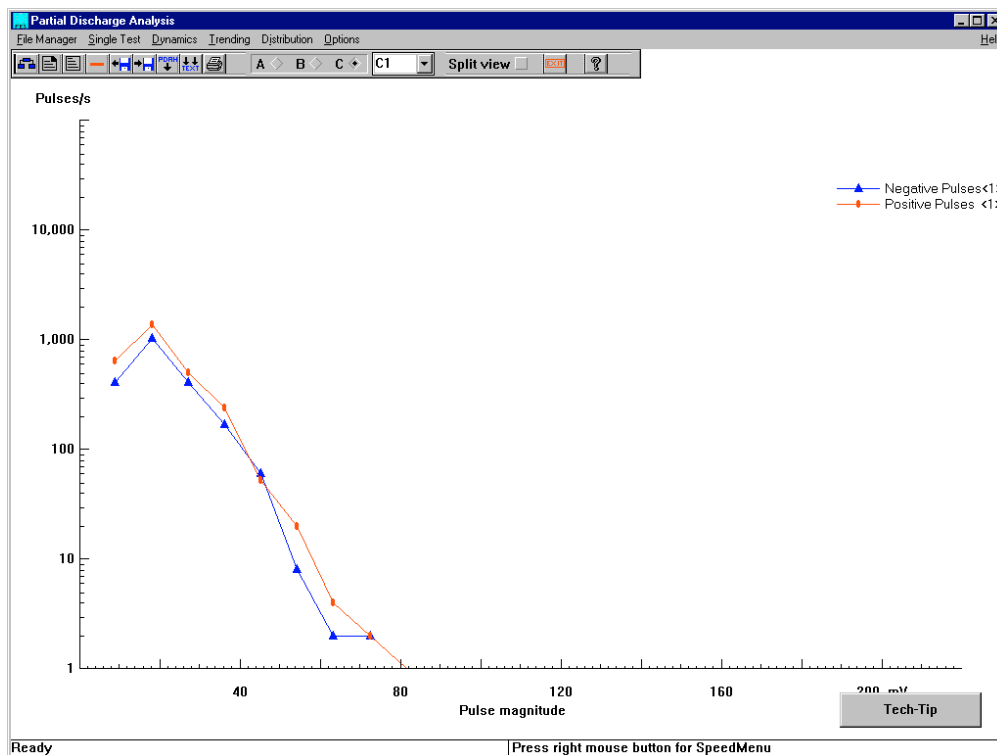
The PD distribution is shown in Fig. 4. By comparing Fig. 2 and Fig. 4, the on-line testing result is similar to that of the off-line testing. This indicated that the hydrogen pressure accompanying the on-line testing did not affect the PD activity much in this case. This may be because the nature of the partial discharges in this generator is internal, hence influence of the hydrogen pressure to the PD activity is not strong. This case also demonstrates that on-line PD testing on a hydrogen-cooled generators is valid.

Fig. 4 PD pulse number against PD magnitude (off-line testing).
