Generator Maintenance: Using PD Measurements to Identify Stator Winding Insulation Problems

Canadian provincial utility BC Hydro uses on-line partial discharge measurements to identify winding insulation problems in the stators at its hydro facilities. Several decades of experience show that this type of measurement is an efficient tool for assessing insulation condition.

By Shunyuan Li

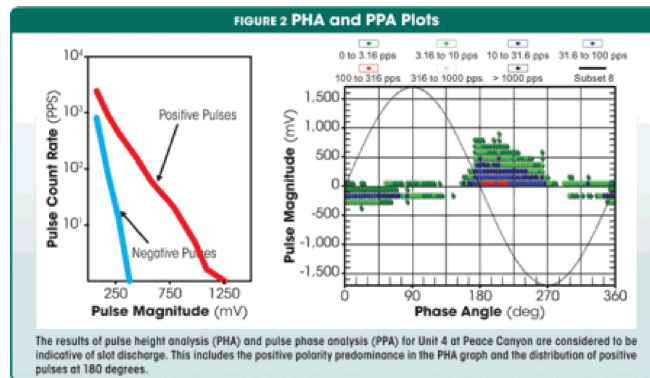
PD test data for all four units has been trended. Figure 1 illustrates a typical PD magnitude trend of circuit T9B in the Unit 4 generator. From 1993 to 1995, PD activity was increasing. In April 1995, injection of conductive room temperature vulcanized rubber into the slot portion of the high-voltage bars temporarily reduced this PD activity. However, PD increased the following year, quickly reaching the level seen before this repair attempt.

In November 1999, a line to ground fault occurred on a back bar while the unit was in service. This fault was determined to be caused by a metallic object left in the machine during construction in 1980. The faulted bar was replaced, along with the 12 front bars that had to be removed to access this bar. Three of the 13 bars replaced are the second, third, and fourth bars from the line lead end of circuit T9B. The PD level decreased radically on this circuit. However, it increased slowly over the following years.

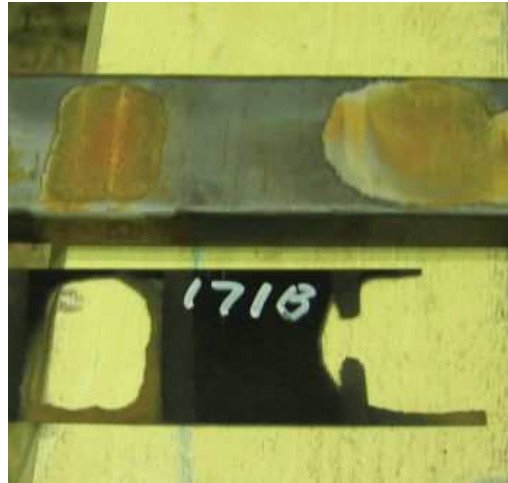
Unit 4 was removed from service in 2006. An inspection was conducted, and 12 front and nine back bars were removed for investigation. These were either the first or second bar from the line end of the three phases. In the slot portion of the bars, a significant amount of semiconductive coating and side packing had been eroded by PD activity.

This type of PD damage was observed on both sides of all front and back bars (with and without side packing), but the damage was more severe on the side with side packing than on the side without. Also, the damage to the top and bottom ends was more severe than that to the middle portion of the bar.

This slot portion of the bars for Unit 4 at Peace Canyon shows erosion of a significant amount of semiconductive coating and side packing. This erosion was caused by PD activity that occurred between the bar surface and slot.

Four stators were replaced at Peace Canyon. High PD was one of the reasons.

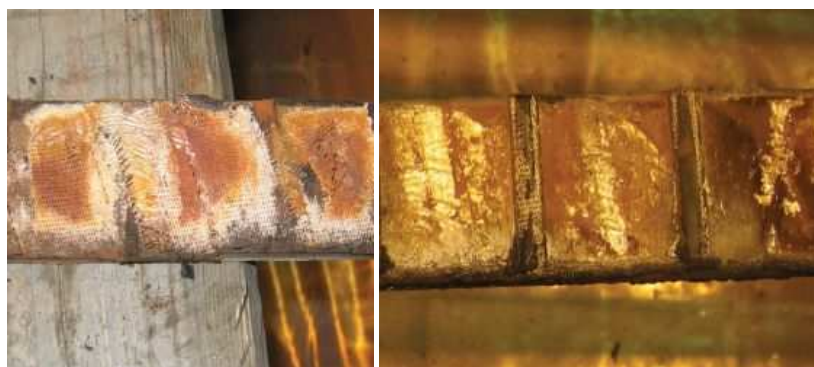
Severe slot discharge damage was observed on seven bars. These bars were in the circuits with high PD readings. The remaining removed bars were in reasonably fair condition. The semiconductive armour tapes were eroded by the PD activity between the bar surface and core and bleached by ozone. Over time, the armour tape was completely eroded away and the mica tape was exposed. The mica tape had degraded and become brittle. This stator has been replaced, but the PD problem was not the main reason.

On Unit 4 at the G.M. Shrum station, the semiconductive armour tapes were eroded by the PD activity between the bar surface and core and bleached by ozone (photo at left). Over time, the armour tape was completely eroded away and the mica tape was exposed (photo at right).
