## Generator inspection first step in avoiding failures attributed to dry stator-winding ties

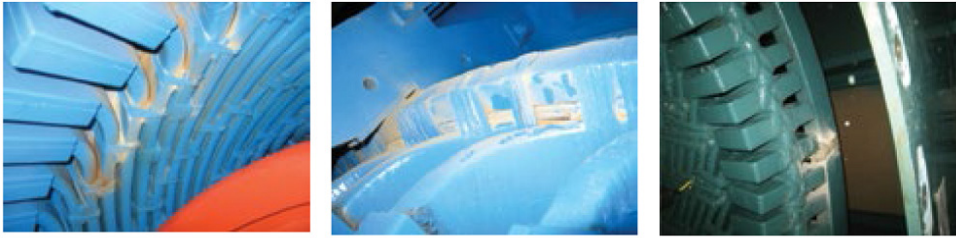
1, 2, 3. Dusting is indicative of early-stage vibration in endwinding

**Gallery.** Figs 1, 2, and 3 show dusting as evidence of early-stage vibration in an endwinding; Figs 4 and 5 reflect vibration of connection rings. Early-stage vibration illustrated in these five photos is relatively simple to repair—that is, to remove the dry ties and replace them with wet ties as recommended by the OEM. Even where insulation wear is significant (Figs 6 and 7), depending on depth and location, it may be possible to repair and retie. An alternative is a stator rewind.

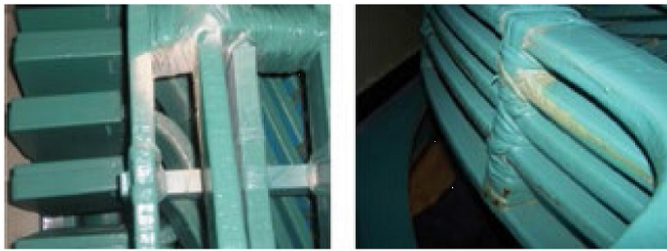
4, 5. Early-stage vibration of connection rings is identified by dusting

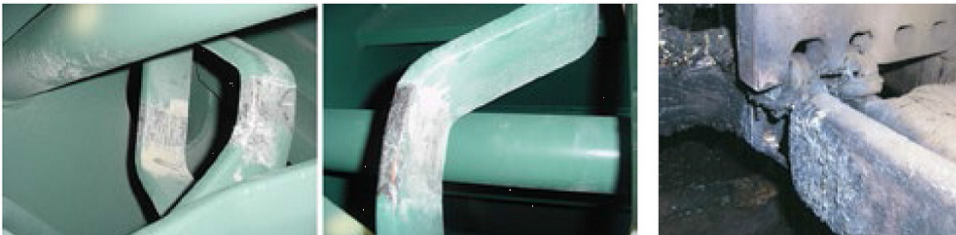
Fig 8 shows a failure location on connection rings. It illustrates the amount of physical damage that can be caused by a failure arc, which persists for several seconds after the breaker trips as field current decays. The photo also shows the relatively weak integration of the tie between ring and support: The ring is connected to the support only at an edge of the ring rather than on a wide face. If the tie and bond are not exceptionally strong, the bond will fail and vibrations and wear can begin.

6, 7. Insulation wear on two rings in different phases is clearly problematic

8. Arc damage was caused by failure of connection-ring insulation

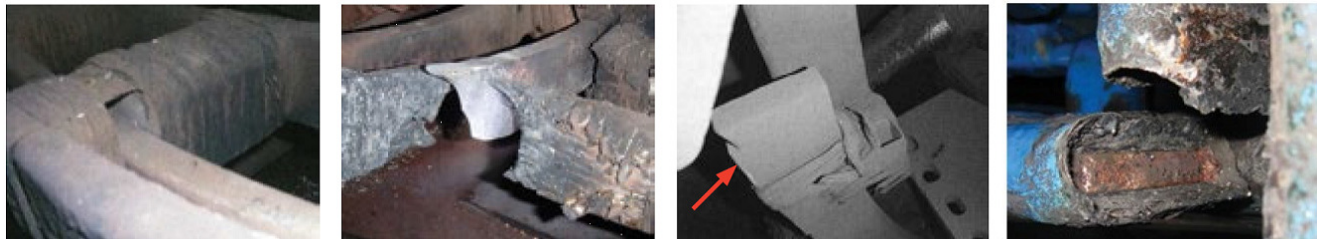
For the support in Fig 9, note that the ring is contained on the faces but it does not fill the opening provided. Thus the ring is retained only by bonding of the faces and if that bond is broken by differential-expansion forces of cyclic loading, the ring will be free to vibrate.

9. Questionable blocking of connection rings was in evidence on a winding that failed in service

10. Arc damage was found at the joint between the stator bar and connection ring

11. Dummy ring supports active connection ring in this design

12. Arc damage resulted from copper fatigue failure of a connection ring

The damage in Fig 10 probably resulted from the arc of a phase-to-phase short circuit between two locations of bared conductor caused by vibration. In the event of a line-to-line failure, the minimum repair likely would involve full stator and field rewinds and extensive core, frame, and cooler cleaning. In a worst case, stator replacement could be required.

A few designs include a dummy ring in parallel to the active connection rings (Fig 11). These generators appear particularly vulnerable to vibration and wear. As shown, the ties are not doing a good job of joining the dummy ring to the support. Keep in mind that the dummy ring is made of a composite material having a significantly different expansion coefficient than copper. During cool-down from bake, and with cyclic loading, the dummy ring tends to disbond and become free to vibrate, shift position, wear the ties, and contact and damage connection-ring insulation. Early failure of the winding may result.

increased levels of component mobility and/or vibration natural frequencies drifting into resonant situations. These changes can result in much faster insulation wear, but they may also result in high-cycle fatigue and fracture of the copper conductor (Fig 12). Each of these conditions, insulation wear and copper fatigue, is extremely dangerous to winding integrity.
