# IEEE standards may not sufficiently address grounding issues in rotor, stator windings

Clyde V Maughan, [clyde@maughan.com](mailto:clyde@maughan.com), [Maughan Generator Consultants](#)

There are two, unfortunately common, generator-winding failure modes that the IEEE standards overlook: the fracture of a rotor (field) conductor and the fracture of a stator conductor. This article describes these types of failures, discusses associated negative impacts of them, and recommends corrective actions.

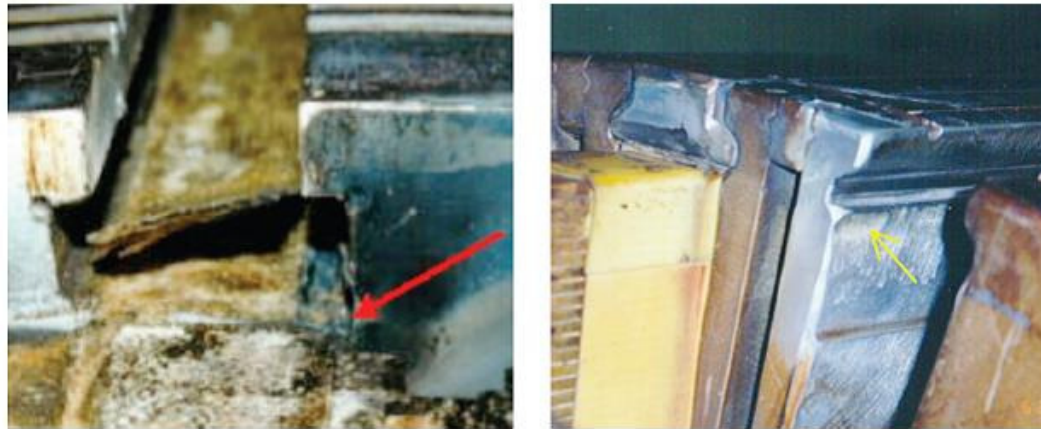
During a short period of time, the author was involved in the analysis of five rotor ground failures. One was a double ground and it resulted in minor forging burning in two locations. Fig 1 identifies one of those locations. The forging burn damage was in an area of low mechanical stress and easily corrected by minor iron removal similar to that shown in Fig 2.

**1, 2. Minor rotor-forging burn damage (left) in an area of low mechanical stress is relatively easy to correct by light grinding of field iron, as shown at the right**

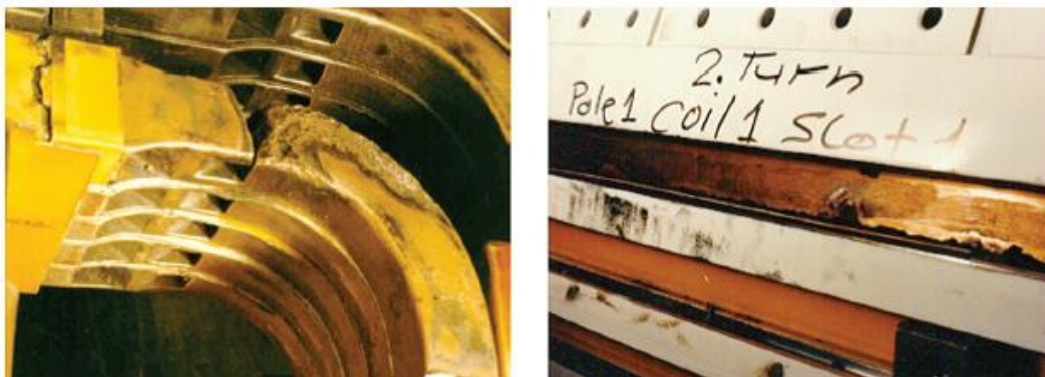
The other four failures were single grounds resulting from broken conductors or shorted coils. Each of these failures involved forging burning of a serious nature. When the turn in Fig 3 broke, current continued to flow through a conduction path that involved the retaining ring and rotor body (Fig 4).

**3, 4. Single-ground failure** initiated by a broken top turn (left) caused serious burning of the forging and copper (right) when current continued to flow

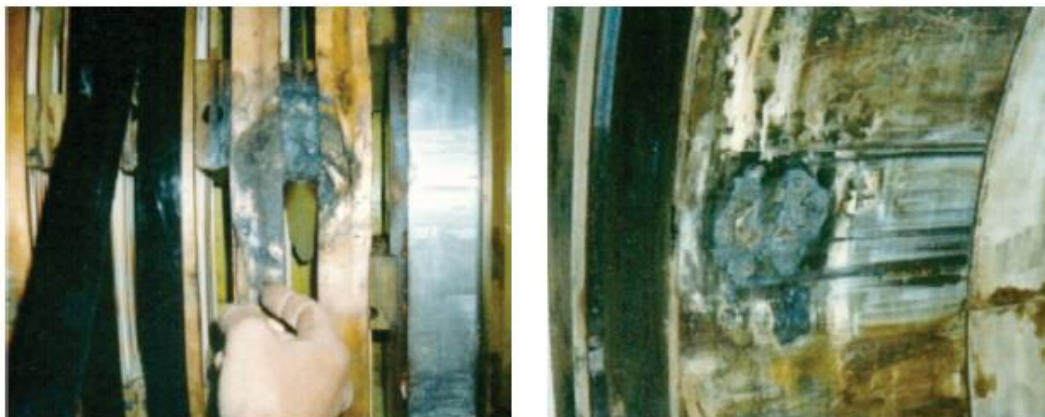
The conditions shown in Figs 5 and 6 resulted from shorting between the two largest coils in a large rotor. (Because the ground detection circuit was incorrectly connected, the ground persisted for a significant period of time.) These conditions would constitute a single ground, but the damage to the retaining ring (Fig 6) was extremely serious and dangerous.

**5, 6. Arc damage from shorting** between two coils (left) effectively removed the coils from the excitation circuit. The single ground lasted for a significant period of time because the detection circuit was connected incorrectly. Result: Near-fatal burn damage to the retaining ring (inside diameter)

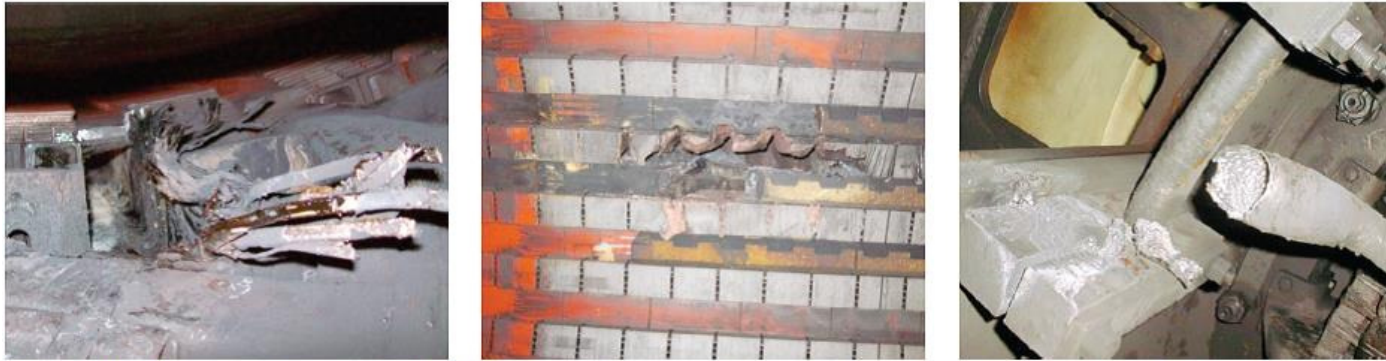
However, the condition of failure-to-ground caused by the fracture of a stator conductor is not rare. If the failure location is in the bottom 5% of the winding, this failure mode is far from benign. The author has been deeply involved in four such incidents in a recent two-year period. All occurred on a neutral bar or neutral

connection ring and caused massive damage to the generator. In addition, three other similar failures have been reported to the author, with similar massive damage. Examples of these failures are shown in Figs 7-9.

7-9. Failure-to-ground caused by the fracture of a stator conductor is not rare; examples are shown in these three photos. Core and winding damage attributed to a burned open bar in a slot is shown in the left and center photos and the burned-away copper of a fractured connection is at the right

Category 2 failures in all situations, almost certainly will be highly destructive to the generator. These failures involve fracture of the current-carrying copper. When a conductor breaks, current will temporarily continue to flow within the stator-winding groundwall insulation, as in a welding arc; the heat generated will be extremely intense. This current will flow inside the insulation until the insulation is mechanically destroyed. Experience has shown that the copper will be vaporized

for perhaps 8 to 12 in. before the internal arcing breaks through the insulation wall and becomes an exposed and widespread arc—and involves ground.

On stators, the historic stator-winding ground protection relay (59GN) should not remain as the sole protection system on any generator of importance to the power system. Based on the industry experience reported here, it is advisable to upgrade the ground protection to include 100% of the stator winding.

Based on operating experience and the current state-of-the-art for relay systems, it appears that an injection stator winding relay system (64S) should be installed on any generator where high reliability and low cost exposure are considered important.

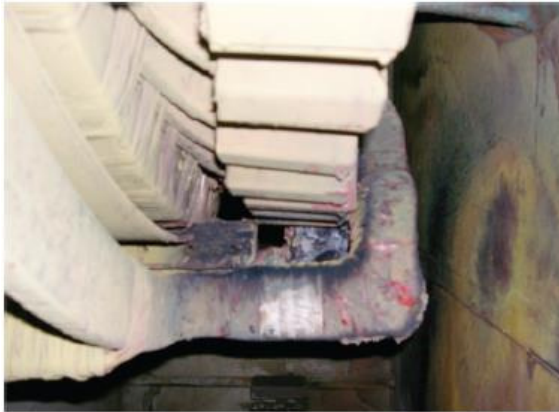
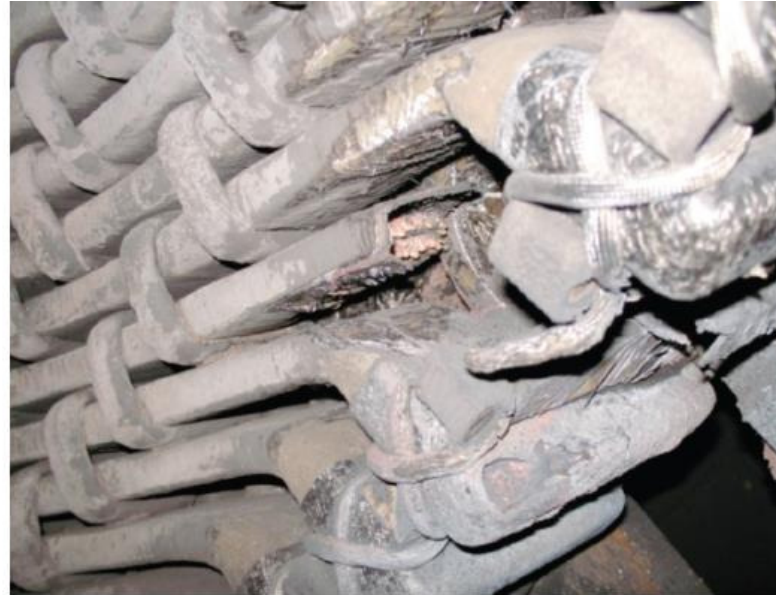
The \$324 million is an incredibly large number. For comparison purposes, there have been numerous stator-winding failures in the higher-voltage portions of windings where the ground relay trip operated correctly. Two such failures are shown in Figs 10 and 11. Following each incident, repairs were relatively minor. In one case, the contamination was sufficient to require a field rewind. In both cases, the stator repair was accomplished without a rewind. Outage time was in the order of one month for each failure.

**10, 11. Numerous stator-winding failures** have occurred in the higher-voltage portions of windings where the ground relay successfully tripped the generator. Repairs to correct the failed phase connection above and the failed series connection at the right were relatively minor
