# Improved Requirements for Stress-Grading Systems at Hydro-Québec

Rémi Tremblay <sup>(1)</sup>, Claude Hudon <sup>(2)</sup>

<sup>(1)</sup> Generation Engineering, Hydro-Québec, Montréal, Québec, Canada

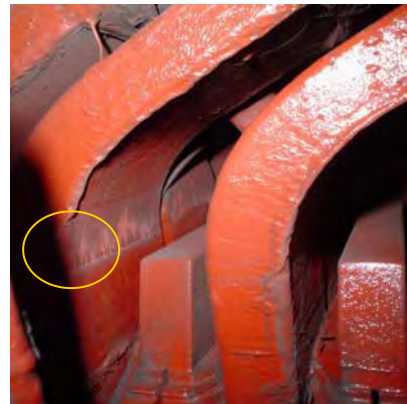
In recent years, inspections have revealed traces of white powder at the junction of the semiconductive and grading coatings of a number of Hydro-Québec stator windings. The white powder results from surface discharges attacking and decomposing the insulating material and by air ionizing around the bar. Such defects were even seen on stator windings with only four years of service (see Figure 1).

Figure 1 – Signs of discharges on a winding after just four years of service

On-site corrective action must be taken to remedy the deterioration before it becomes critical. This entails shutting down generating units, which is clearly undesirable in an increasingly competitive market for electricity sales.

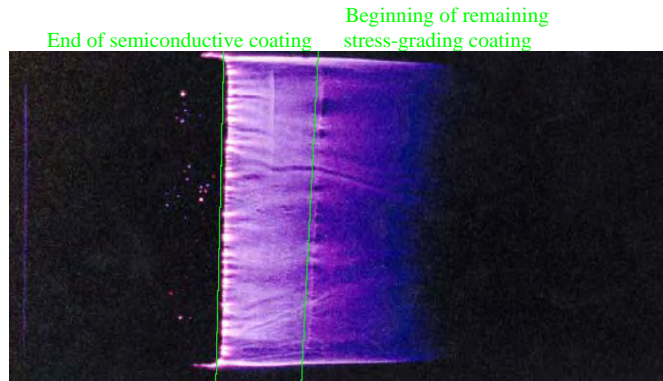
Several bars were subjected to accelerated ageing tests at 20 kV. Figure 2 is a photograph taken in the lab of a bar whose junction was artificially degraded.

Figure 2 – Corona effect at a degraded junction subjected to 20 kV in the laboratory

In the laboratory, breakdowns occurred inside the slot near the slot exit. The same kind of defect was observed earlier in generators with fairly marked signs of the corona effect. At the time, however, we were unable to associate the defects with deterioration of the junction. The hypothesis put forward to explain this phenomenon is that when the junction has completely deteriorated, the overall surface current from PD activity exceeds the ohmic resistance of the semiconductive paint. The current is near-uniformly distributed around the bar between the paint-paint junction and the iron substrate, and the current density is too weak to burn the semiconductive coating. Ground contact in the slot, however, is much less uniform due to the rough surfaces and inevitable gaps between the bar and the sides of the slot. Furthermore, since the coating has a much higher resistance at very high frequencies than at 60 Hz, the PD current would tend to drain to the iron as soon as it enters the slot. Discharge currents will thus drain to ground at just a few spots. The local current density can therefore be very high and can raise the temperature above the acceptable limit for the coating, thus causing it to burn. This will cause the corona to appear in the slot and may lead to breakdown of the ground-wall insulation.

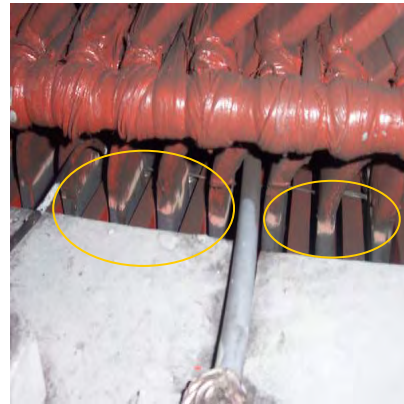
Figure 3 – Priority 1 signs of the corona effect

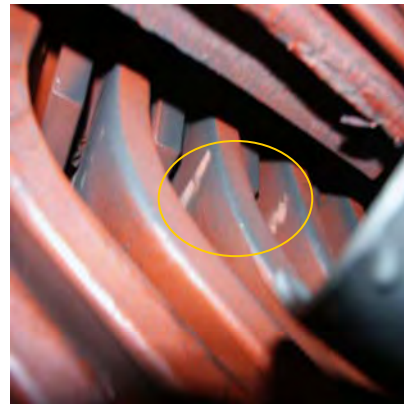
Figure 4 – Priority 2 signs of the corona effect

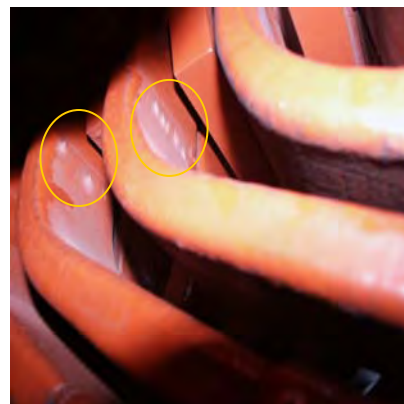
Figure 5 – Priority 3 signs of the corona effect

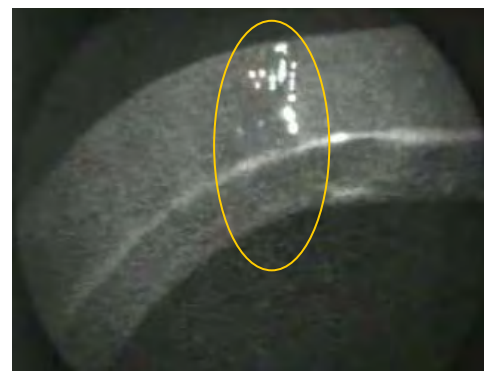
To better understand the problem of corona effects and the poor initial performance of coatings, IREQ conducted tests with an ultraviolet (UV) camera on spare bars supplied some 30 years ago (Figures 6 and 7). During lab tests on 31 stator bars from three manufacturers and with four kinds of semiconductive and stress-grading coatings, corona inception voltages (CIVs) as low as 5.2 kV were recorded at the stress-grading junction. Such values are clearly unacceptable since bars on the phase side of the stator winding are permanently subjected to 7.9 kV on most Hydro-Québec generators. Some bars, however, had excellent results (see Table 1).

Figure 6 – UV camera view of the corona discharge at the junction – Case 1

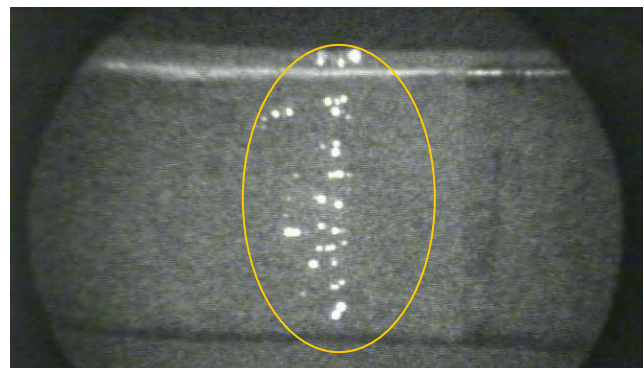
Figure 7 – UV camera view of the corona discharge at the junction – Case 2

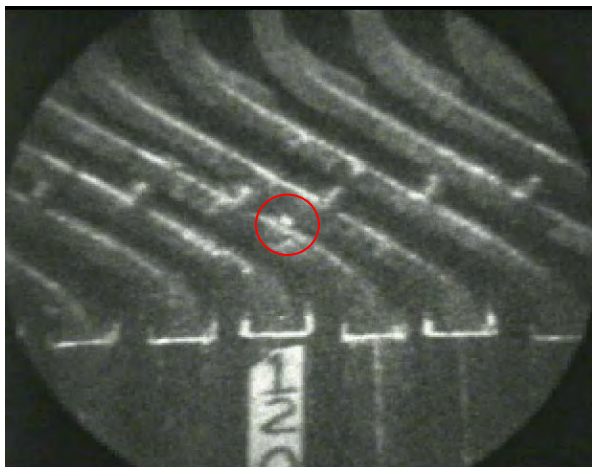
Figure 9 – Sign of the corona effect in the generating station

Besides factory tests that ensure that the stress-grading coating itself is of high quality, other testing is carried out at the generating station after the unit has been assembled but just before applying finishing paint. This final testing ensures that defects did not slip in during assembly (scratches, chipped paint, inadequate spacing, mispositioned RTD cable, etc.). During generating station testing, each stator phase is energized while the other two phases are grounded. The test voltage is 12 kV AC at ambient temperature. Spots with visible PDs must be repaired by sanding, cleaning or applying stress-grading paint.
