POWER

Vol. 150 • No. 1 • March 2006

Include generators and exciters in your outage inspections

By **Bill Moore, PE**, National Electric Coil

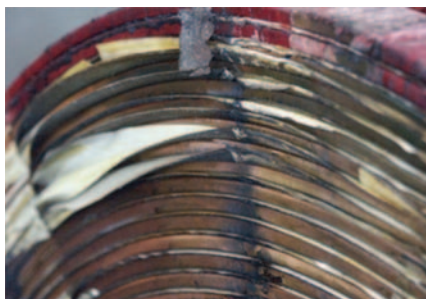
1. Creeping out. Exposing the end windings of this GE Frame 7's generator by removing its retaining rings reveals that insulation has crept out from between the turns. *Courtesy: National Electric Coil*

Problem. Across the industry, a number of generator rotors have experienced the problem of turn insulation migration. The insulation between the copper turns slips out of position because the adhesive bond between the insulation and the copper breaks down. Short-circuits develop as bare copper is exposed. Coils with shorted turns run cooler, and this causes a temperature imbalance. If enough turns develop shorts, rotor vibration can increase to unacceptable levels.

Prevention. Inserting a borescope under the retaining rings can help identify existing insulation migration. Removing the retaining rings can confirm the extent of the problem (Figure 1). Completely rewinding the rotor with Class F insulation and using a proven adhesive to hold it in place is the best long-term solution. Partial rewinds have proven less successful.

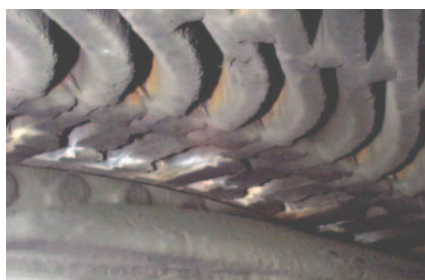
2. Telltale sign. Evidence of partial discharge activity is the white discoloration on the coil insulation surface of this stator winding of a 9,490-kVA, 600-rpm generator from the UK's Brush Electrical Machines Ltd. In this case, the PD likely was caused by the lack of a gradient coating in the end turn cell bend area. *Courtesy: National Electric Coil*

coil if the insulation is manufactured with the presence of voids. PD external to the core often occurs in the gaps between the coil and the stator core or in the end turns if the coils are in close proximity. Because the breakdown is partial, the condition does not create a full electrical ground. However, over time, PD can cause enough cumulative deterioration to create a full ground, tripping the generator off line. If PD activity is severe, it can totally destroy the resins and binders of slot filler materials. PD activity is often observed as a discoloration, usually white, of the coil insulation surface (Figure 2).

Prevention. PD activity can be monitored while a generator is on-line. But doing so requires inserting stator slot couplers under the stator slot wedges to track the magnitude and frequency of the discharges. Merely detecting PD activity alone isn't as beneficial as trending it over time, because different machines have different baseline values. For example, if PD levels double over a six-month period, a

generator should be opened up and visually inspected. Once PD has damaged a unit, rewinding it with properly designed coils or bars may be the only permanent solution.

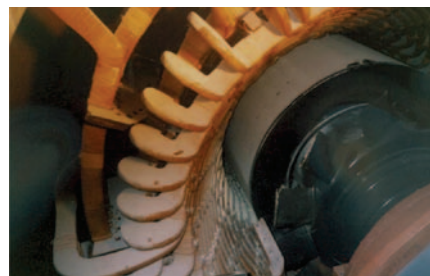
3. Condemnation. Fire extinguisher chemicals contaminated this four-pole Brush unit, which was designed to produce 21,150 kVA at 1,800 rpm. Its rotor and stator windings and core were condemned. *Courtesy: National Electric Coil*

Problem. Contamination by oil, chemicals, or dirt can cause all sorts of generator problems. For generators cooled by hydrogen, maintaining the purity of the gas is critical to their efficient operation and cooling. Oil leaking into a generator can reduce hydrogen purity enough to cause a trip. For air-cooled machines, dirt and dust are a common cause of electrical grounds. Generators sited outdoors or in corrosive environments face similar risks from airborne contaminants. Even fire extinguisher chemicals can cause extensive damage (Figure 3).

Prevention. Good maintenance practices are the first line of defense against contamination. Hydrogen dryers and leak detectors should be inspected regularly for signs of oil or water intrusion. Desiccants should be replaced regularly and filters for air-cooled units cleaned regularly. Though contamination from accidents may be unavoidable, work and emergency procedures should be reviewed to minimize risks. Insulation resistance tests, and calculation of the PI (Polarization Index) are a good way to gauge a rotor or stator winding's overall cleanliness.

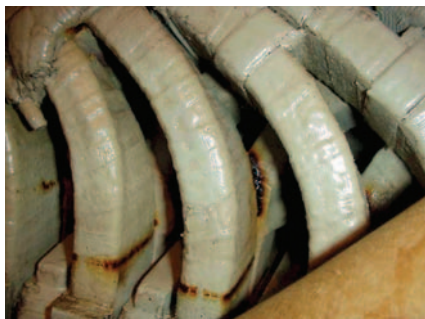
4. Vibration's damage. The greasing between the coils is symptomatic of end-turn vibration. The grease results from the mixing of entrained oil with particles of insulation dislodged by the relative motion of coils. *Courtesy: National Electric Coil*

tion (precipitating a ground fault) or breakage of coil strands (leading to overheating). Stator vibration, which is caused by double-frequency operating forces, can loosen the end turns over time. Figure 4 shows the telltale greasing produced by end-turn vibration. As the coils' relative motion wears away their insulation, particles of dislodged insulation mix with entrained oil to form grease. Figure 5 shows the white dusting (caused by contact of the stator coil's end turns and the support bracket) of the juncture of the bracket and the end-turn surge ring.

Prevention. A "bump" test can reveal if a generator's stator windings are resonating at 120 Hz, making them prone to vibration problems. Stator windings whose end turns vibrate chronically may have to be retrofitted with a new bracing system. Such a system must be carefully engineered so it decouples the end turns from the stator core and braces them radially while allowing their free axial expansion with temperature changes.

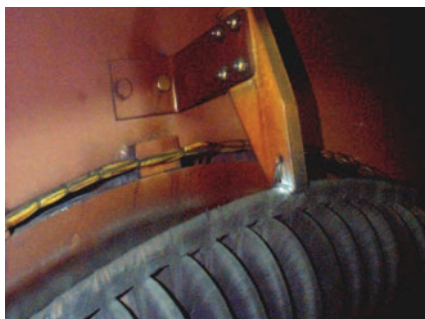
5. Ah, there's the rub. Note the white powder where the bracket and the end turn surge ring meet. The dusting was created by the relative movement of the stator coil's end turns and the support bracket. *Courtesy: National Electric Coil*

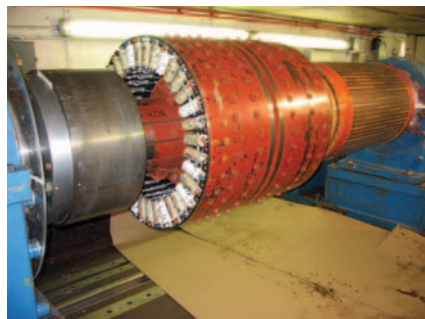
6. High-speed balancing. A high-speed balance of the entire exciter assembly is an important part of a quality exciter refurbishment. The 3,600-rpm Siemens-WH exciter shown—with a nameplate rating of 4,500 kW—is one of only a handful of hydrogen-cooled exciters in operation and among the largest exciters in existence. *Courtesy: National Electric Coil*

Prevention. Any inspection and testing program should include visual inspections and procedures for removing, cleaning, testing, and reassembling individual components. When an exciter needs to be refurbished, the scope of work should include electrical testing and high-speed balancing (Figure 6) of the exciter assembly.

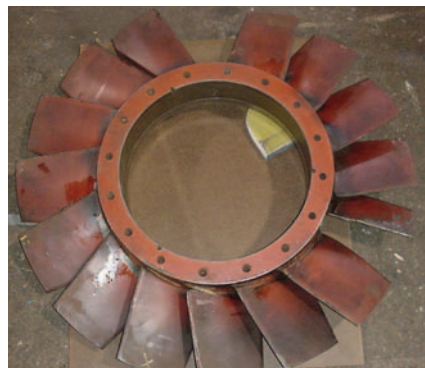
7. Cracking under fatigue. Rotating fans can develop fatigue cracks with enough operational cycles—as this one did. Pieces of blades came loose and caused enough damage to require both stator and rotor rewinds. *Courtesy: National Electric Coil*

Prevention. Any generator component that can fail or be dislodged—including rotor fan blades (Figure 7), balance weights, slot wedges (Figure 8), bolts, and pantleg washers—should be inspected regularly. Obviously, take care not to leave any inspection, testing, or maintenance tools behind, because they could cause catastrophic damage upon re-start. Pulling the generator's rotor facilitates more-thorough inspections. Following the visual inspections, do a final crawl-through and remember to perform ultrasonic or magnetic particle tests on critical rotating components. In the case of the

fan shown in Figure 7, its replacement was designed to eliminate or reduce harmonic vibratory modes and stresses. The blades of the new fan were made thicker and stronger, significantly increasing their mechanical-resonance frequencies.

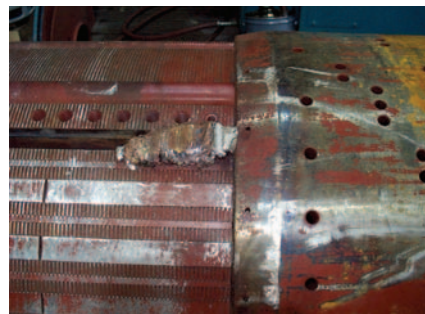
8. Wreaking havoc. The failure of a rotor slot wedge also can produce severe damage. *Courtesy: National Electric Coil*

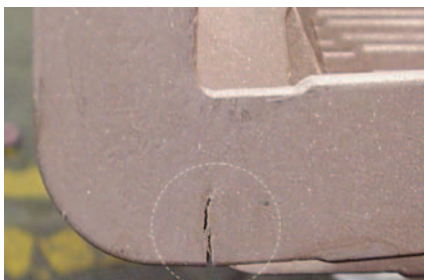
Problem. Many generator components are susceptible to fatigue stresses that can foster cracking. With rotors, cycling service can cause low-cycle fatigue cracking of forged rotors, including cracks in tooth tops, snap ring grooves and fluted areas, windings, slot wedges, wedge grooves, and retaining rings. The failure of a forged component can initiate conditions that can completely destroy a generator or even cause loss of life. Figure 9 shows cracking of a copper turn—in the blade base area, rather than in a weld joint—that was attributed to low-cycle fatigue stresses. Rotating fan blades are more susceptible to high-cycle fatigue cracking.

9. Tired turn. Low-cycle stresses can lead to fatigue cracking of copper turns. The resulting arcing and burning can cause short-circuits and rotor imbalance. *Courtesy: National Electric Coil*

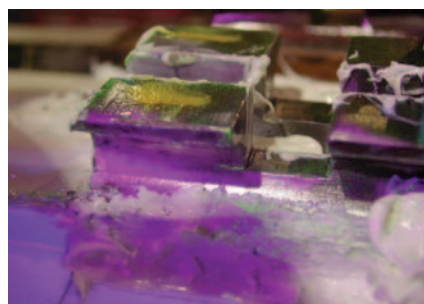
10. Test to prevent cracking. Cracks in a rotor's snap ring groove can be identified by a wet fluorescent magnetic particle test. *Courtesy: National Electric Coil*

Prevention. Regular nondestructive examination (NDE) helps you find cracks early, before a failure occurs and the component has to be repaired or replaced. The choice of inspection method depends on the material, accessibility of parts, and other criteria. Select from among ultrasonic, wet fluorescent magnetic particle (Figure 10), eddy current, and simple dye penetrant testing.

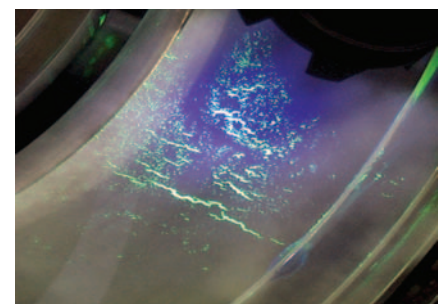
Problem. Stress corrosion cracking (SCC) occurs on nonmagnetic retaining rings—particularly those made of 18Mn5Cr alloy steel. The presence of high stresses (retaining rings typically are the most highly stressed component of a generator), moisture, or chlorides will initiate cracking and pitting of this material. Laboratory tests have shown that when conditions are ideal

for cracking, cracks can grow as quickly as 0.001 inch per hour.

11. Early detection essential. Stress corrosion cracking of an 18Mn5Cr retaining ring revealed by nondestructive examination. *Courtesy: National Electric Coil*

Prevention. SCC of retaining rings can be prevented by keeping them dry. This can be difficult on air-cooled generators because—unlike hydrogen-cooled machines—they are influenced by ambient conditions. Regular NDE, using ultrasonic and dye penetrant testing, can detect cracking early (Figure 11). An alternative—but expensive—approach is to replace the 18Mn5Cr retaining rings with rings made of 18Mn18Cr, a material that is much less susceptible to SCC.

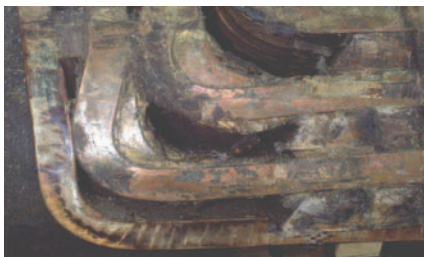
Problem. Severe rotor winding distortion and turn displacement can cause shorted turns or electrical grounds. The distortion can be caused by poor design of the end-turn blocking supports or by the lack of an adequate slip plane between the top copper turns and the retaining ring. This causes the top turns to elongate, as shown in Figure 12.

12. Out of whack. Rotor coils or turns can short out when the turns elongate. Because the shorted turns operated at a lower temperature than their counterparts on the opposite pole, the rotor bows, creating an unbalance. Shorted turns also reduce the rotor's excitation capability. *Courtesy: National Electric Coil*

Prevention. Proper design of the rotor coils and the blocking supporting the coils under axial loads is essential. In some instances, if only the top turn is distorted, it can be put back into its proper position. Rotors should be tested for turn-to-turn shorts with a flux probe at operating speed. Retaining-ring ground insulation should have a Teflon surface to allow coils to expand and contract with temperature.

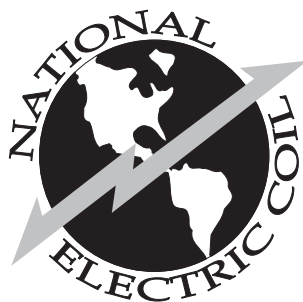
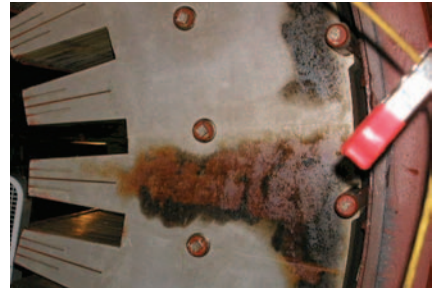
13. Surprising stator. The arc damage to the surfaces of the lamination was invisible until the stator core was unstacked. The generator shown is a 3,600-rpm Westinghouse unit rated at 493,000 kVA with a direct hydrogen-cooled, double-tube stack winding. *Courtesy: National Electric Coil*

Problem. A stator core can loosen over time as pre-tensioned through-bolts relax. A loose core is susceptible to coil and lamination damage. If laminations vibrate relative to one another, they can cause wear of surface insulation. Such wear leads to shorts, core hot spots, and—eventually—core-to-core or coil-to-core failure. Note that in Figure 13, the arc damage to the surfaces of the lamination was not visible until after the core was unstacked.

Prevention. Inspection of through-bolt tightness is recommended at regular intervals. Regular EL CID (electromagnetic core imperfection detection) tests or loop test inspections of the stator core can be used to verify its continued integrity. The knife test is an even simpler way to check for stator core looseness. ■
