Partial Discharge Activity vs. Operating Temperature Investigation

Jeffery Nofsinger
Power Production Engineering
Idaho Power Company

DC Ramp Testing on 6.9 kV Generators

Cable Testing at the Lower Salmon Plant

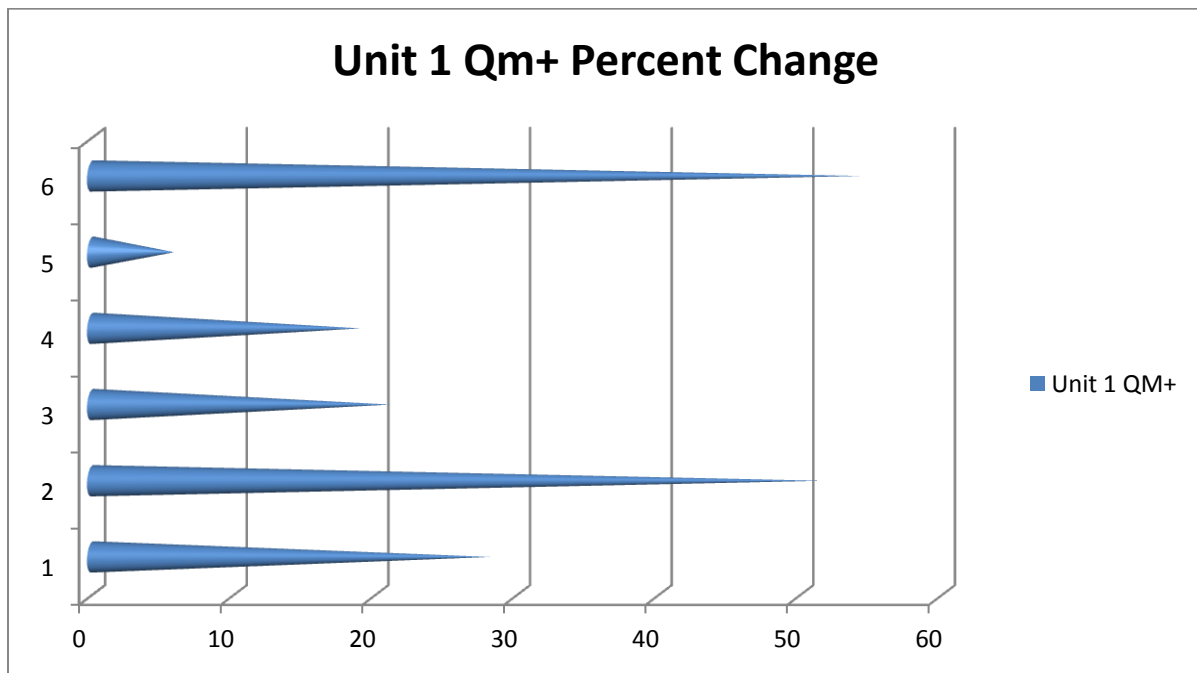
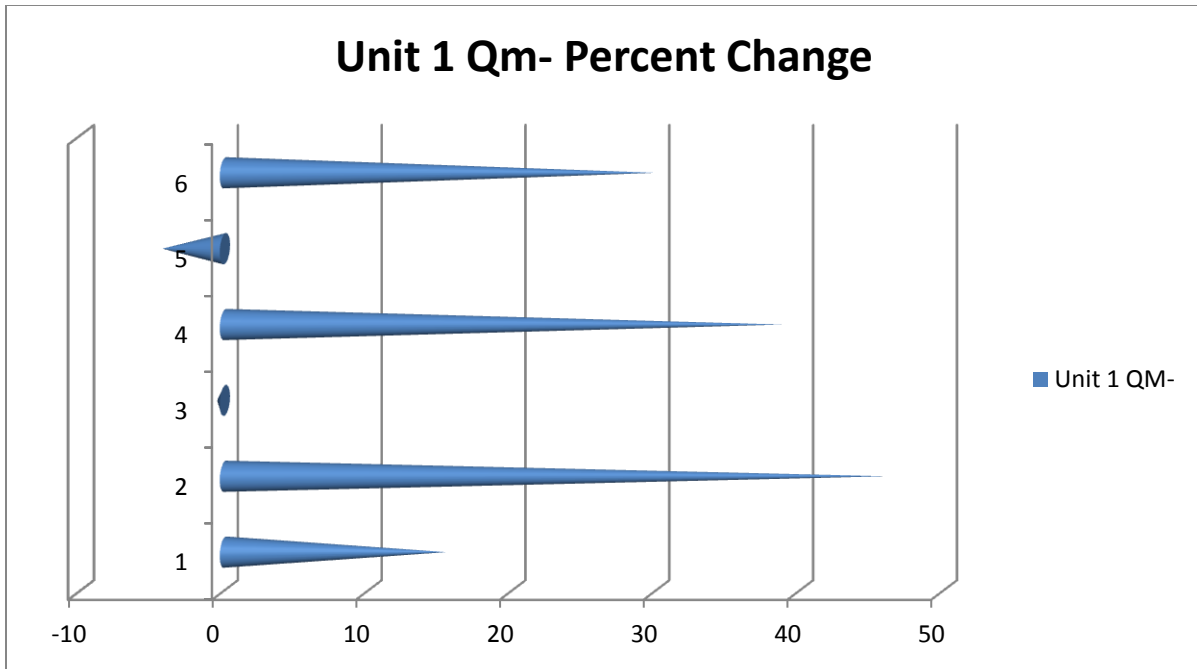
As shown in the charts, Unit 1 Qm levels rose significantly when the power level and temperature was reduced in the unit. To see if any predominance occurred in the unit when cold, the following chart depicts the change in Qm with a shift toward the Qm+ as a positive number to the right. The chart shows a slight shift to Qm+ but not substantial. The results for this unit show that overall PDA levels increase in this unit when cold and at low power and that the PDA remains in the bulk of the insulation.

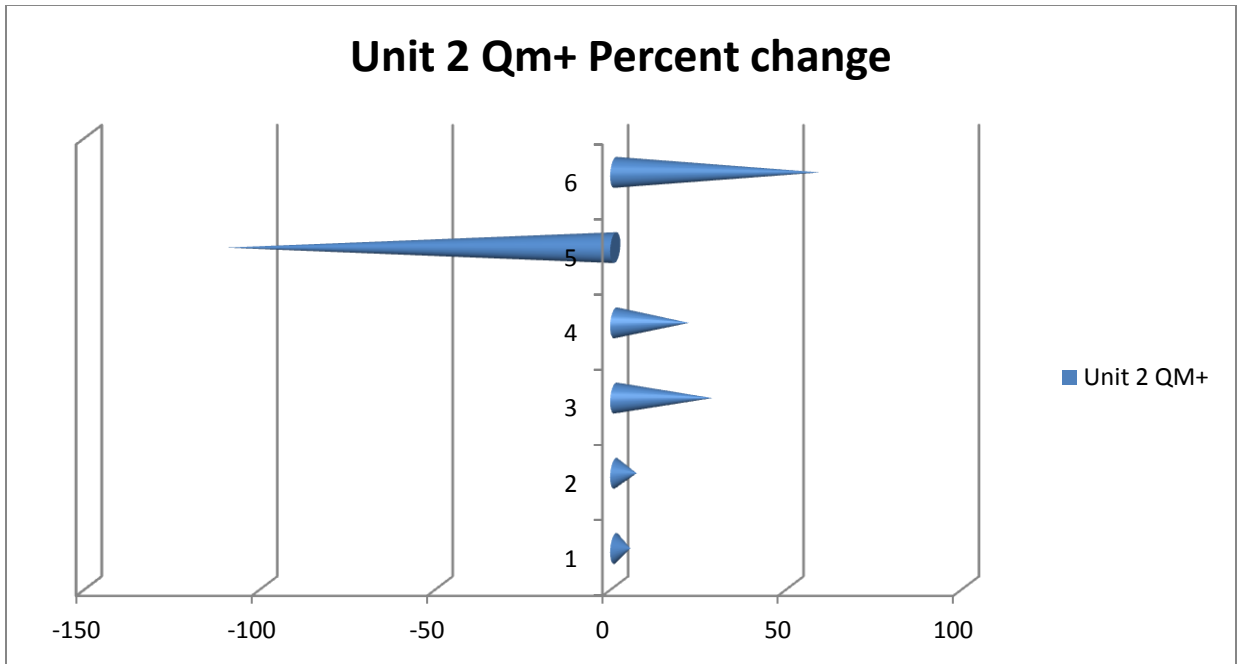
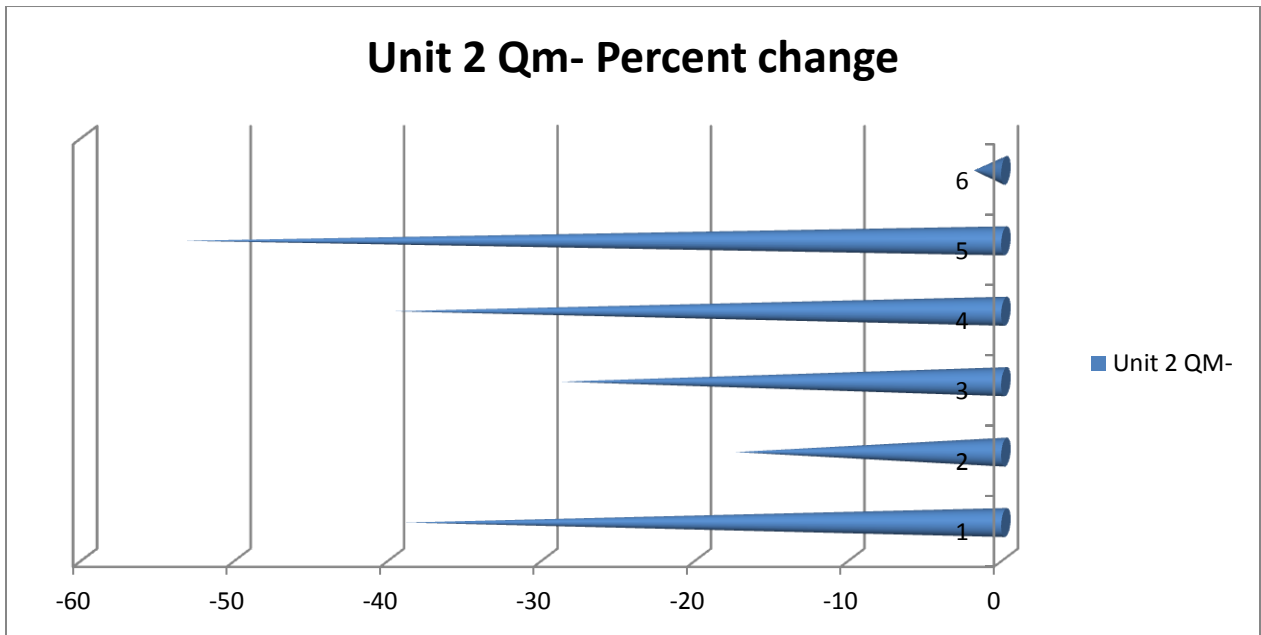
The results show that the Qm+ levels of 5 of 6 couplers increased with the remaining coupler falling over 100%. This coupler is consistent over time as in 2002 it showed the largest negative change.

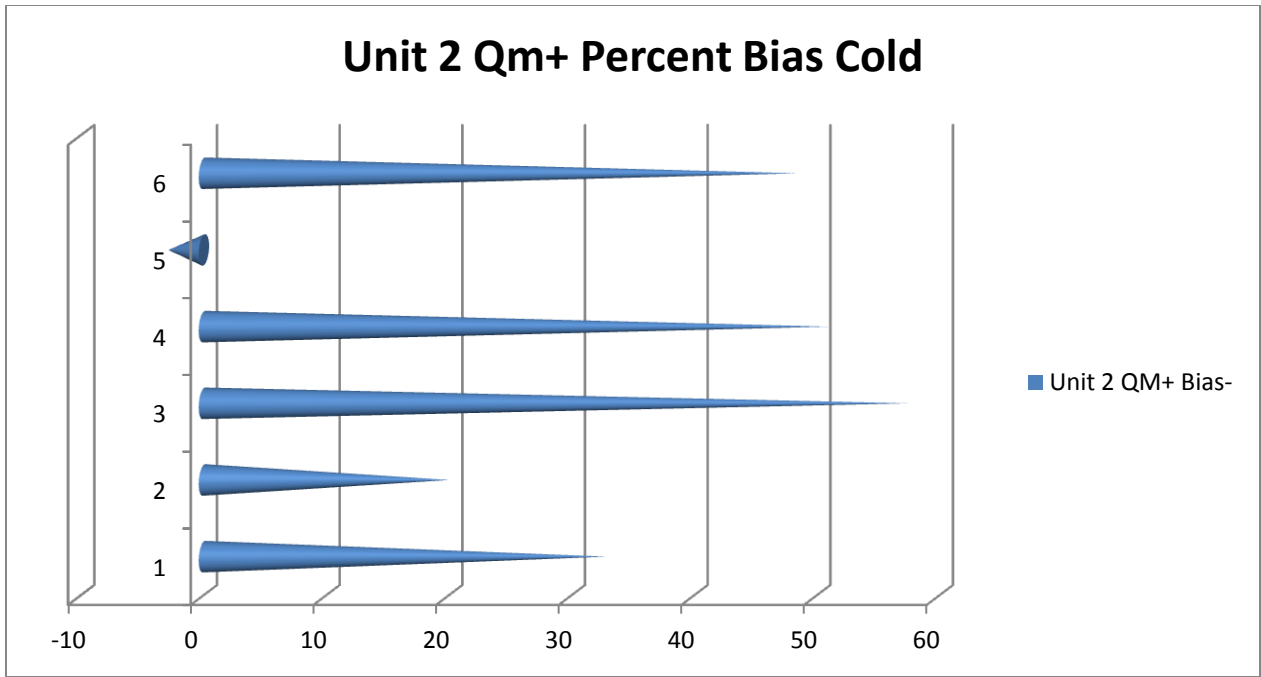
The Qm- levels changed significantly in the negative direction. The chart below shows that there was a significant bias towards Qm+ when the unit was cold and thus the amount of surface PDA increased in this unit compared to the hot condition.

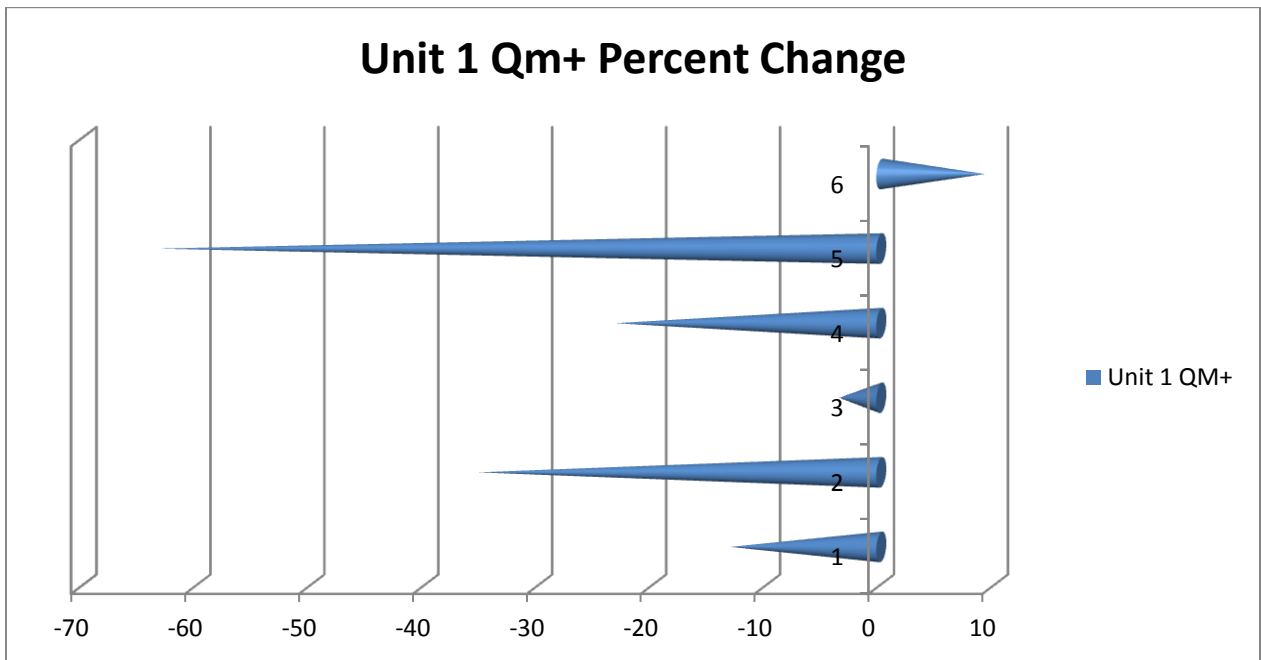
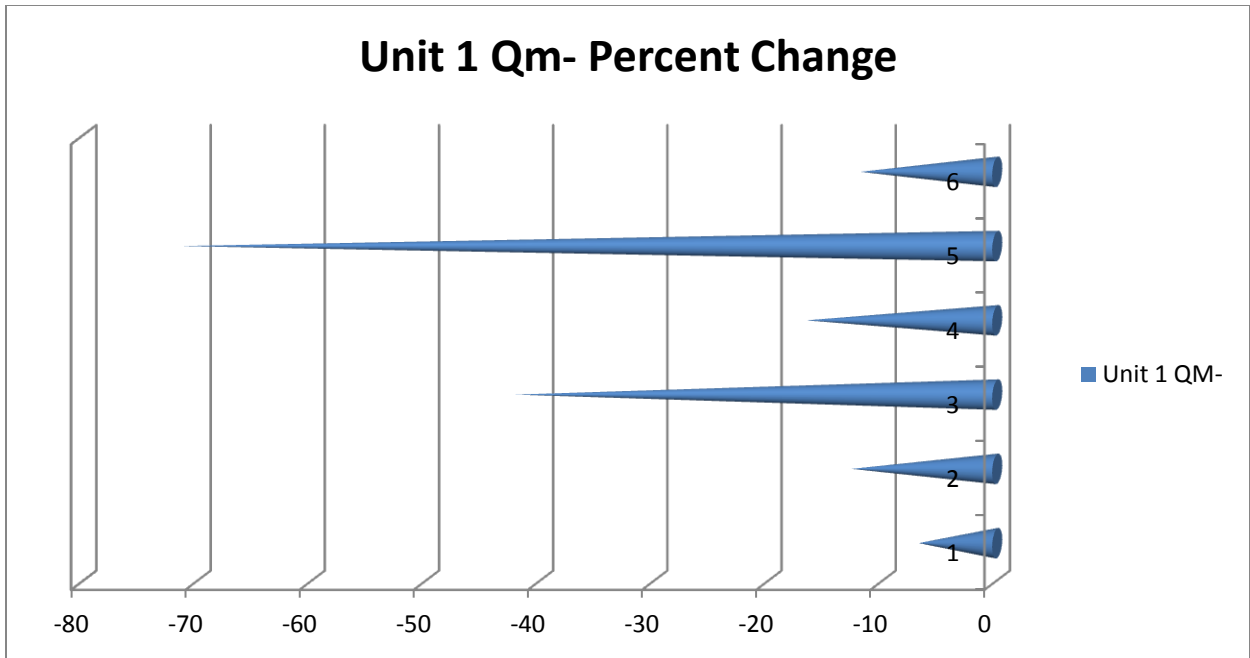
The above charts show that the PDA in Unit 1 has changed from going down to going up on a change from full load hot to low load cold. The bias chart below shows that the bias has shifted from a surface to a bulk insulation PDA. This could be attributed to better control of surface PD by the maintenance crews.

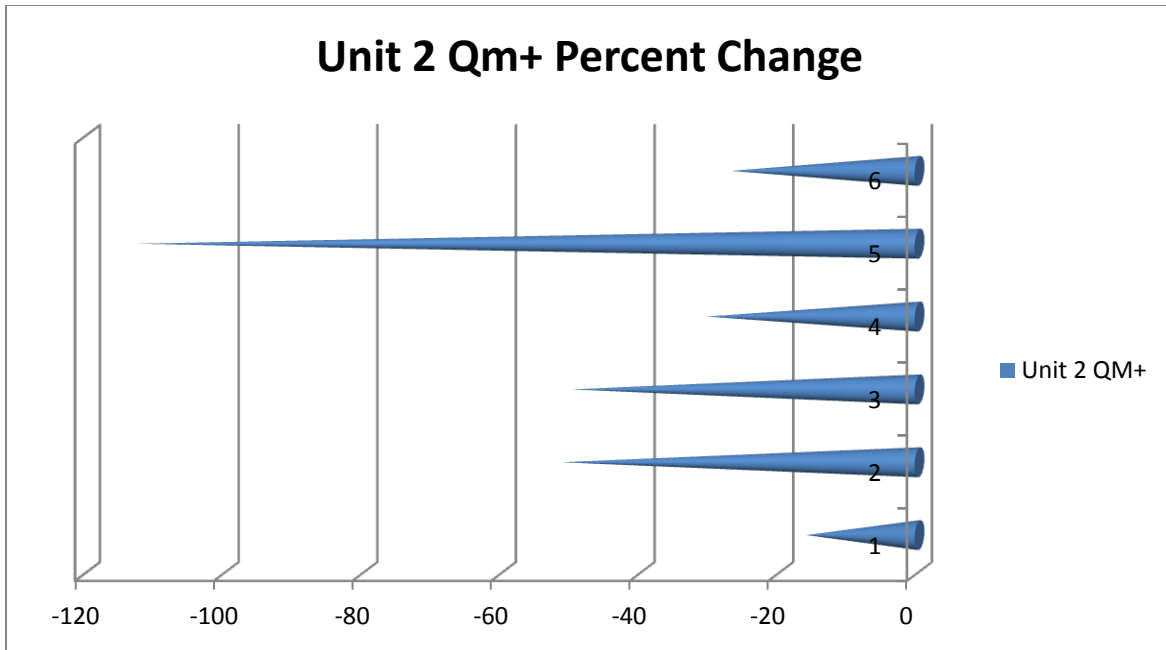
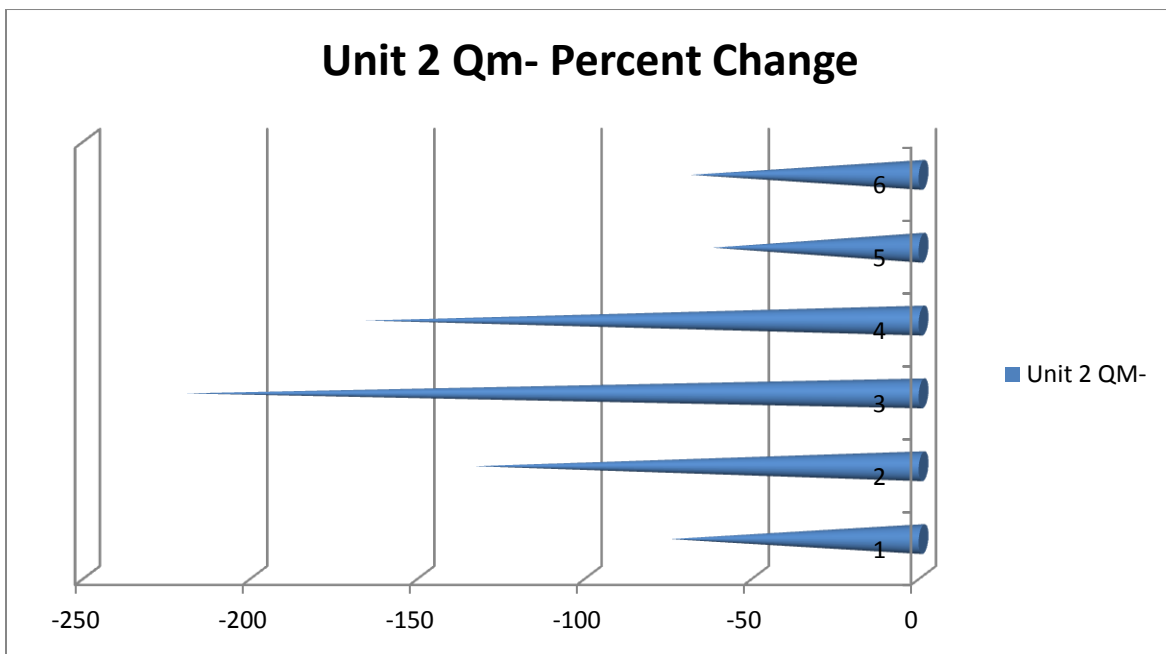
Unit 2 has also shifted toward more PDA at the lower temperatures. The Qm+ all decreased in 2002. In 2012, only one decreased. In 2002, Qm- decreased a minimum of 63%. In 2012 the maximum decrease was 54%. The chart below compared to 2012 shows that the bias has increased in Unit 2 towards surface PD at the lower temperatures.

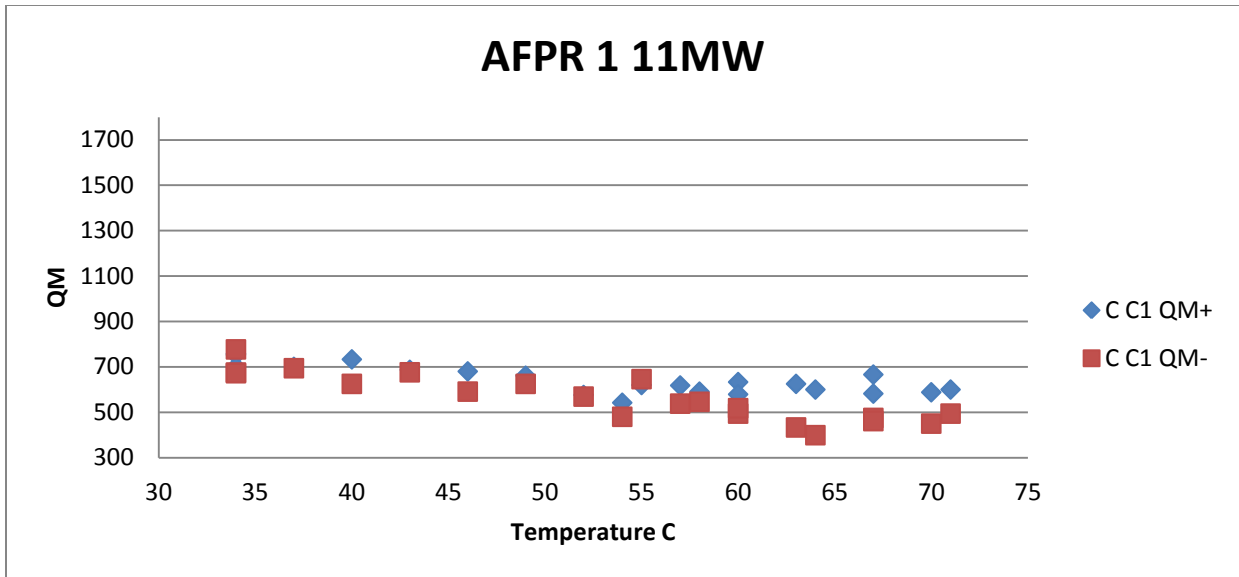
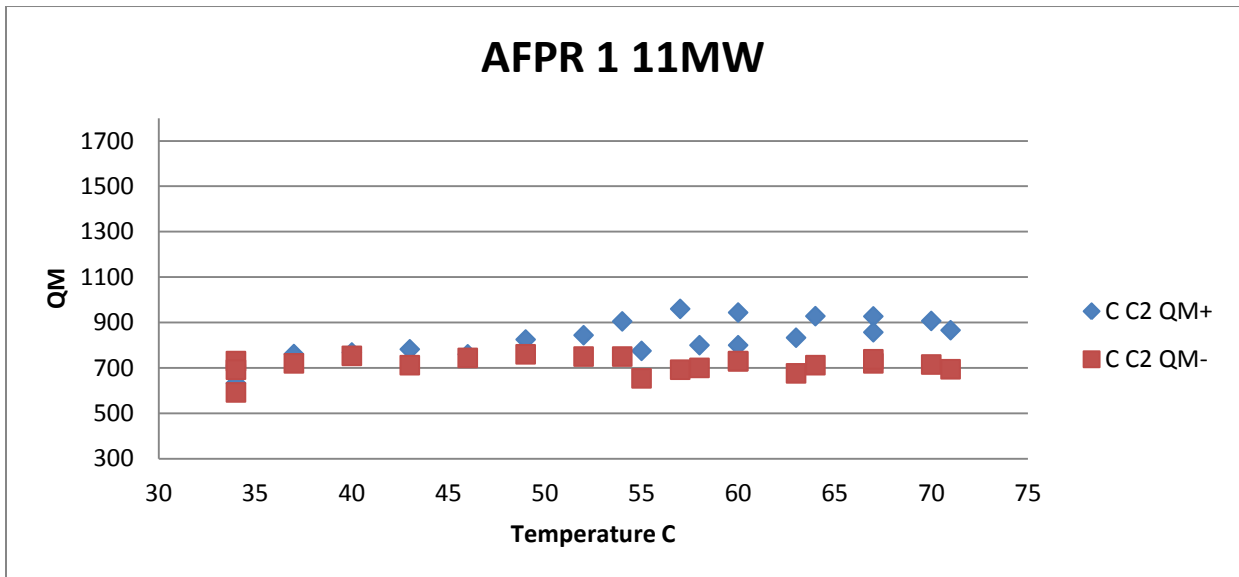
The phase A C1 results show a decrease in Qm+, which is consistent with loose windings. Qm- remains constant. C2 remains constant but what is of note is how low the PDA is on that coupler.

Both couplers on B phase increase with temperature. The only failure mechanism that normally increases with temperature is PD in the Semicon/Grading coating interface (SGCI). However it normally has a positive predominance and this phase has a negative predominance.

Phase C C1 has a decrease with temperature and goes to Qm+ predominance. C C2 has a constant Qm- with an increase in Qm+. Both of these couplers show some SGCI is occurring as the temperature increases.

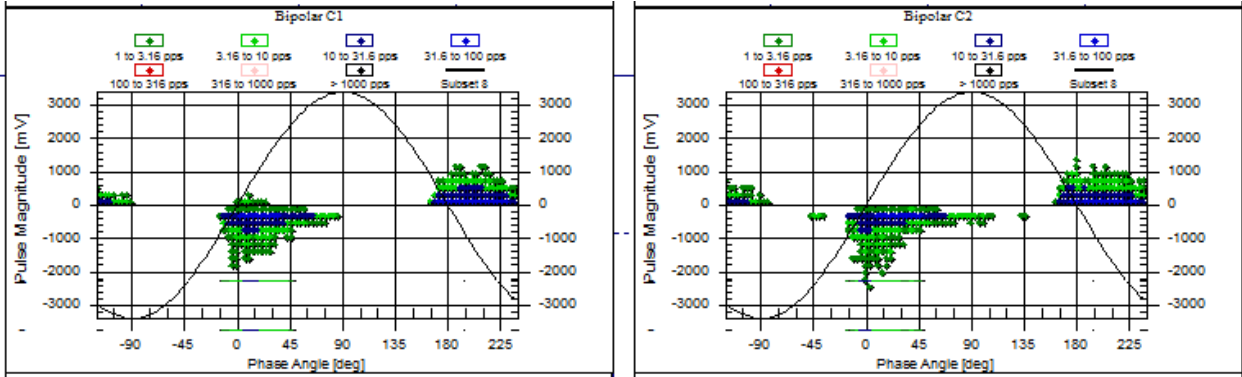
Of note is the phase B PPA shown below.

If the SGCI is severely deteriorated this may show up as pulses at 0 and 180 degrees. (1) This also could be a combination of contamination, inadequate spacing, and SGCI.

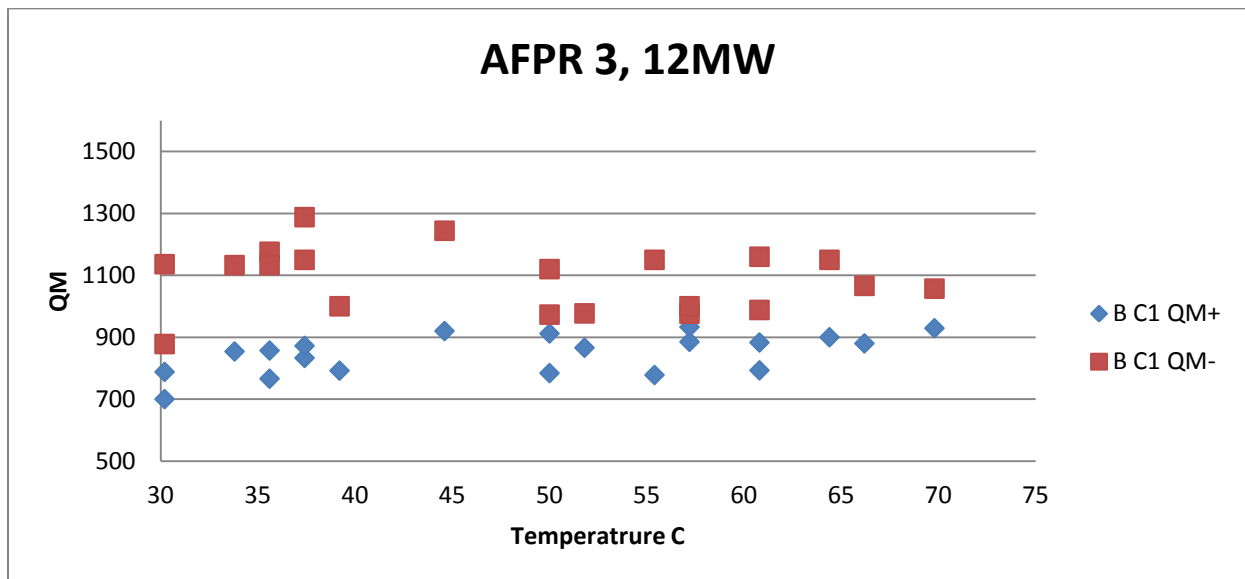
On this coupler, the positive increase in Qm with temperature is an indication of deterioration of the semicon/grading coating. The Qm- bias and then its decrease is indicative of voids near the copper surface normally seen with load cycling. Even though the average Qm is basically constant, the general decrease in Qm- compared to the increase in Qm+ would be a considered a good thing as a deterioration of the semicon/grading coating area can be repaired, insulation near the copper cannot.

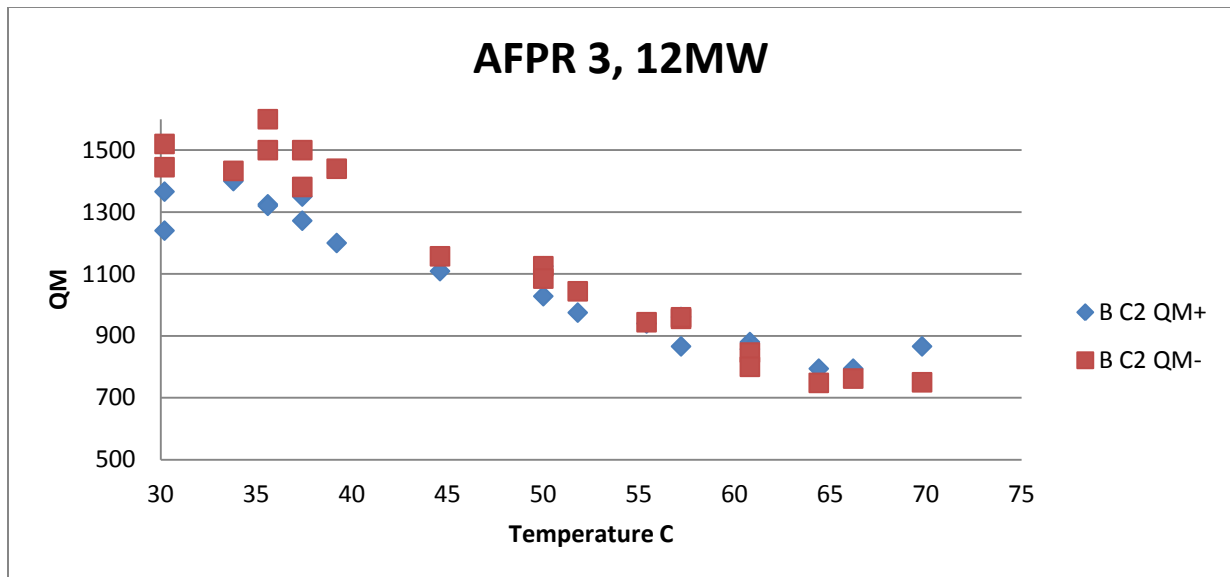
On this coupler, the decrease in Qm is very large. That both Qm+ and Qm- decrease by such magnitude indicates the temperature increase tightens up the windings a large amount where this coupler can see. At low temperatures, there is again a slight Qm- bias and then it decreases until it turns into a Qm+ bias. In general, the tightening of the coils transfers the PD from near the copper to the surface. The Qm- predominance along with a slight 45 degree predominance would indicate the load cycling failure mechanism. The large drop in both Qms indicates that the coils are very loose at low temperatures.

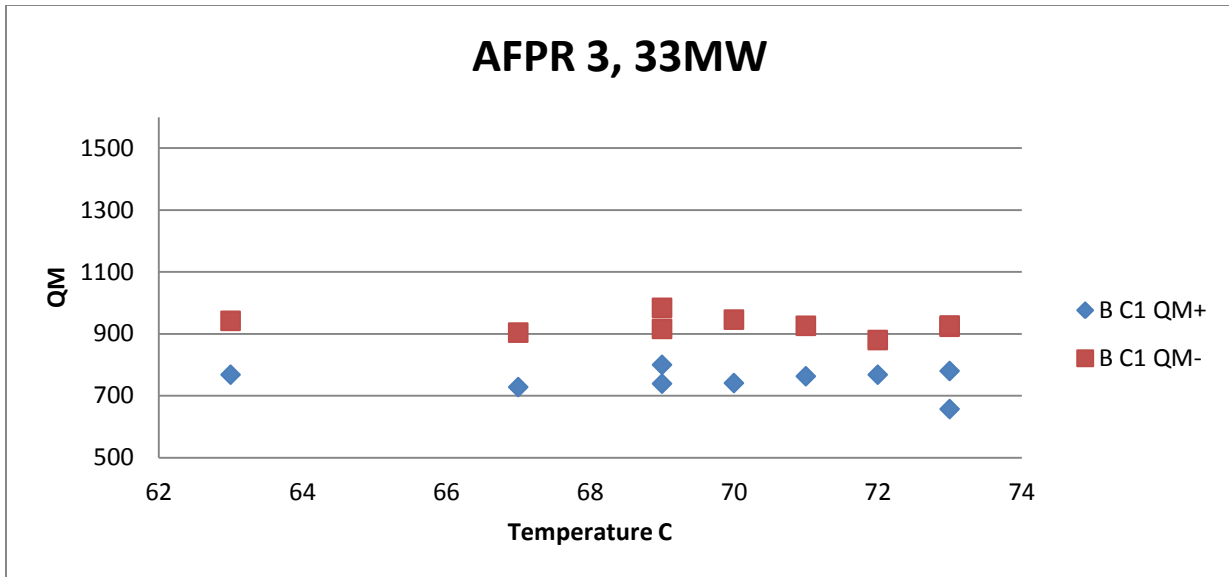
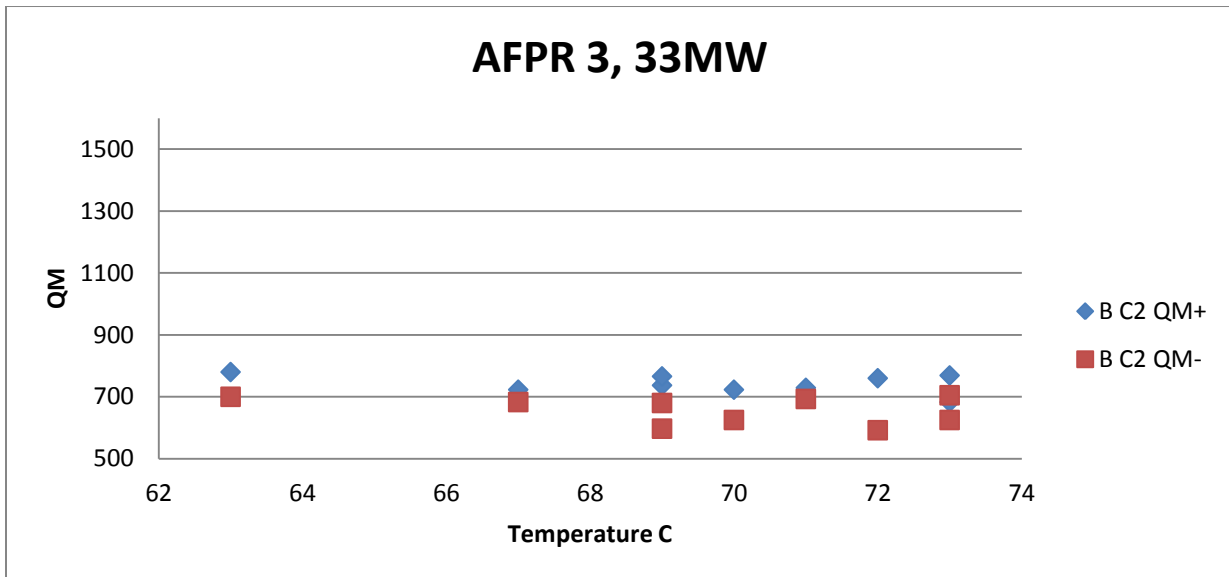
Both couplers remain relatively constant over this temperature range. The item of note between the high and low load readings is that the PDA drops on C1 by 20% to 30% on an increase in load. This combined with the negative predominance points toward the load cycling failure mechanism. This mechanism is a deterioration of the bond between the groundwall and turn insulation.

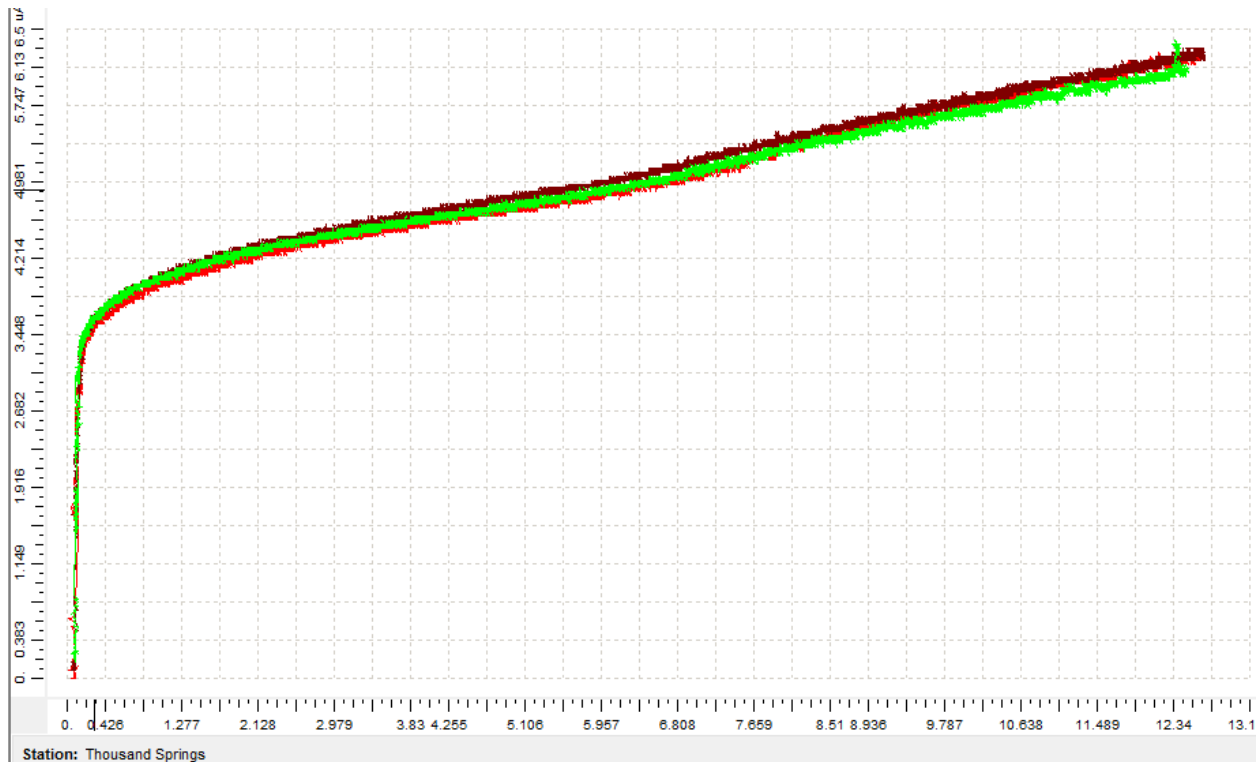
The results show a slight shift in slope around 6 kV. In some studies this shift is attributed to deteriorated insulation. Others have found that contaminated end windings can also cause this. We will see this shift in all the 6.9 kV machines tested. While these machines are hard to clean and most are fairly old, it is seen on asphalt, polyester, and epoxy windings of varying ages.

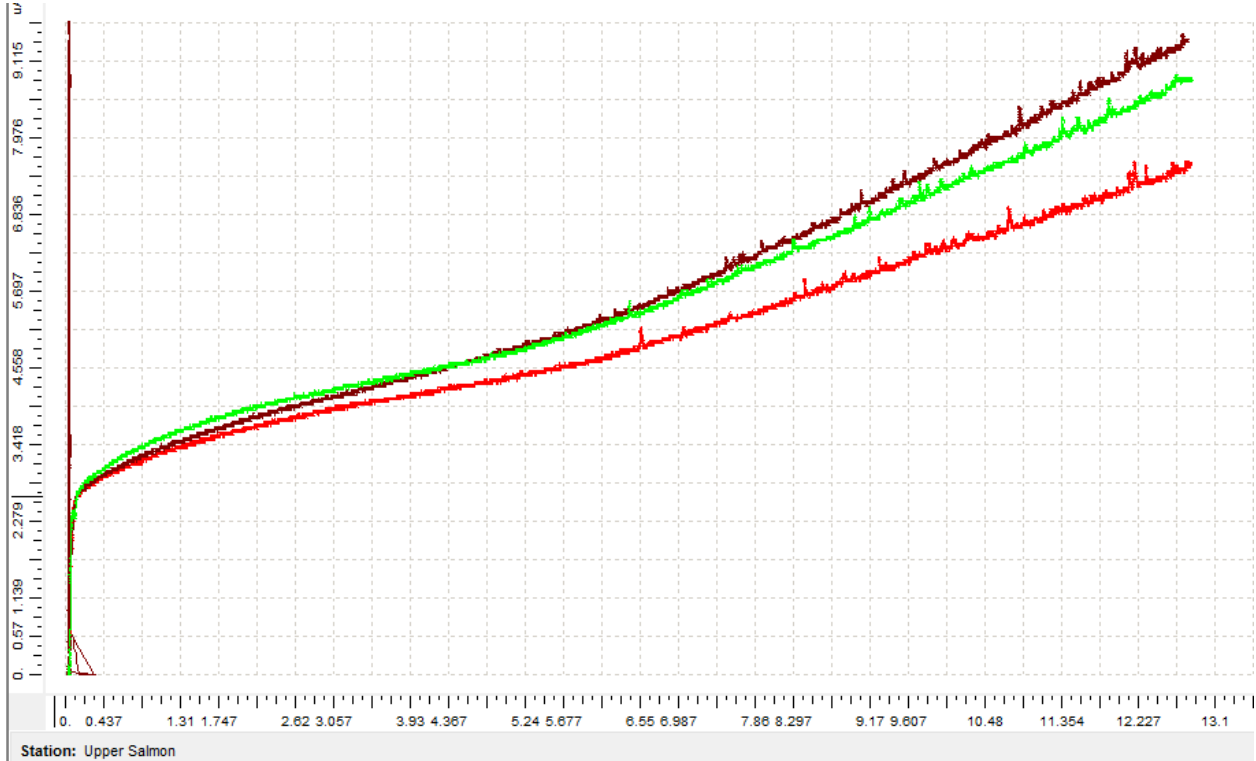
The results show marked differences between the phases. Assessable connections were inspected and cleaned but the results remained constant. With the age of the unit there could be different types of materials used in different places that could cause these results.

The leakage is higher than Thousand Springs 3, but is not excessive.

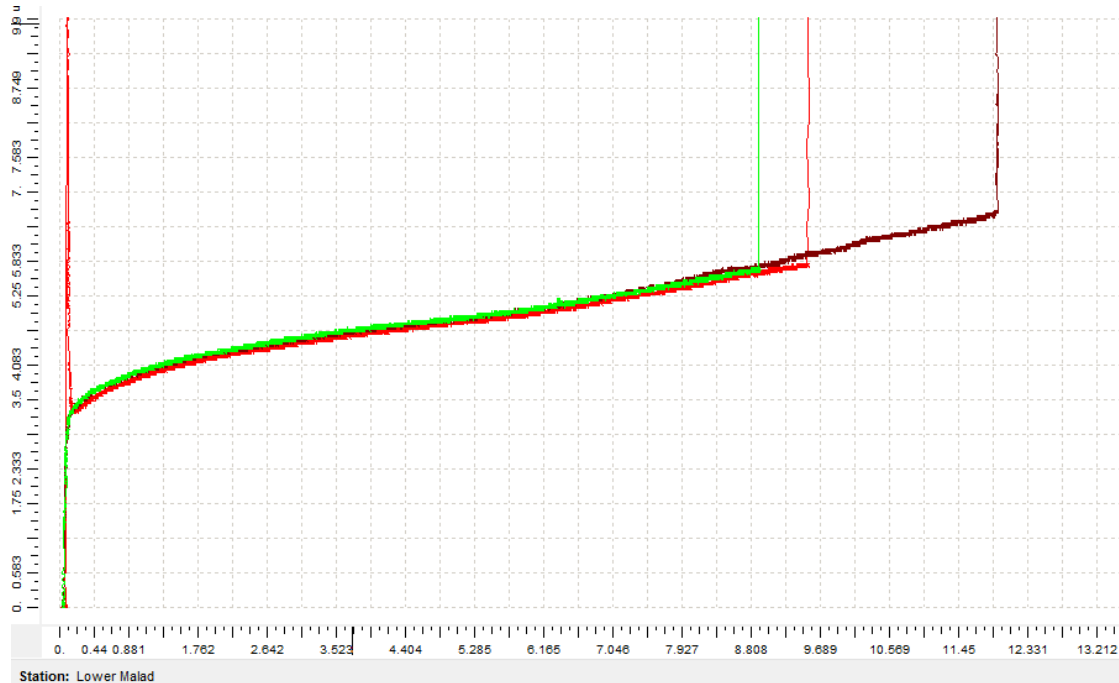
As can be seen, the unit had some issues. This type of result is indicative of a crack in insulation. This unit has had a troubled life and had recently burned up a set of main cables to the transformer as well as had a fire in the lightning arrester compartment. The only external component that not had been recently replaced were the neutral leads and the insulation was known to be in bad shape on them. Since the results up until the point of flash over were consistent with little noise, it was felt that the neutral leads were indeed the problem. It was then planned to replace the neutral leads at the next outage. When the old leads were removed, the DC Ramp test would be run before the new leads were installed to isolate the windings as much as possible. The below results are from the second test.

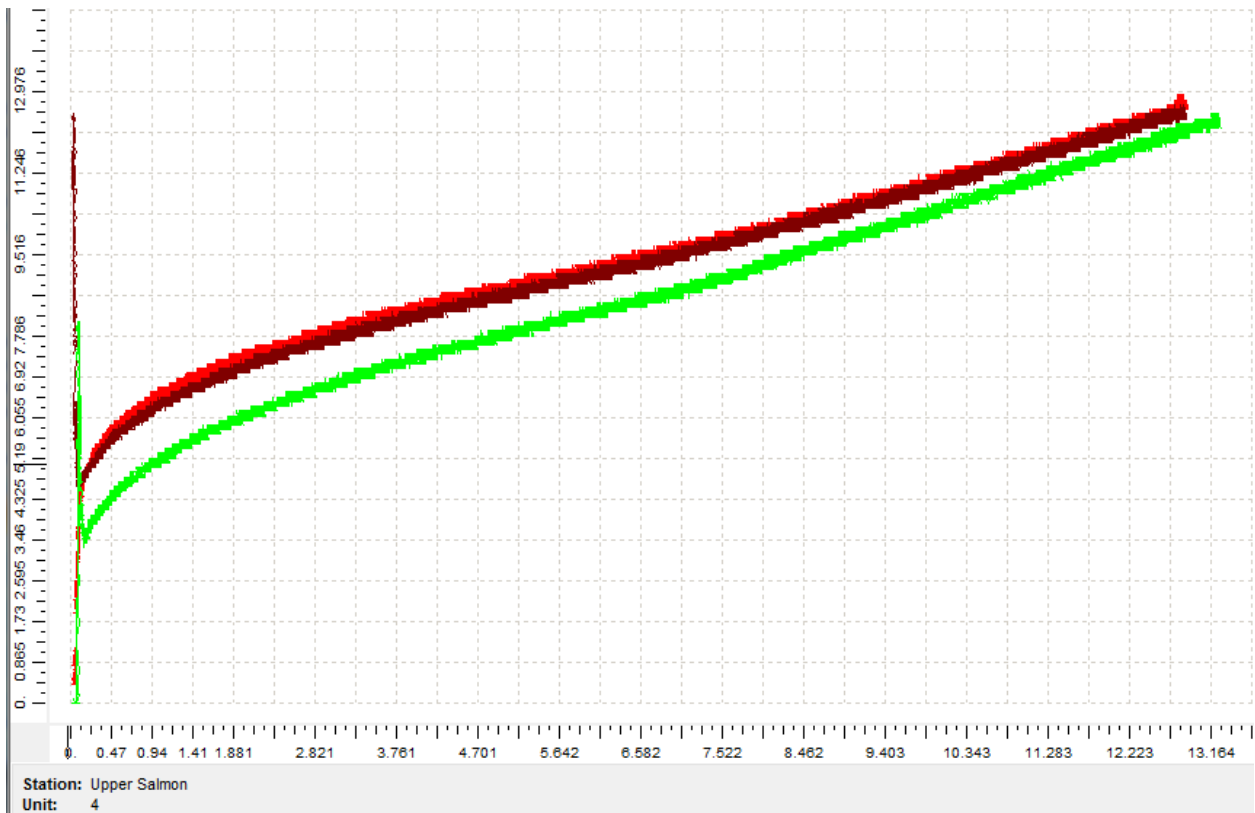
Phase 1 and 3 are the higher results, phase 2 is the lower result. The cause for the differences in the phases is unknown. There is no indication of noise due to tracking on the graphs. Due to how consistent that both sets of curves are, it would seem that there has been something changed on phase 2 compared to the other phases. As old as these machines are, there is a good possibility that some piece of the system was changed over the years. Insulation repairs at external connections, changing of a cable, insulators, etc. could all change the leakage in the system. The unit's isolation was verified and the system where it could be cleaned had been cleaned before testing. Retest showed the same results. It is interesting that both of the Upper Salmon units tested had differences between the phases.

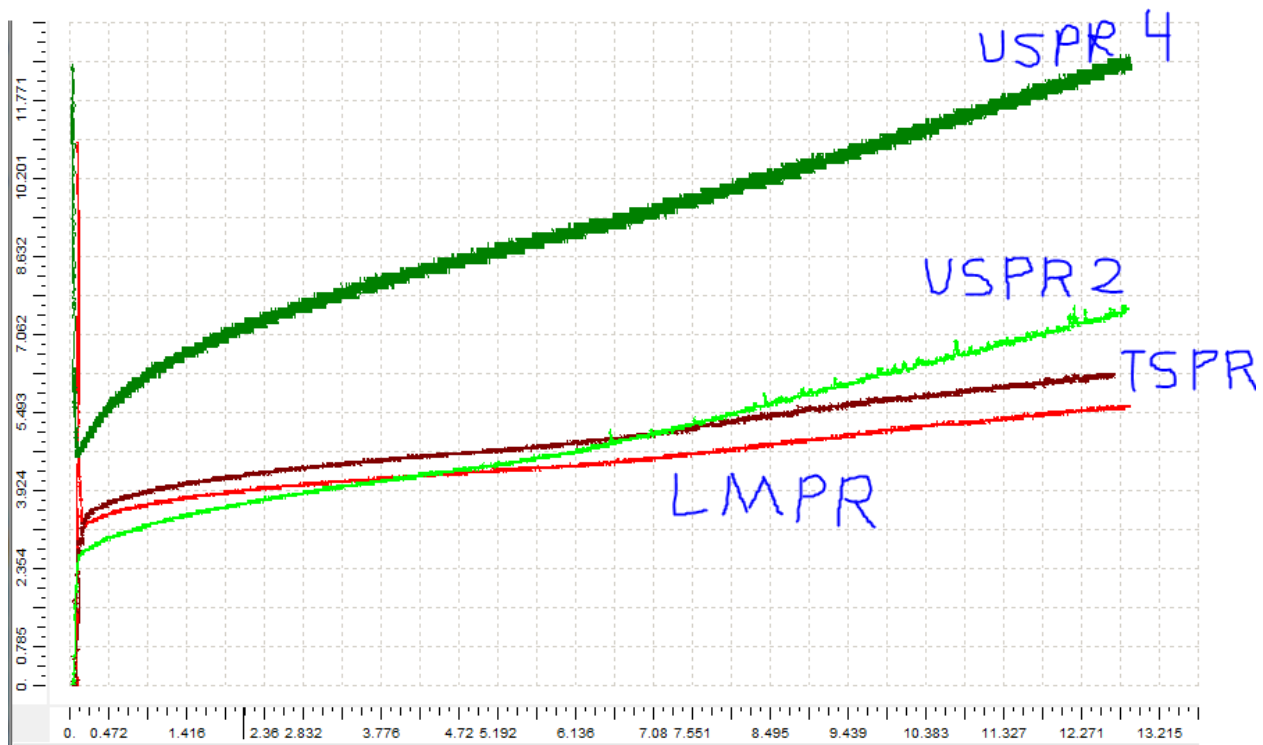
The USPR 4 windings are known to have been severely overheated in the past. While asphalt windings are forgiving to temperature changes since they are more flexible than the polyester or epoxy windings, severe overheating with loss of asphalt will compromise them. These windings are also 13 years older than the TSPR windings.

Of note is that the leakage rates, or slope, of USPR 2 and 4 are very similar after about 6 kV, 0.5 micro amps per kV for USPR 4 versus 0.433 micro amps per kV for USPR 2. This would indicate that there is a physical similarity between the units that is causing this.

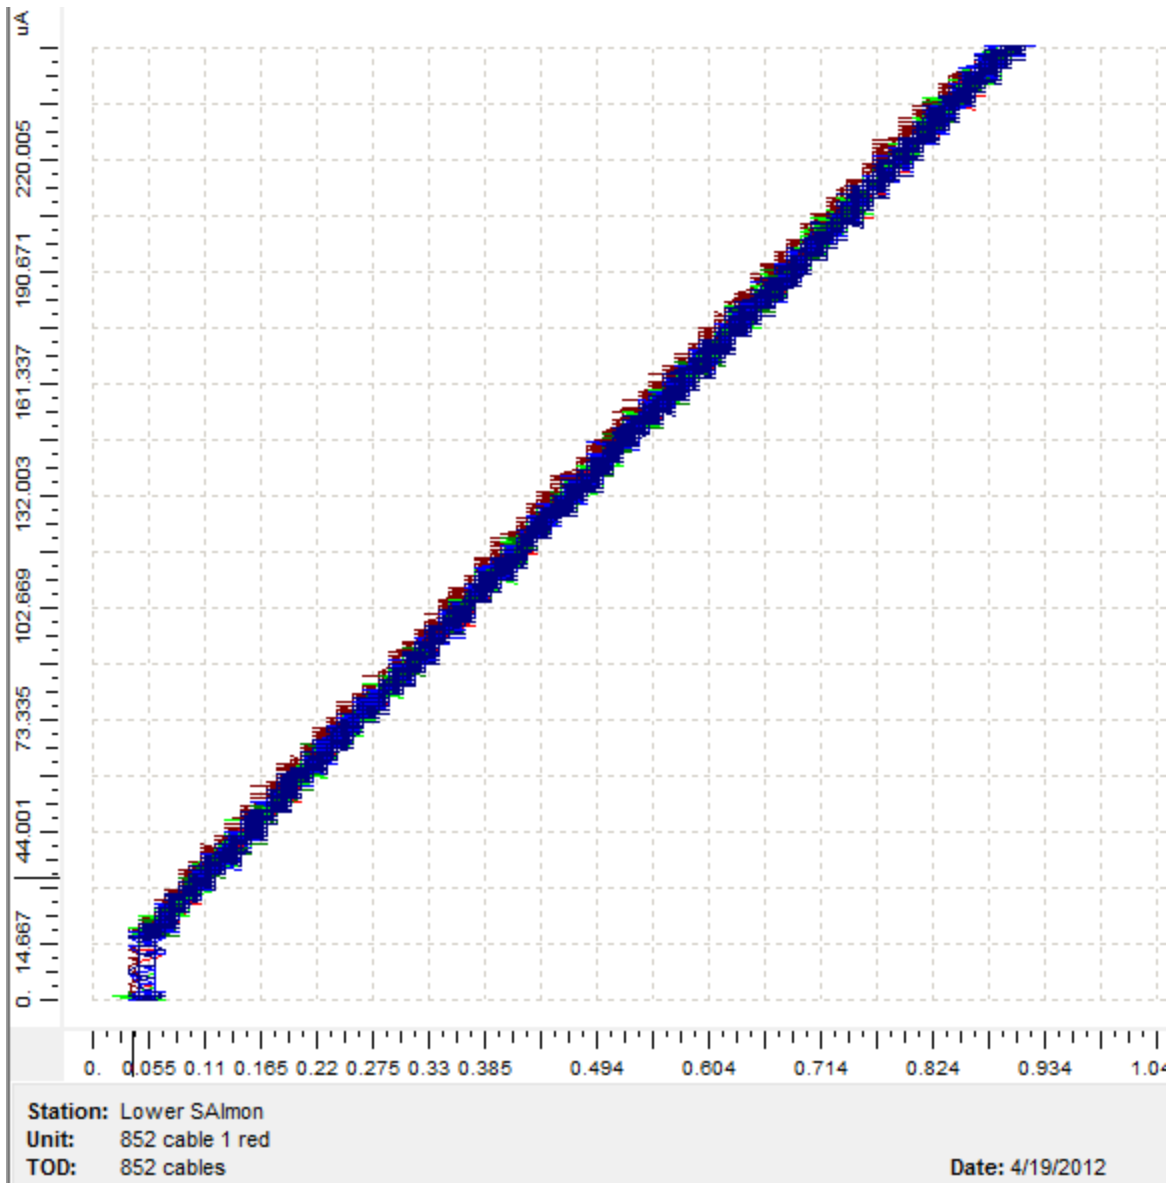
The DC Ramp tester was then connected to each cable from PC B to LC D with the other cables grounded. The test was at 250 volts per minute to a final voltage of 1000 volts. In the graph below, all 6 cables are shown. The test was stopped when the current reached 250 micro amps, which is the limit of the machine.

As can be seen in the above test results, the PC B to LC D set of cables had an obvious insulation failure. This failure may have been there for years before the fuses were installed. The fuses were initially blamed for causing an outage when they were doing their job and interrupting a fault.

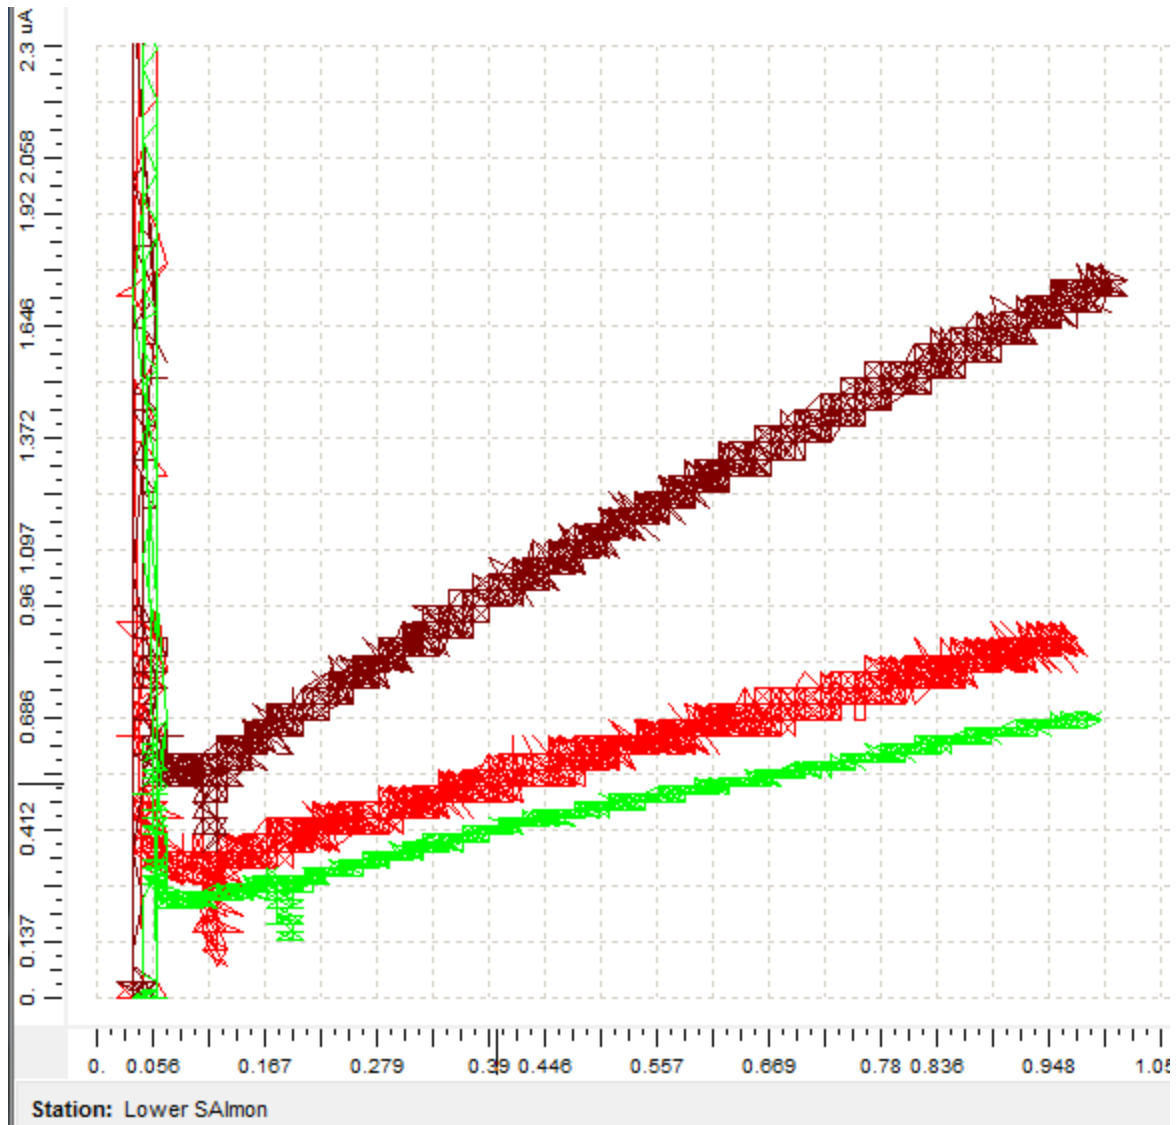
The other three sets of cables were then DC Ramp tested in the parallel configuration. The graph below shows tests from one phase of each of the three other cable sets.

This testing showed that the DC Ramp tester can be used as a precise insulation tester for cables as well as windings in machines. The other three sets of cables showed being in very good condition for their age and could continue on in service. The testing highlighted how damaged an insulation system can become before it gives an obvious physical indication.
