# **PARTIAL DISCHARGE AS A CONCERN ON TURBINE-GENERATORS**

Clyde V. Maughan P.E.  
Maughan Engineering Consultants  
Schenectady, New York 12306 USA  
Email: [clyde@maughan.com](mailto:clyde@maughan.com) Web: [clyde.maughan.com](http://clyde.maughan.com)

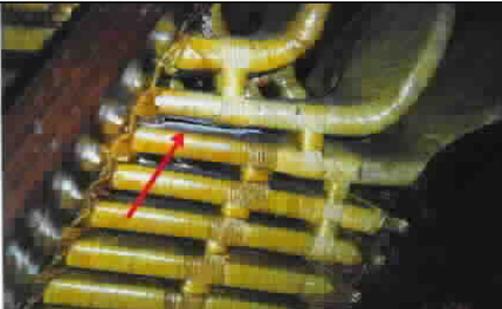
PD indications are common on air-cooled generator endwindings. PD is seen as extensive surface erosion, usually whitish in color. Photos 1, 2 & 3.

Photo 1. Damage to the Bar Surfaces due to PD at a Line-to-Line Phase Break.

In the end winding access is much better, although many areas cannot be reached and treated. Perhaps light sanding and careful scraping can clean off some of the indications and the surfaces may be repainted, with semi-conducting paints as appropriate. Where PD is occurring on non-mica insulation at phase breaks, the non-mica insulation should be removed and replaced with mica tape/sheet.

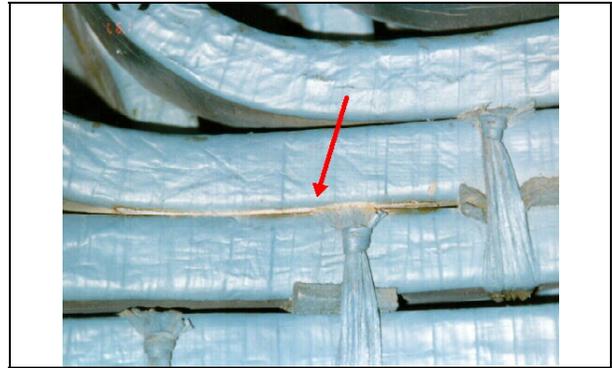
Photo 2. Minor PD Indications at a Physically Very Close Line-to-Line Phase Break.

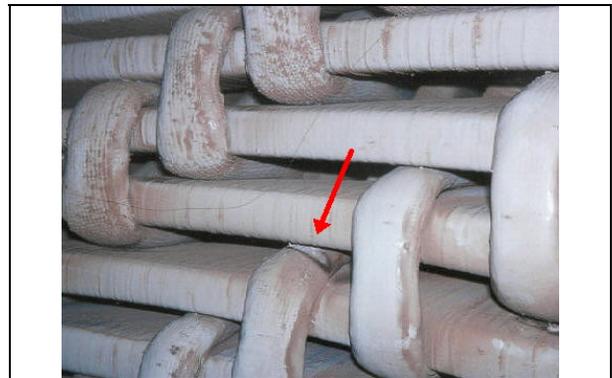
Photo 3. PD Indications Due to a Bar Tie Bridging a Line-to-Line Phase Spacing.

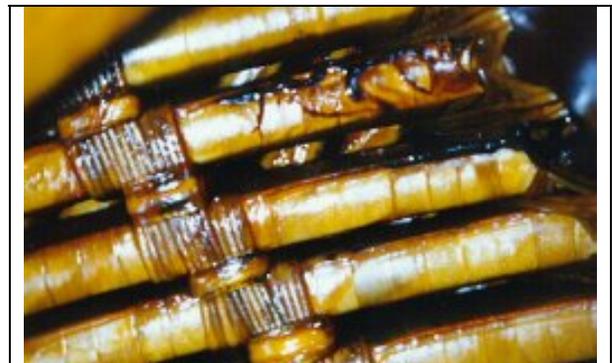
The actions of PD may also precipitate considerable amounts of a black semi-solid on oily generators; these deposits seem to be formed from bearing oil mist being transformed into a heavy, viscous state in the presence of a PD field. Photo 4.

Photo 4. Tar-like Substance Produced by Oil Mist in a PD Field.

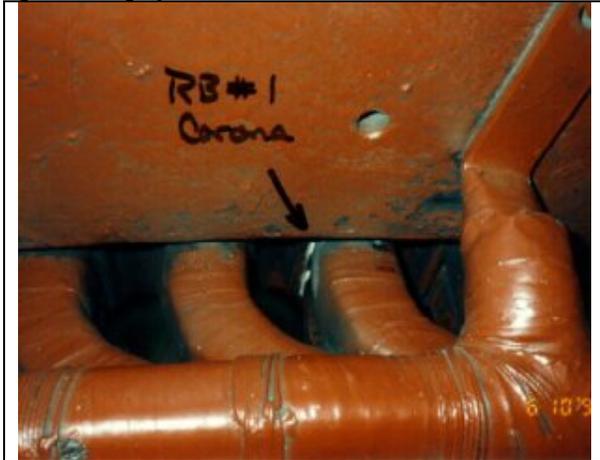
PD may also attack the junction point between the endwinding voltage grading and the slot grounding system. Photo 5.

Photo 5. Arc Damage Due to Inadequate Contact Between End Arm Grading and Slot Grounding Paint/Tape.

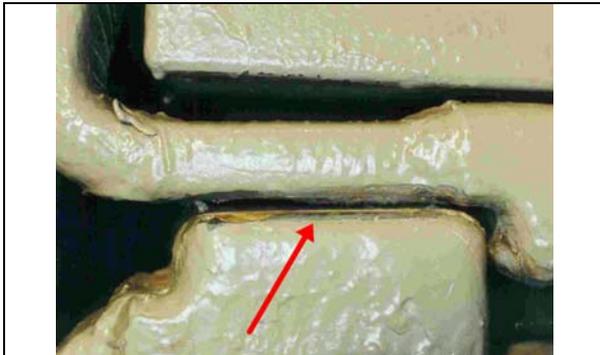
On generators with non-mica insulation on the series and phase joints, PD may severely attack the non-mica materials at the high-voltage phase breaks. Photo 6.

Photo 6. PD Indications on Non-Mica Insulation (Non-Mica Spacer Removed.)

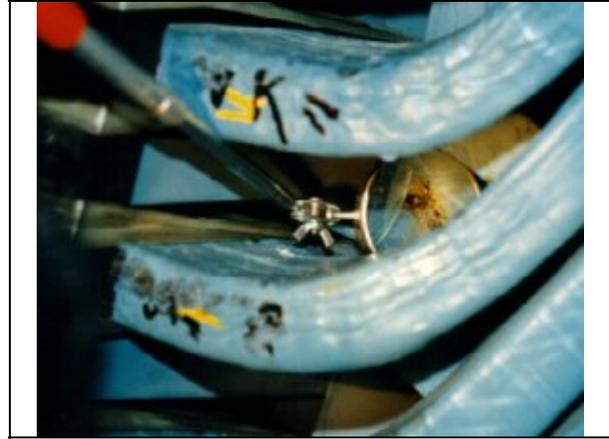
A particularly difficult inspection point is the cross-over gap between top and bottom bars that are located in higher voltage portions of different phase belts. Photo 7.

Photo 7. PD Indications Between Top and Bottom Bars Seen Through a Mirror

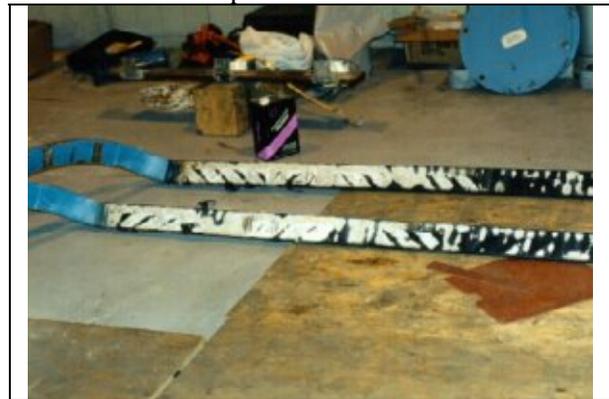
The slot portion of the stator winding is difficult to inspect on all generators. On generators with ventilation spacer ducts, some access is available through these ducts. The PD on the bars in Photo 8 was found by inspection via borescope. These PD indications are obvious on the removed bars; however, while still in the slot the indications were difficult to detect through the distorted view of a borescope.

Photo 8. Bars After Removal from Slots Showing Significant PD Indications.

Complete repair is probably not possible on significant PD that is occurring in the slots. Even on machines with radial ventilation ducts, only a portion of the surfaces can be coated. It is not possible to access all surface areas, and thus there will remain locations that have not been treated.

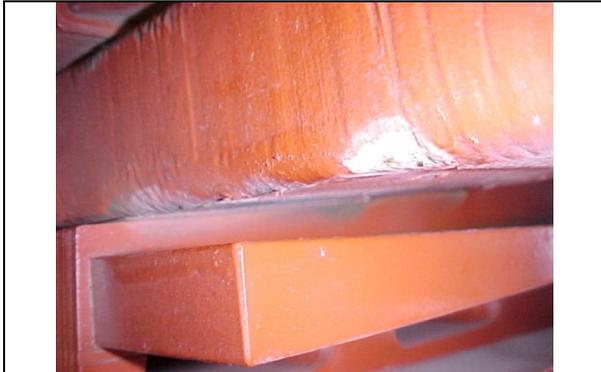
PD may also be observed at the ends of the slots, with strong suggestion that the PD carries on into the slot. Photo 9.

Photo 9 Significant PD Indications at Bar Exit from Slot.

If the inspection reveals a condition of PD at the end of the slot, Photo 9, PD in the slot may be suspected. But only removal of the bar can confirm the actual bar condition.

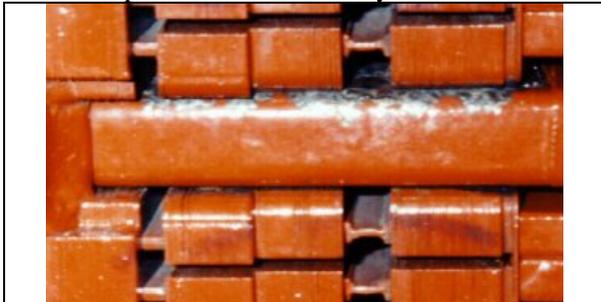
On units with heavy step-back of the core iron at the ends of the core, wedges may be omitted in the last several inches of the slot. This design feature may expose the top bar surfaces and allow inspection for PD activity. Photo 10.

Photo 10. PD Indications on a Generator with large Step-back in the Core Iron.

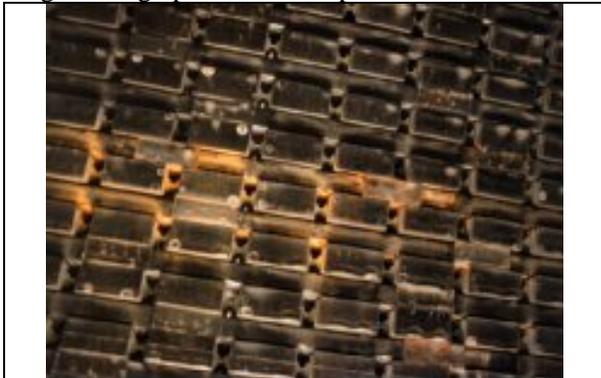
Where PD is severe in the slots, the wedges may be attacked on those slots with top bars at the high-voltage portion of the phases. Photo 11.

Photo 11. Severe PD Attack of Stator Slot Wedges.

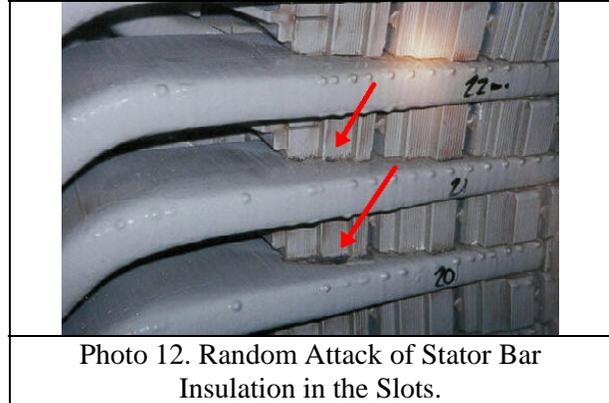
It is suspected that some reported cases of PD cutting into the groundwall insulation were actually the actions of vibration sparking. The activity shown in Photo 12 was found to be occurring independent of the location of the bars in the phase belt, and therefore could not be PD.

The energy source for vibration sparking appears to be the voltage of the air-gap flux. The flux that generates the voltage in the bar copper (typically about 50 volts/foot of slot length) also generates the same voltage in the bar surface grounding paint/tape. This voltage then generates a small current flow in the circuit consisting of the bar grounding paint/tape and the stator core iron. If the bar is allowed to vibrate, the normal current flowing in this electrical circuit is interrupted at 120 Hz (60 Hz generators). The resulting spark energy can mechanically cut (etch) the groundwall insulation at an unacceptable high rate, and has failed mica insulation systems in less than three years of service.

On stators with core ventilation ducts, semi-conductive bonding resin can be injected alongside the bar, or a bead of semi-conducting silicone adhesive can be applied in the ducts to improve electrical contact between the bar surface and the core. Both approaches will tend to bond the bar to the core and stop vibration sparking. There is the concern that if bonded sufficiently well, the system may not adequately allow for differential expansions between the bars and the core. However, this is thought by some OEM engineers to not be a problem, and machines that have been bonded by either process have run satisfactorily for many years after the applications.
