PARTIAL DISCHARGE AS A STATOR WINDING EVALUATION TOOL

Clyde V. Maughan P.E.
Maughan Engineering Consultants
Schenectady, New York 12306 USA
Email: clyde@maughan.com Web: clyde.maughan.com

Abstract: This paper has been prepared to illustrate the value of partial discharge (PD) testing in assessing the condition of stator windings on operating generators and motors. The database of one particular PD system vendor was chosen for this study because of the magnitude of data accumulated by this company over the last 15 years. It was felt that sufficient data had been accumulated to allow useful statistical analysis of the capabilities of PD testing.

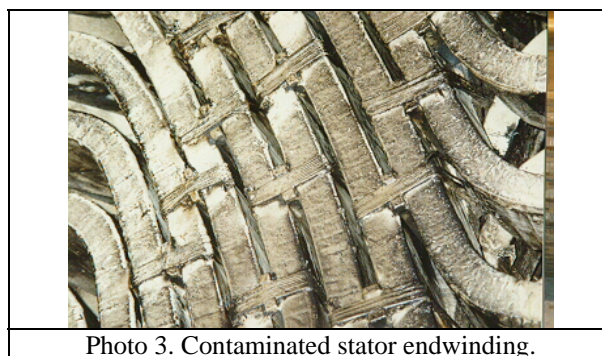
Contamination. As indicated above, contamination in general is not readily detected by PD, Photo 3, although if the contaminant were conductive, e.g., metallic filings, PD may give an indication of pending troubles.

Photo 3. Contaminated stator endwinding.

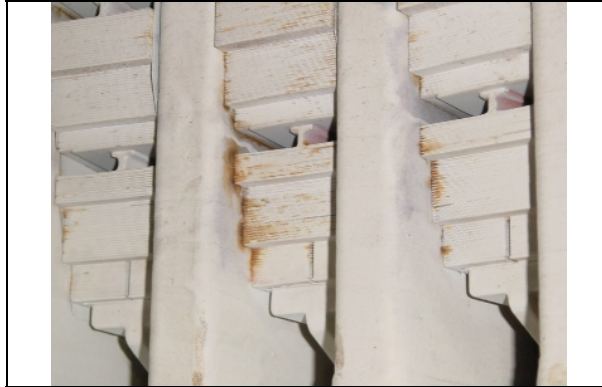
Vibration. This is the most serious type of deterioration likely to be detected by PD readings, Photos 4 & 5. Particularly, bar vibration in the slot is a serious concern that PD may be expected to detect. Since this type of deterioration is fast acting – several months to a few years – early detection is important. Of the instrumentation applied to generators, only PD is likely to detect the problem prior to in-service failure. (Indirectly, bar vibration in the slots may be expected if RTD sensors in the slot are failing one after another over time.)

Photo 4. End-of-slot indications of vibration sparking.

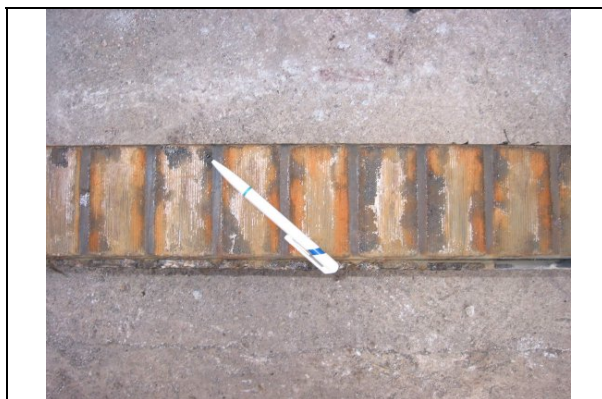
Photo 5. Stator bar failure due to slot vibration sparking.

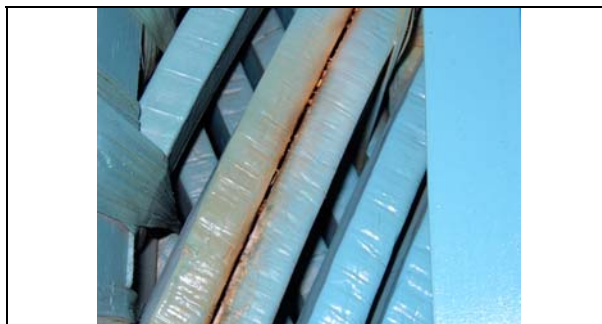
Design/Manufacturing. Numerous conditions on the original winding may result in generation of PD. For example, close clearances between bars in different phases will facilitate PD generation. Photo 6. Most 2-pole stator windings have three locations at each end and on each layer, around the endwinding circumference, where line-to-line voltage exists between adjacent bars. If clearance is less than about 3/16", PD is likely to be generated.

Photo 6. PD at inadequate bar spacing.

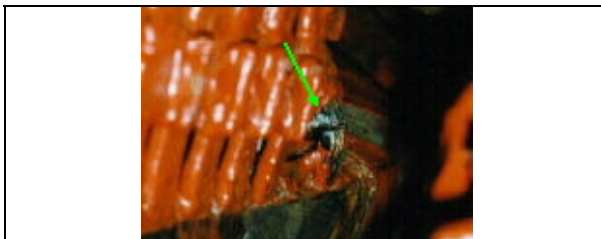
Operation/Maintenance. Thermal cycling is unavoidable where load changes are required on a generator. Significant deterioration may result, and in most cases this deterioration will not cause conditions which will result in high PD readings. Failing electrical connections may result from original manufacture or from repairs; any associated arcing may be detected as PD if readings are being taken during the short time that failure is occurring. In parallel electrical circuits within armature bars, once separation occurs arcing will cease and PD will not detect the incident. Photos 7 & 8. Thus, in general, failing connections are unlikely to be detected by PD instrumentation.

Photo 7. Failure to 1 of 28 parallel circuits in a series connection.

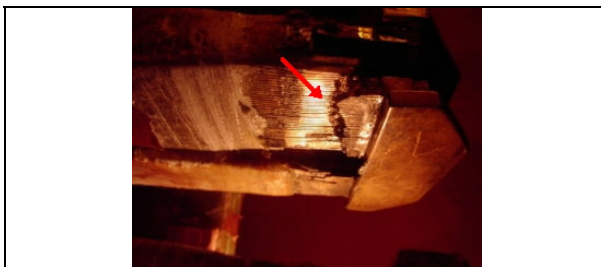
Photo 8. Failure of a parallel one-half bar.
