## GENERATORS: Problems experienced with modern generators

By Clyde V Maughan, *Maughan Generator Consultants*

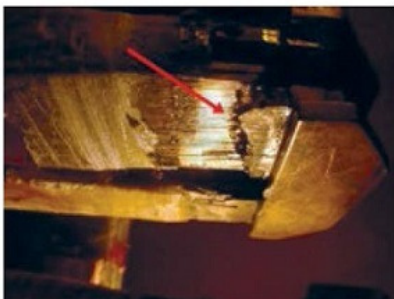
**Stator endwinding vibration** has been an ongoing issue for large generators. Problems have been exacerbated as engineers designed to accommodate higher vibration driving forces while simplifying support systems. A case in point is the elimination of series blocking on the endwinding in Fig 1, which caused the broken bar in the photo. Local endwinding resonance resulted in the failure shown in Fig 2.

1. Broken bar was caused by absence of series blocking on an endwinding

Protection against such failures probably is best obtained by being sure a thorough bump test is performed on new and reworked windings. Resonant values should be outside the 115-140-Hz range (for 60-Hz generators).

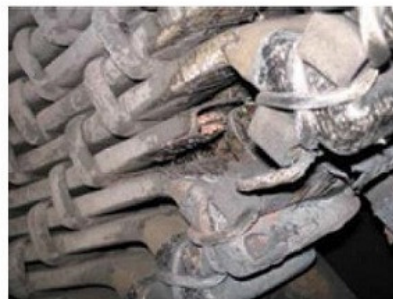
2. Several inches of copper burned away on a stator bar as a result of endwinding resonance

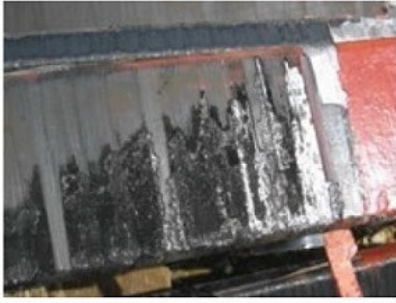
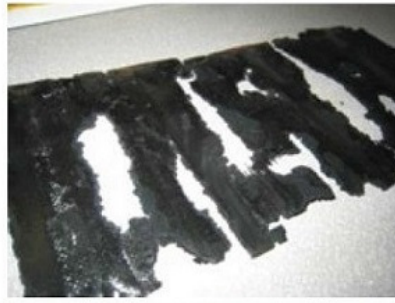
**Stator-bar slot vibration.** Large, indirectly cooled generators typically have many stator slots and tall, narrow bars. This design approach maximizes the area for transferring heat through the groundwall insulation. But it also may allow the tall, narrow bar to vibrate sideways in the slot, probably driven by core vibration. Such vibration causes vibration sparking, a fast-acting destructive phenomenon (Figs 3, 4).

**3, 4. Vibration sparking** is a fast-acting destructive phenomenon as evidenced by bar damage at left and side-packing damage at right

Designers believed side filler would prevent side vibration. However, packing of incremental thickness cannot fully fill a continuously varying space, and vibration can occur. If deterioration is significant, corrective action probably requires a rewind to remove the fatally degraded bars and allow installation of side pressure springs.

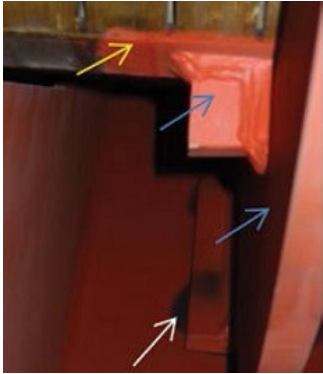
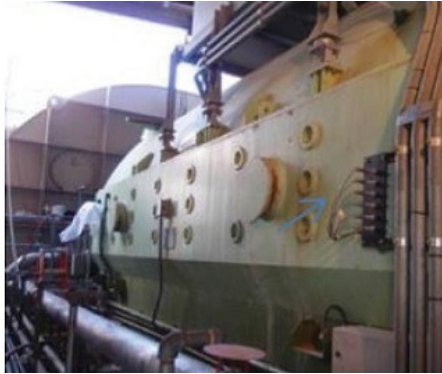
The core-to-frame support structure for the Fig 10 generator is shown in Fig 9. The core (yellow arrow) is attached directly to the keybar/bore ring fabricated structure (blue arrows), which is welded directly to the frame outer wrapper (white arrow). This configuration eliminates the cost of isolation components, but leaves the generator vulnerable to noise levels approaching 116 dB(A), and the prospects of possible frame and foundation cracking. Operation may be acceptable if the noise levels can be tolerated and frame and/or foundation cracking do not occur. Otherwise, this condition may not be correctable without stator (or generator) replacement.

**9, 10. Core-to-frame support structure** at left is for the generator at right. Welded method of attachment without vibration isolators increases the susceptibility of the generator to frame and foundation cracking

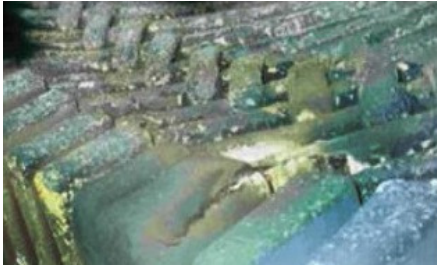
This is perfectly adequate at the low voltage difference between series connections. But if air-gap clearances are less than about 3/8 in. at phase-to-phase locations, partial discharge can occur. Figs 11 and 12 were photographed at one such line-to-line phase break. Designers now typically use potting compound on the series connections, but insulate the phase connections with mica tapes.

**11, 12. Inadequate clearances** at phase-to-phase locations difficult to insulate are conducive to failed connections (left). At right is copper burning caused by a non-mica connection insulation failure

- A stator winding failure on a 200-MW generator was incorrectly attributed to “lightning.” Corrective action taken was based on this misdiagnosis. The unit failed again several months later at the same location for the same reason—partial discharge (refer back to Figs 11, 12).

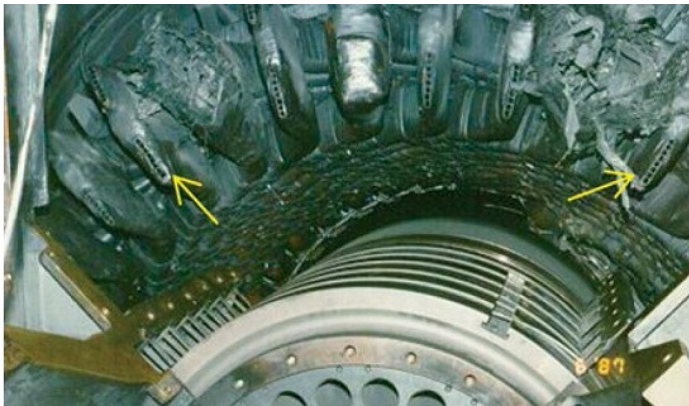
However, it is impossible to fully insulate the connections on direct-gas-cooled stator windings—because access for gas flow must be permitted. Numerous massive winding “ring-of-fire” failures have occurred on machines with heavily contaminated insulating surfaces and air gaps. Contamination that led to the failure in Fig 13 was the result of an arc from a broken bar or connection. For stators manufactured with bared conductor, your first line of defense against failure, and possibly the only one, is to assure no gross contamination occurs.

**13. Ring-of-fire failure** occurred at this stator endwinding. Arrows identify typical bare-conductor locations

- A ring-of-fire stator winding failure on a 900-MW water-cooled winding was incorrectly attributed to the internal piping arrangement. Had the correct design error not been identified by further consultation, repeat of the massive stator winding failure would have been inevitable (refer back to Fig 13).

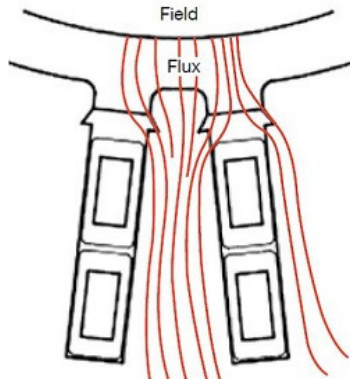
But in these new designs, the top of the top bar is above the core tooth iron (refer back to Fig 14). If the bar is shallow in the slot, as it is in hydro generators, there is air-gap flux cutting the top strands of the top bar and you can get the condition shown in Fig 16.

**15. Where the top of the top bar in Fig 14 is deep in the slot, the air gap flux essentially all transfers into the iron; no flux cuts the copper and there is no side EMF on the bar (left)**

**16. If the bar is shallow in the slot, air-gap flux cuts the top strands of the top bar and displaces them (right)**

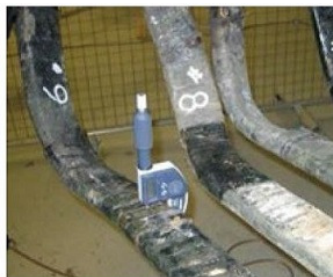
**18. Small coil-wound generators made with inappropriate asphalt material post-1970 reintroduced the failure mechanism illustrated in Fig 17. In photo, the remaining groundwall measured 20% of original thickness**
