Problems with Modern Air-Cooled Generator Stator Winding Insulation

Key Words: Coil vibration, global VPI windings, rapid load cycles

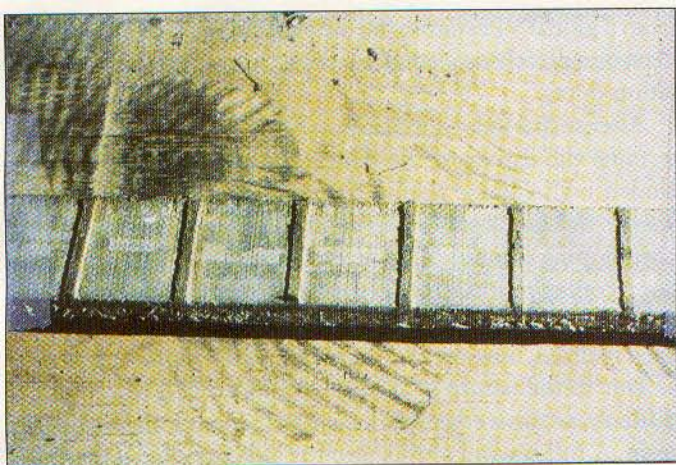
Fig. 1 Photo of a coil removed from a stator bar that failed due to slot discharge. The original winding was not installed in the winding tightly, and no ripple springs were used. This was a conventionally made stator, where the coil insulation was cured outside of the slot.

There has been a tendency in the modern turbo generators to reduce the cost and complexity of the slot support system. Unfortunately, cases have occurred where the windings were able to move in the slot when new, or gradually become loose in operation, especially if oil is present. The result has been some premature failures caused by the slot discharge process. Figure 1 shows the side of a coil for a 40 MVA generator where about 30% of the groundwall insulation thickness has been abraded away by the vibration, prior to failure. It is believed that the coils were not originally installed tightly enough during manufacture. The ridges where no abrasion occurs at the stator core ventilation ducts are clearly visible. The larger the machine, in general, the larger the magnetic forces acting on the coils/bars, and thus the faster the failure process.

Arresting this failure process is fairly straightforward, if somewhat expensive. During a suitable opportunity with the rotor removed, re-side packing and rewedging are needed, preferably with ripple springs and/or two part wedges. If the repair can be done before the semiconductive coating is abraded away, then the winding can often be restored to as-new condition. Unfortunately, if the semiconductive layer is worn away and the epoxy-mica insulation is exposed, then PD will continue to occur, gradually (but at a much slower rate) destroying the groundwall. Injecting into the slots carbon loaded varnishes, silicone rubber or epoxy can somewhat restore the semiconductive coating, but PD will still occur in areas where the injection was incomplete.

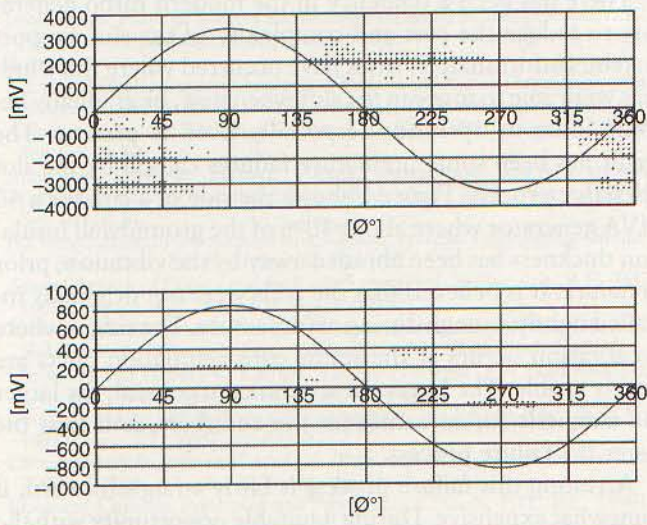
Fig. 2 Examples of PD on two globally VPI air-cooled generators from different manufacturers (note different PD magnitude in y-axis scale). The horizontal scale shows the phase angle of the ac cycle.

Figure 2 shows levels of PD between two different OEM air-cooled generators. The difference in levels is of an order in magnitude. Both have similar slot packing systems and are subjected to the same global vacuum impregnation technique.

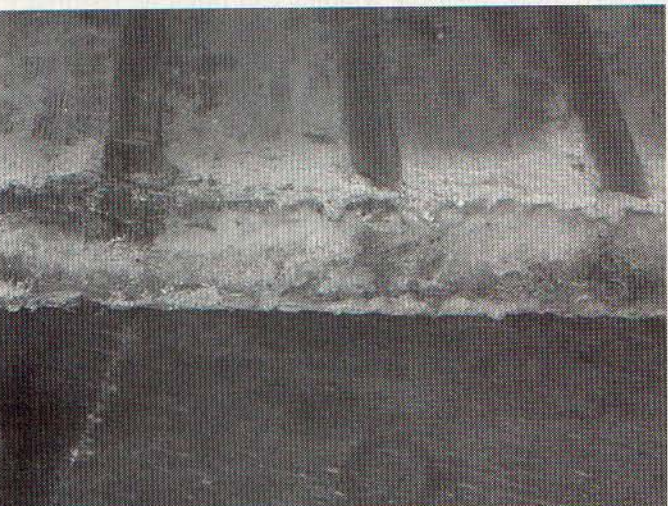
Fig. 3 Example of bar removed from a global VPI stator that failed due to slot discharges. The photo shows the edge of the bar where abrasion and PD damaged the insulation.

As movement increases and PDs become stronger, the main wall insulation is gradually abraded away, just as described above for conventionally made stator windings. If there is a weak spot at any point in the insulation, perhaps where the resin did not fully penetrate during manufacture, insulation may fail completely with all the attendant alarms and excursions. Figure 3 shows an example of such a failure

from a global VPI stator; the outer semiconducting layer has been completely eroded along the bar except for at the ventilation ducts.

After such a failure, extensive testing was carried out to determine the extent of the damage in the machine. This included high-voltage testing the winding, checks on the slot wedge tightness, stator bar-to-core contact resistance, and boroscoping around 50% of the stator vent slots. Until the boroscoping results were seen the full extent of the damage to the remaining winding, other than the one failed bar, had not been realized, thus altering the extent of the repair necessary.

Due to the nature of the global VPI process rewedging is difficult, as the wedge will have been glued to the bar by the resin. A full rewind at this point is uneconomic, despite extensive damage. This leaves injection of a semiconducting material as a palliative attempt to restore the integrity of the insulation system.

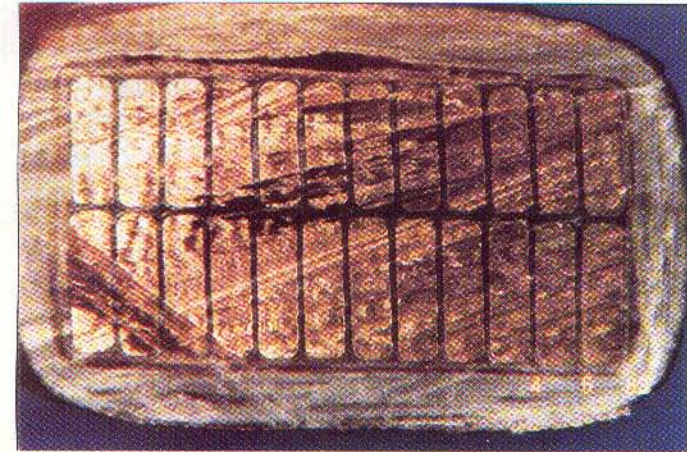
Rapid load cycles are possible in gas turbine generators—where the load can change from zero to full load in one or two minutes. If an unloaded generator suddenly increases to full load, the temperature of the copper conductors can reach maximum operating temperature in a few minutes, due to the copper I^2R losses. The increase in copper temperature causes the copper to expand as governed by the coefficient of thermal expansion. The coil may grow as much as 1 or 2 mm in the axial direction [8]. Unfortunately, the epoxy mica insulation on the coil does not expand as much as the copper—primarily because the epoxy mica insulation is considerably cooler than the copper in the first 10 to 15 minutes after a rapid load change. The result is a shear stress on the bond between the copper and the insulation after each rapid load change. Experience shows that with a sufficient number of rapid load changes, and a high enough winding temperature (possibly greater than 120° C), the bond between the copper and the insulation, or between insulation layers, will fatigue crack. The delamination created will enable PD to occur, hastening the failure process. Figure 4 shows the delamination in a 13.8 kV coil in a stator that saw thousands of rapid load cycles.

Fig. 4 Cross section of stator bar where the copper has separated from the groundwall due to thermal cycling.

Once the stator is constructed no maintenance other than a rewind can fix or slow down this problem. However, operational changes—such as slowing the rate of load changes or limiting the maximum operating temperature—can slow the deterioration process.

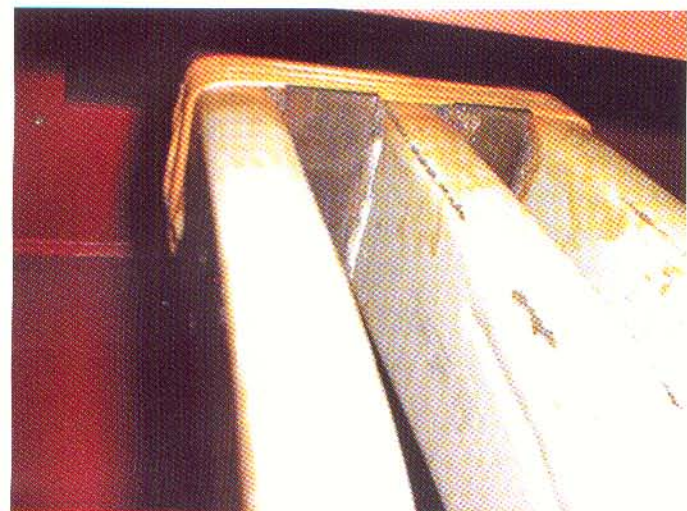
Fig. 5 Small air space between blocking at two phase leads has created PD (white band).

The close spacing has resulted in highly stressed air between coils or leads in two different phases. The resulting PD will eventually bore a hole through the insulation, triggering phase-to-phase or phase-to-ground faults. Figure 5 shows PD occurring in the air space at blocking between two-phase leads. Figure 6 shows insulating material use to fill the air spaces between leads, and indicates that not all repairs can successfully correct the problem. Figure 7 shows similar problems in the coil endwinding area. The coils are of opposing phases and have the highest potential along with the highest electrical stress.

Now that these problems have been identified, what can be done to either arrest the PD activity or completely eliminate the PD? For the lead problems, the best repair, and the one that would be permanent, is to open the clearance between the two phases, reducing the likelihood of PD. Two options are available to open the space: 1) redesign the

endwinding utilizing a new connection method, or 2) modify the existing design by reducing the amount of insulation on the phase leads. The second option requires stripping the insulation from each lead and reinsulating.

Another approach, which would be quicker but not necessarily permanent, is to fill the void between the two-phase leads with a silicone rubber material. The silicone rubber has to be applied void free or PD activity can reoccur. Similar to the above approach is to install Nomex® (trademark of Dupont) sheets between the phase leads, fill all voids with an epoxy, and apply conducting paint to attempt to redistribute the electrical stress at the insulation contact point between the two phases. Again this approach may not be permanent and could require further maintenance. These two repairs will require less time and cost initially but could result in higher maintenance in the long run.

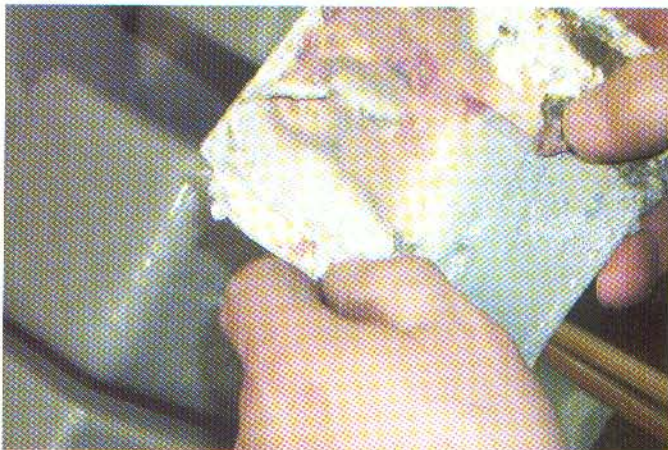
Fig. 6 Nomex used to fill space between phases in different phases. PD activity has eaten into the insulation.

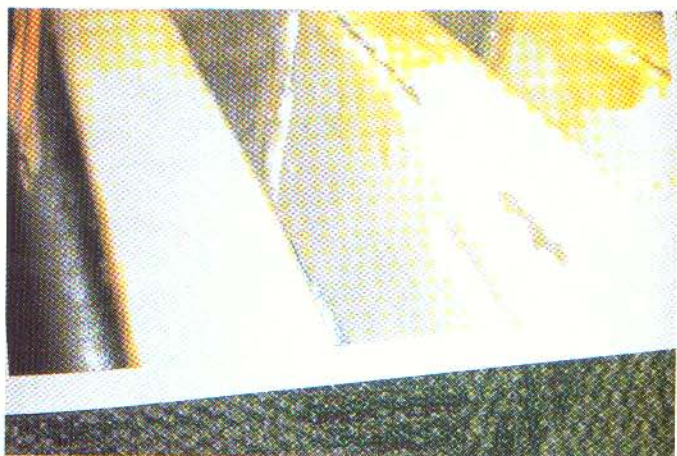
Fig. 7 White powder from PD activity in a small air space in the endwinding between two bars operating at very different voltages.

As to the repair of the endwinding PD between two adjacent coils of opposing phases one is left with few choices. As the spacing is set by the current design one may be only able to reduce the PD activity by inserting a solid insulating material such as silicone rubber in the affected areas.
