RECENT PROBLEMS EXPERIENCED WITH MOTOR AND GENERATOR WINDINGS

Copyright Material IEEE
Paper No. PCIC-2009-6

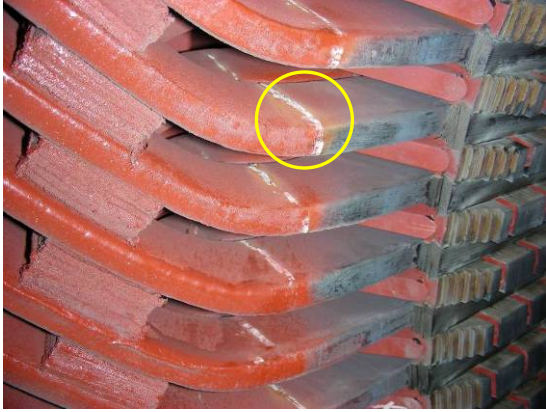
Fig. 3 shows a turbine generator stator where a very noticeable white band is visible at the junction of the semicon coating and the silicon carbide coating. Fig. 4 shows a winding where the semicon has virtually disappeared in the slot due to poor application of the semicon coating. This will normally only occur in air-cooled machines rated 11 kV and above. However, the introduction of voltage source converter drives has shown that these problems can occur on motors 3.3 kV and above [3,4]

Fig. 3: Semicon and and grading coating overlap deterioration.

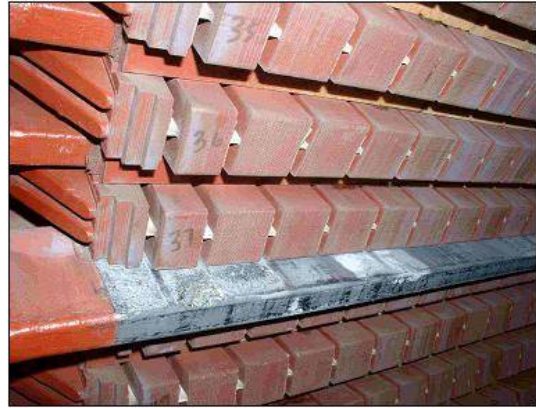
Fig. 5: Bar abrasion due to loose windings in the slot of a turbo generator.

Fig. 5 shows a bar in the process of being removed from a stator where the semicon and about 30% of the groundwall thickness has been abraded away. The manufacturer had not mechanically secured the coils in the slots by means such as sidepacking, ripple springs, two part wedges, conformable restraint in the slots, etc.

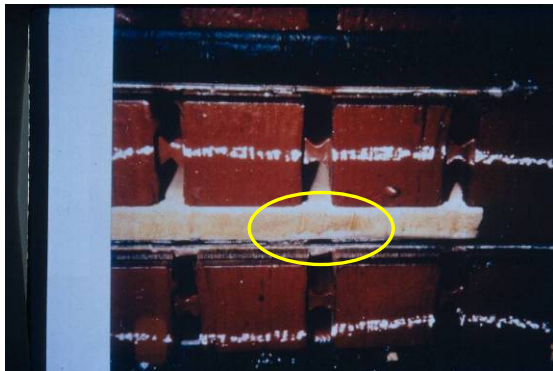
Fig. 4: Destruction of the coil semicon coating in the stator slot due to PD and ozone.

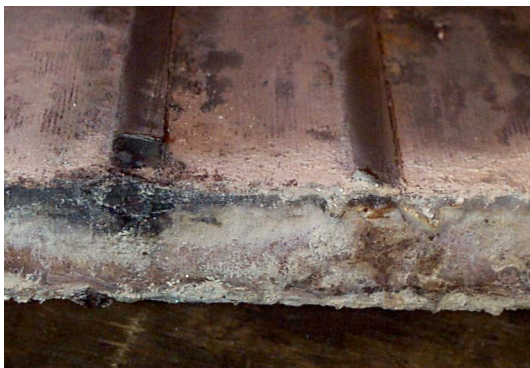
Normally one would not expect loose coils to be a problem in a global VPI stator, since the coils are effectively glued to the stator core. However, if the coils are made too small for the slot, and are subjected to load cycling that creates shear stresses between the coils and the stator core, then loose coils and slot discharge may occur in some designs (Fig. 6).

Fig. 6: Damaged bar surface due to loose coils in GVPI stator.

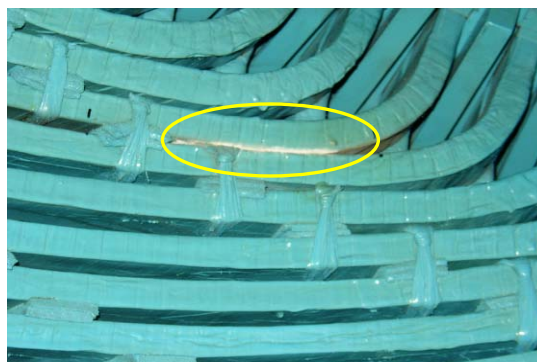
Fig. 8 PD occurring between high voltage coils in two different phases.

Unfortunately, in many motors and generators rated 6 kV and above, we have noted inadequate spacing, and consequently high PD (and ozone). Fig. 8 shows the white residue caused by ozone resulting from PD between two coils in different phases that were installed too close to one-another. Fig. 9 shows the same issue, but between two circuit ring busses that are in different phases. Fig. 10 shows the PD between the grounded pressure finger at the end of the core and the side of a coil where the manufacturer did not extend the semicon stress relief coating far enough into the endwinding. This resulted in a high electric stress between a line end coil and the pressure finger, and hence PD and ozone. In all three cases of inadequate spacing, the failure process is purely by PD and ozone attack, which are slow processes if the insulation is composed of epoxy mica. However, if such PD occurred between phase leads in the motor terminal box, failure could occur much sooner since such leads often have only rubber insulation, which is much less resistant to PD attack.

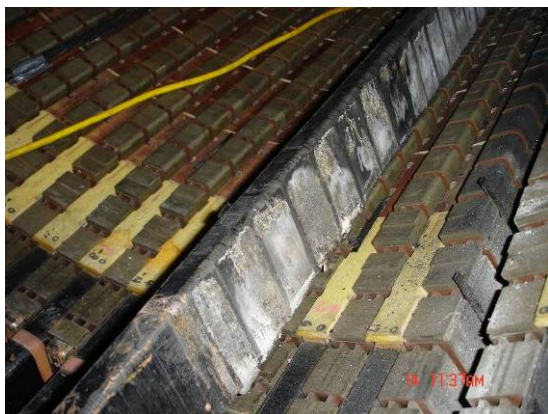
This failure process can be very aggressive, resulting in failure in as short as about 5 years. Although most manufacturers are careful to make the semicon have a minimum resistance, there is a set of turbine generators made in the past 10 years where the material is too conductive, and failures are occurring (Fig. 7). Vibration sparking is driven by the magnetic flux, and thus damage can occur anywhere within the winding, unlike the slot discharge process described above which can only occur near the phase terminals.

Fig. 7: A neutral end stator bar damaged by vibration sparking.

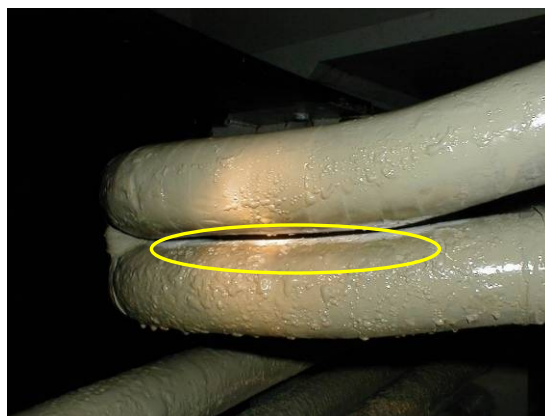
Fig. 9 PD between circuit ring busses that are too close together.

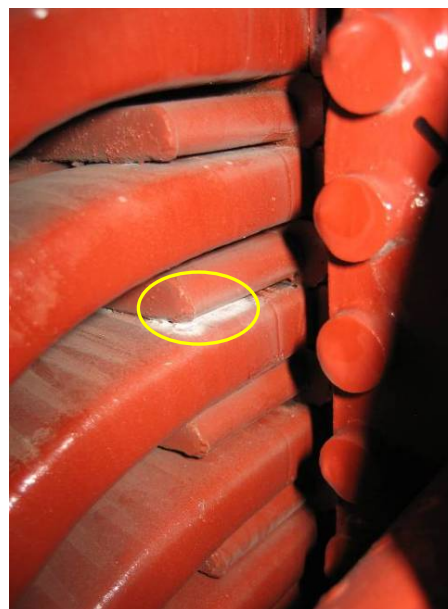
Fig. 10: PD occurring between a core pressure finger and a high voltage coil.

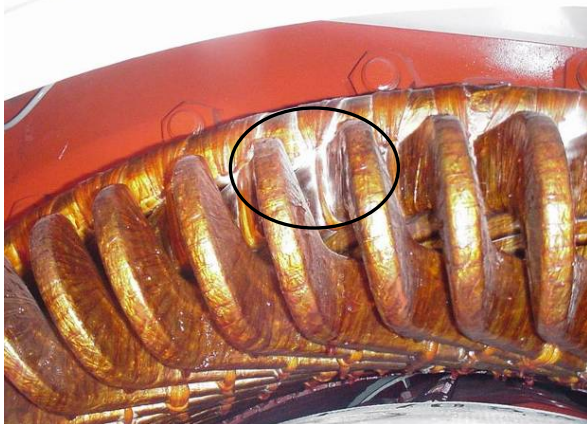
A well known problem that seems to be happening more and more frequently during the past 10 years is caused by inadequate support of the coils in the endwinding area. The current flowing in the coils gives rise to a 120 Hz magnetically induced vibrational force, just as can occur in the slot, with the force being proportional to the current squared. During motor starting, there is a 36 times higher magnetic force between the coils in the endwinding. If the blocking and bracing in the endwinding has not been designed well enough to withstand the starting forces, the coils may become a little loose. Under normal operating conditions, these slightly loose coils will begin to move (also at 120 Hz). The relative movement between the coils and support rings and at the blocking between coils leads to fretting of the insulation and a characteristic white powder (Fig. 11). Note that this white powder is not the same as the one that occurs from PD (Fig. 8-10). Powder due to fretting can occur anywhere the coils are loose, including the neutral-end coils. Powder due to PD will only occur on coils at or near the phase terminals.

If the fretting problem is not corrected, then eventually the insulation will be abraded down to the copper, at which point there is a high risk of a ground fault.

Fig 11: White powder due to fretting at interfaces caused by endwinding vibration.

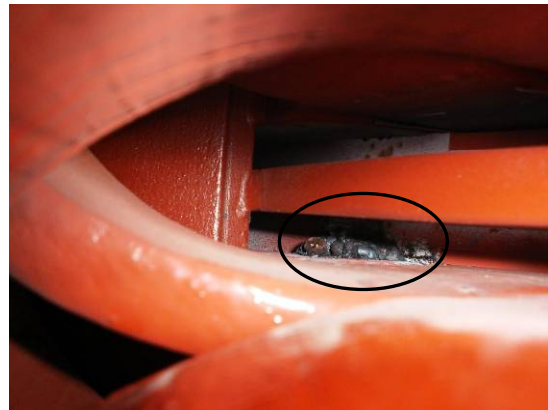
Fig. 12 indicates one such failure, on a 13.8 kV, 40 MW air cooled generator installed in an industrial power plant.

Fig. 12. Melted stator core as a result of over fluxing events.

In spite of the very high temperature that melted the core, the stator bar insulation did not fail, and there was no indication of this problem. The melted core was discovered during low-power (electromagnetic core imperfection detector -EICid) core test, conducted during regular maintenance.

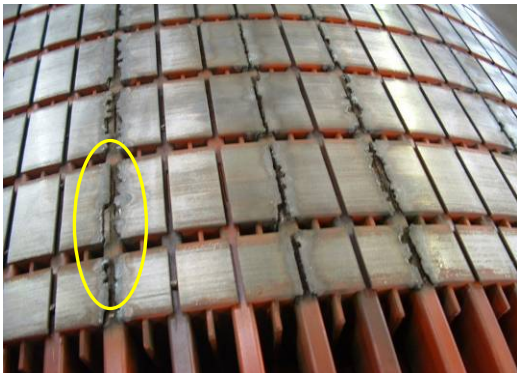
Fig. 13: Damage to an induction motor rotor core due to loose bars in the slot.

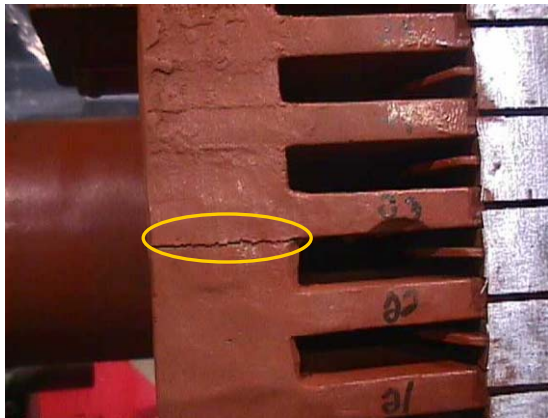
Fig. 14: Cracked short circuit ring.

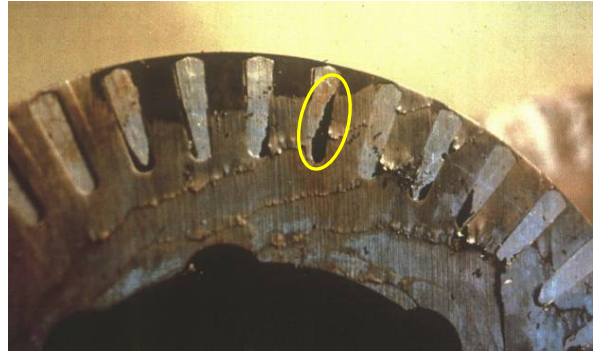
Fig. 15: Voids in a cast aluminum rotor bars in rotor slots due to poor manufacturing.

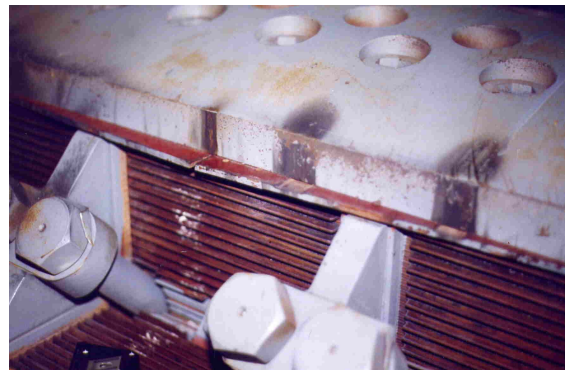
The radial and tangential centrifugal forces imposed on rotor winding insulation system components tend to distort the coil conductors, inter-coil connections and crack the coil insulation if they are not adequately braced. Fig. 16 gives an example of a top pole washer that failed under such forces.

Fig. 16: Top pole washer failure from mechanical forces.

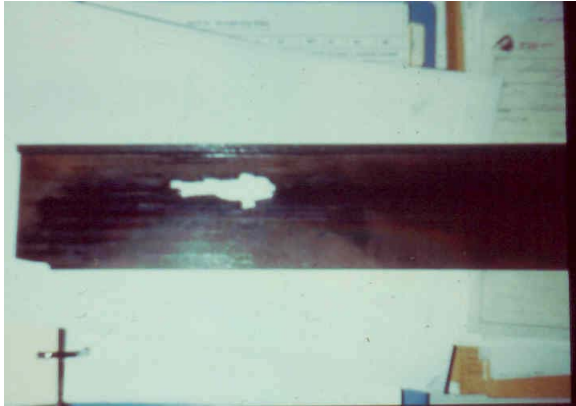
Figure 17: Slot Cell Electrical Failure to Ground
