Stator Winding Failure Due to Spark Erosion

National Electric Coil

Abstract

This paper describes a 2007 generator failure attributable to spark erosion deterioration of a high voltage stator winding. The unit is a large air-cooled generator, rated at 213 MVA and 19 kV. The unit began commercial service in 2000, and operated 51,636 hours before failing in 2007. Initial repair work included removing a total of 12 bars damaged from spark erosion. These bars were re-insulated by NEC and then the bars were re-installed. This was done quickly to return the unit to reliable service as fast as possible. Subsequently, NEC manufactured a new, replacement stator winding and installed it into the same machine later that same year.

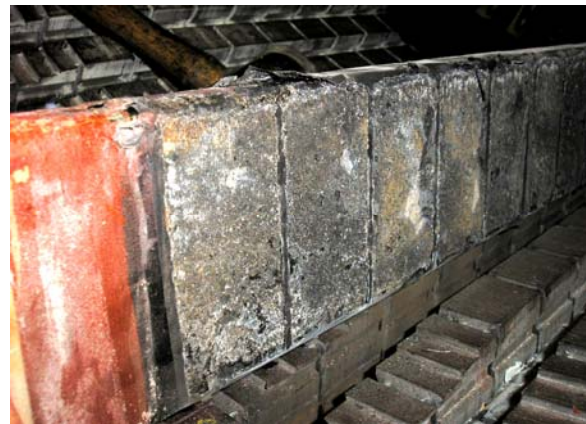
A large air-cooled generator failed in service due to a stator winding fault. The unit had been in operation for about 7 years prior to the failure. The unit is an air-cooled generator, rated at 213 MVA and 19 kV. Failure occurred on a top phase bar in slot 31. This bar and the top bar from the adjacent slot 32 were initially removed from the stator core after the failure. After further inspection and evaluation, 10 more top bars were removed from slots 21 to 30. In total, 12 top bars were removed and visually observed to have suffered spark erosion damage. In other published sources, spark erosion has also been referred to as slot dischargeⁱ and vibration sparkingⁱⁱ. It is a fast acting, stator bar failure mechanism, that causes damage to the bar's ground insulation. The primary contributor is loose bars in the stator slots. These 12 bars were reinsulated by NEC in the

Figure 1. Stator bar with spark erosion damage being removed from slot.

summer of 2007 and installed back in the winding. The purpose of the reinsulation was to allow the unit to be put back on line as quickly as possible. In October of 2007, the unit was taken off-line for a stator rewind with all new stator bars manufactured by NEC. The original stator winding was sent to NEC at their Brownsville, Texas facility for evaluation.

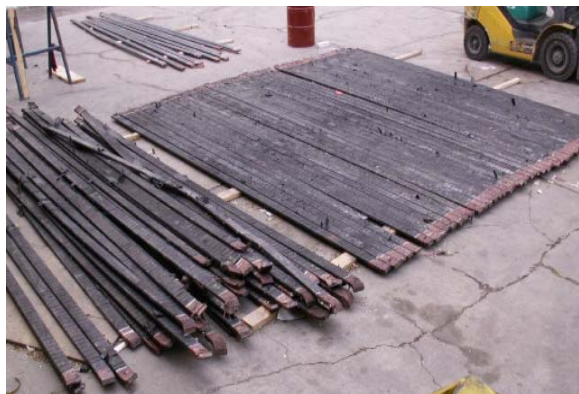
Figure 2. Removed stator bars laid out in sequence for evaluation and inspection.

It was found that 36 of the 60 original OEM top bars had specific marks of spark erosion on the cell semi-conductive coating surface. The other 24 top bars had no evidence of spark erosion at all. The newly reinsulated 12 top bars, when removed at the time of the rewind, had no traces of spark erosion. Not a single one of the 60 originally installed bottom bars had any evidence of spark erosion. The graph below shows the distribution of damaged bars compared to the individual voltage of that bar.

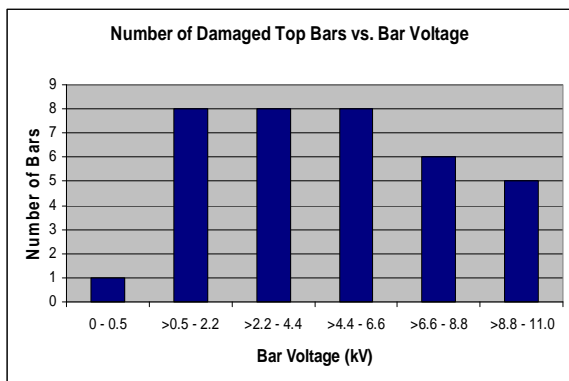
Figure 3. Graph showing number of damaged bars versus individual bar voltage.

This distribution is typical of spark erosion in that bar damage by this failure mode does not just occur on the bars having the highest voltage, but is typically distributed across bars of all voltages.

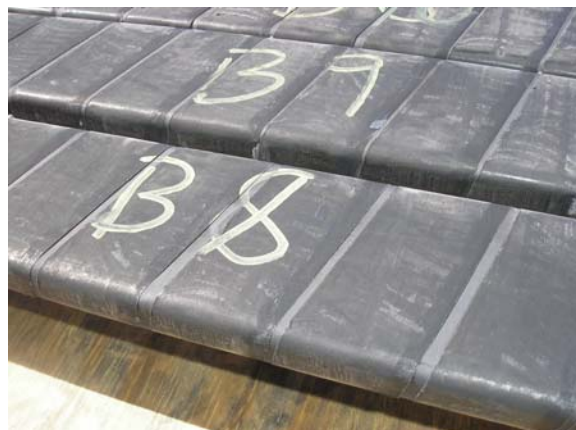
Figure 4. Photo of undamaged bottom bars removed from the original winding.

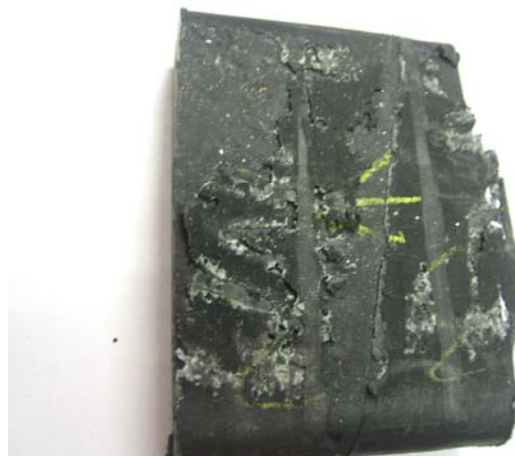
For Stage I Degradation, shown in Figure 5 below, the outer spiral double layer of semi-conductive tape is partially damaged with areas open to the bar's semi-conductive coating.

Figure 5. Photo of Stage I Degradation.

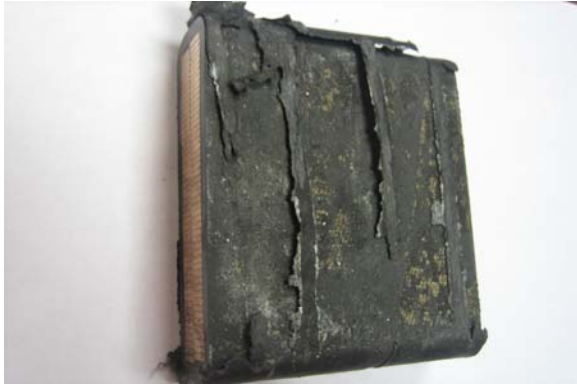
Stage II Degradation is characterized by portions of the bar's semi-conductive tape completely open. There is no spiral outer layer of semi-conductive tape left over the cell semi-conductive tape. The cell tape underneath is partially eroded and there are "slag-like" looking deposits on the this surface.

Figure 6. Photo of Stage II Degradation.

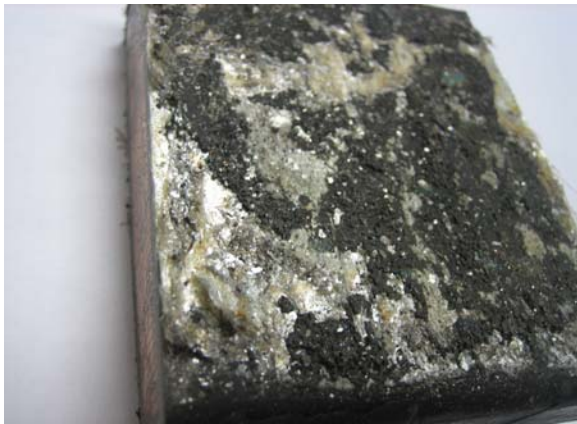
Stage III Degradation includes complete destruction of the outer spiral double layer of semi-conductive tape. The cell semi-conductive layer is also badly eroded everywhere. Instead of the smooth semi-conductive tape surface, a slag-like surface is now present. The outside layer of the insulation becomes carbonized. Conductive tracks appear in the outside and inside insulation layers. These layers are conductive with surface resistivity ranging from 10^5 - 10^7 ohm s.

Figure 7. Photo of Stage III Degradation.

As part of the failure investigation, surface resistivity measurements were made on all the bars. For undamaged bars, the surface resistance of the outer most semi-conductive tape portion was measured to be between 300 and 400 ohms/square. However, in the heavily damaged areas, surface resistance was measured to be much greater and more non-uniform. Values ranged from 100,000 ohms per square up to 10,000,000 ohms per square in these heavily damaged area.

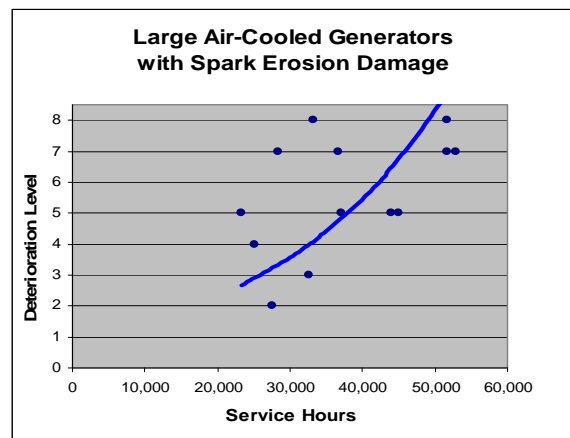
Figure 8. Stator bar deterioration level due to spark erosion versus actual service hours.

Included in the data are two units from two different OEM's that had actual stator winding failures. These are identified as deterioration level 8. One unit failed after 33,183 hours, and the other unit failed after 51,636 hours of operation. The other data points are from units currently in operation that have some level of spark erosion degradation.

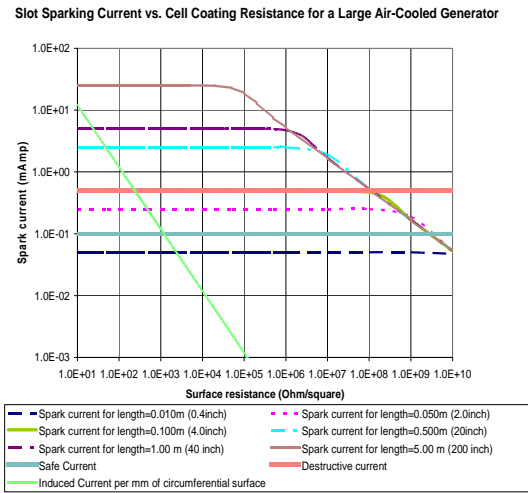
The graph in Figure 9 identifies sparking current levels (horizontal lines) as a function of stator bar surface resistances, according to the capacitive discharge model. The sparking current for the capacitive discharge model can be calculated according to the formula $I = \sqrt{\frac{U}{\pi \times C \times l}}$ (bar voltage) x f (frequency) x C (capacitance) x l (length between contacts). These curves are only applicable if the bars are loose in the slot, and, due to bar vibration, the bar is making intermittent contact with the core. Destructive current levels are noted at the 0.5 milliamps level and above, with safe currents identified at the 0.1 milliamps level and below.

A "grey" area exists between 0.1 and 0.5. Based on a standard capacitive discharge approach, contact of the bar to the core at a length of 20 inches will result in a very high and damaging current above 1 milliamp. On the other hand, having the bar contact the core at intervals in the range of 0.4 inches, will result in a safe level of current that will not be damaging to the stator bar surface.

The green diagonal line represents the inductive levels of current according to the model $I = \frac{\sqrt{U \times C}}{\sqrt{\pi \times l}}$ (generated voltage/inch x bar circumference (inches))/bar resistivity (ohms/square). It states that at lower levels of surface resistivity, higher sparking currents can occur if the bars are making and breaking contact (loose). At 300 ohms / square, for

instance, sparking current values are at 0.4 milliamps. This is a level at which damage occurs. At 1,000 ohms/square, for instance, the induced current level is about 0.12 milliamps, and considered a safe value.

Figure 9. Slot sparking current as a function of the bar surface resistivity.

It is also known that the surface resistivity can decrease with age, so levels sufficient enough to anticipate this reduction should be incorporated at the initial bar manufacture. If the surface resistance of the bar gets too low, there is danger of shorting the core laminations and inducing additional core losses.

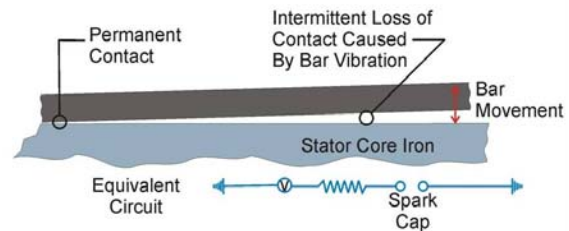
Loose stator bars in the slot are the primary contributor to spark erosion. If gaps in the slot exist, bars can vibrate, causing repeated opening and closing of the gaps between the bar and the core. The intermittent contact, combined with the voltage presence on the surface of the bar, creates sparking. The diagram below illustrates the effect of this intermittent loss of contact between the bar and the core.

Figure 10. Mechanism of spark erosion caused by intermittent contact between bar and core.

One of the findings of the failure investigation described previously, is that the average gap between the stator bar and the core iron was 9 mils. This was based on the average of measurements taken of undamaged bar widths, versus the core iron slot width. A gap of 0.009 inches in the slot between the bar and the core is considered excessive, and correlates well with the root cause of this failure. A gap of 0.009 inches with no followup side pressure from a ripple spring will allow the bars to be loose in the slots and vibrate.

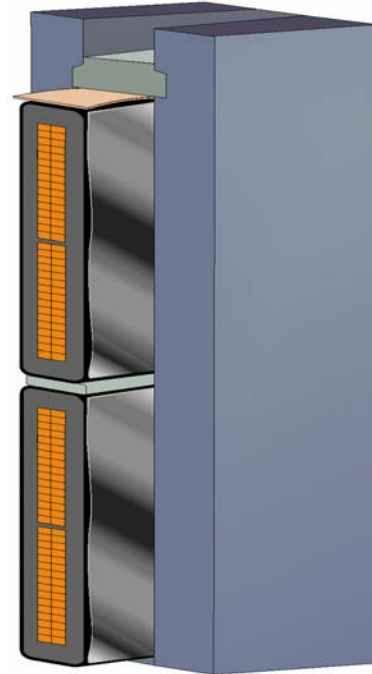
Figure 11. Illustration of top ripple and semi-conductive side ripple springs in the stator slot.

NEC, along with one other OEM, has recommended and used semi-conductive side ripple springs for many years. Side ripple springs, as shown Fig. 11, allow the bar to be fitted tight against the core iron, down the entire length of the slot.

More importantly, the side ripple springs keep the stator bar tight against the slot for many years, due to the spring action loading of the ripple, maintaining a constant force pushing the bar tight against the core. Although side ripple springs are more costly, the resulting improved performanceⁱⁱⁱ justify their installation.

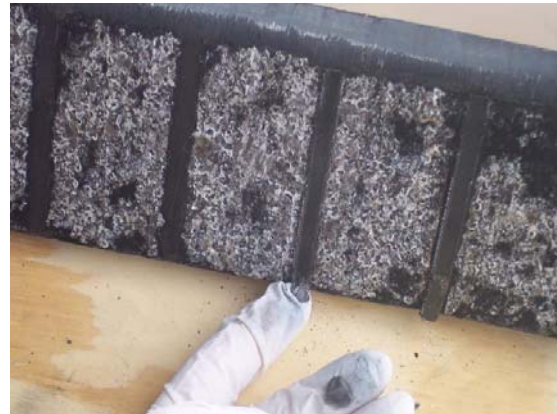
NEC also had the opportunity to conduct a failure analysis on the removed stator bars from another generator OEM. This unit also failed from spark erosion^{iv}. It too, was a large air – cooled generator, rated at 226,000 kVA and 18,000 volts. A photo of the damaged stator bar from this other OEM machine is shown in Figure 12. It is evident the spark erosion damage is similar in both machines.

Figure 12. Photo of spark erosion damage on a winding from another OEM. This winding failed after 33,183 hours of service and less than six years of operation^v.
