Twin Falls Hydro Project

13 MW 13.8 kV Generator Failure

NWHA Technical Workshop

June 2002

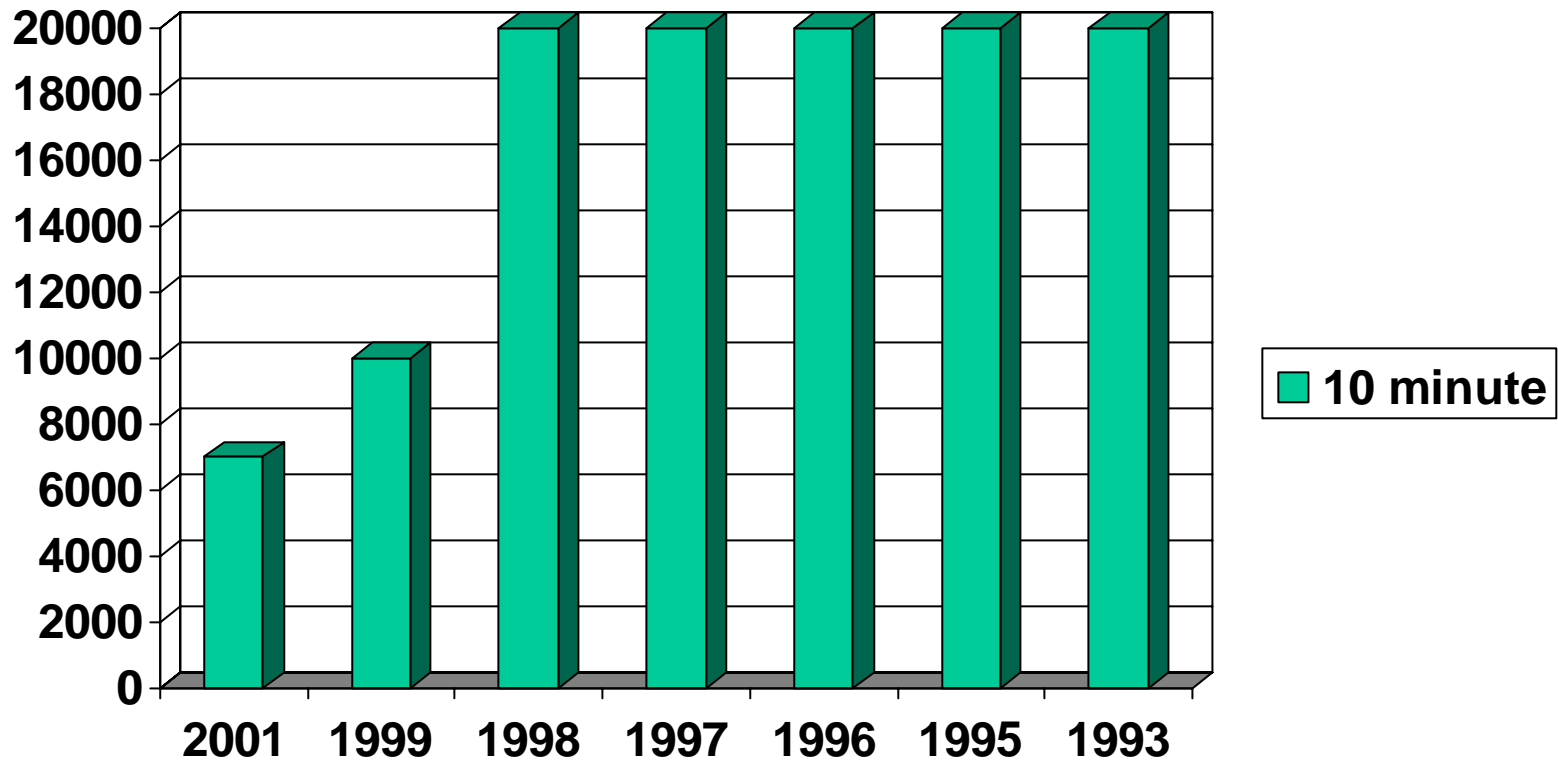
Mega ohms

- Megger tests performed annually
- Some scatter in results
- Typically megger tests taken in summer when unit off-line during annual maintenance and low river flows
- Damp environment

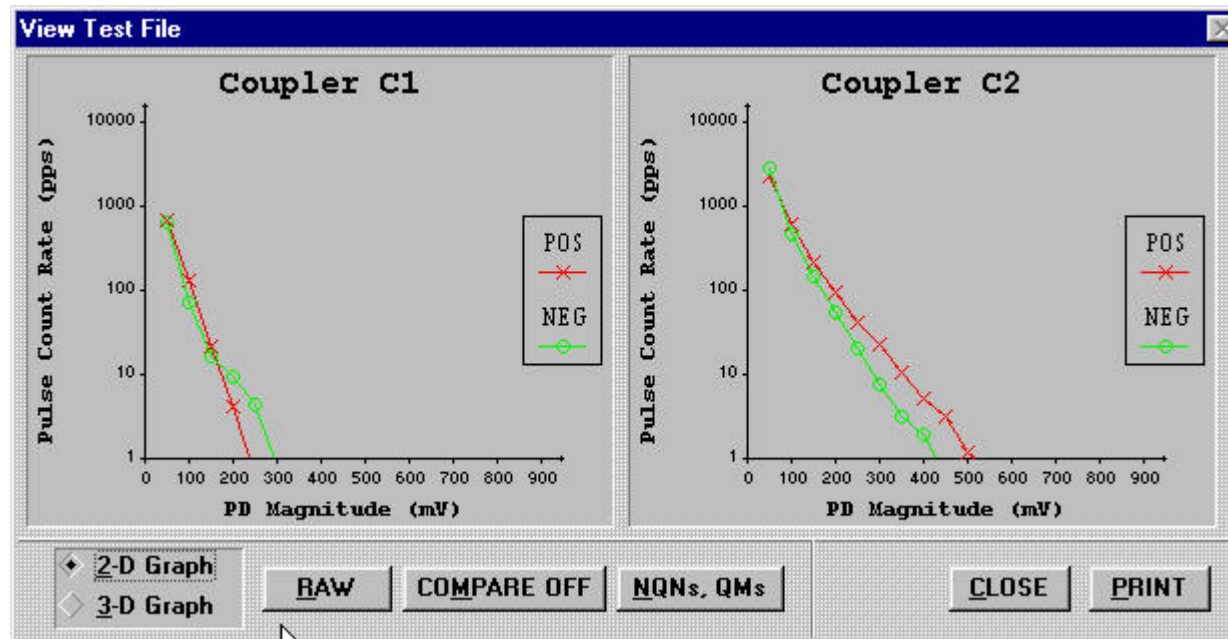
Unit #1, phase A, 8 MW

- With the recognition of potential problems PDA couplers were installed in 1997
- IRIS Power Engineering PDA
- Baseline run in 1997 indicated high partial discharge activity (typical values in the 100 mV range these units run ~300 mV)
- Interpretation of PDA results indicated thermal delamination, coil looseness and end-winding contamination

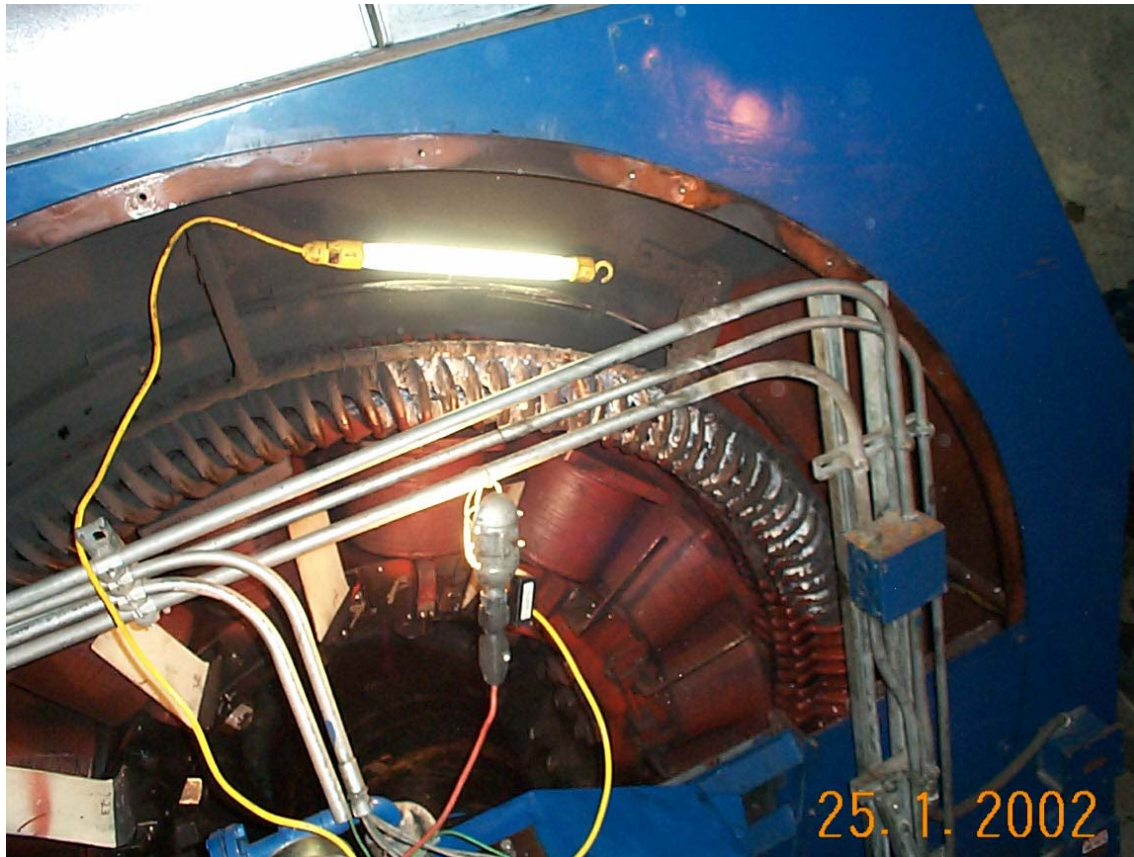
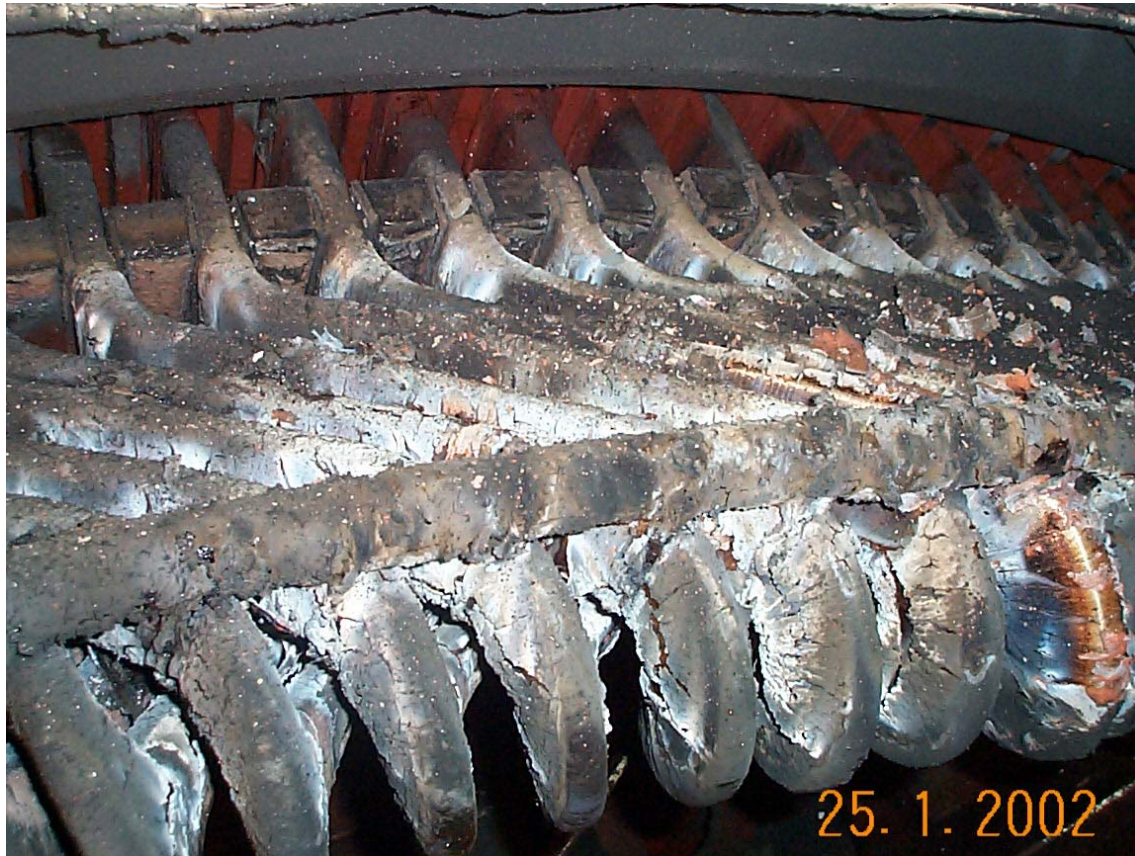
- January 25, 2002 Unit #2 generator fire while unit running at full load
- Operator called out at 02:30 when unit tripped off due to fire alarm and 86E ground fault
- Operator found dense smoke and burning coils

- Forensic inspection indicated a turn-turn failure in the end winding area
- Marginal design on insulation thickness (~75 volts/mill)
- Marginal strand insulation
- Sectioning indicated delamination of original windings

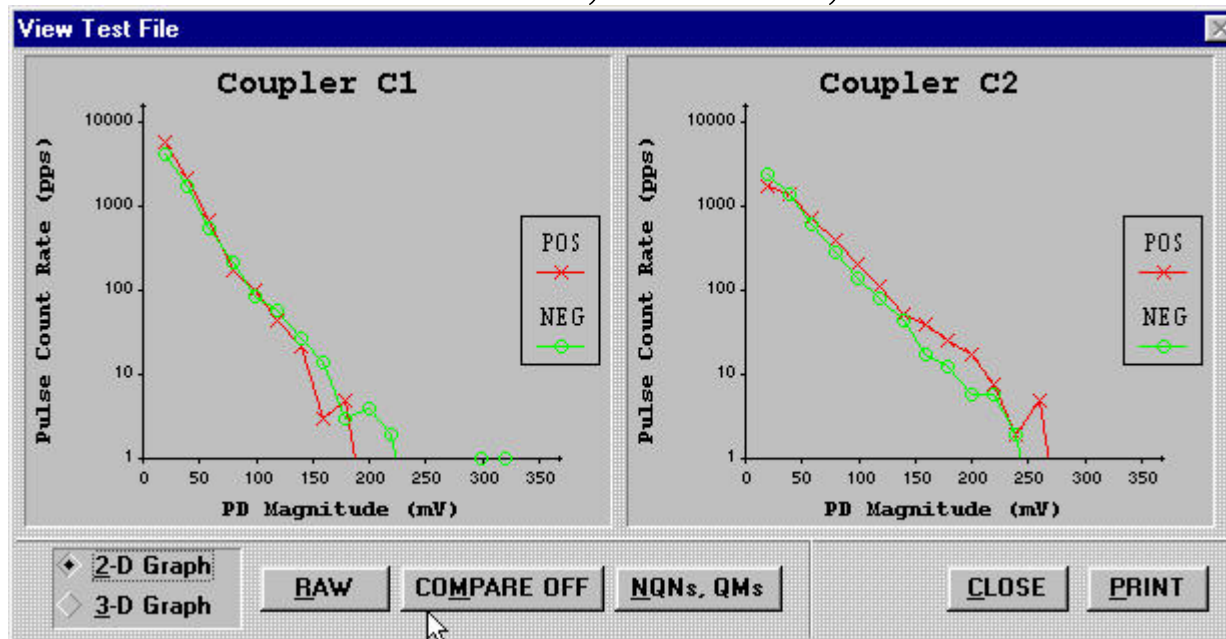
2002 Unit #2, Phase C, 5 MW

- PDA tests performed on Unit #2 following failure of Unit #1
- No PDA testing performed since 1997
- Interested in current condition of remaining generator
- PDA tests indicate delamination of windings and some slot discharge
