Vibration Sparking and Other Electrical Failure Mechanisms on Large Generator Stator Windings

C. V. Maughan
Maughan Engineering
246 Juniper Drive
Schenectady, New York 12306

G.C. Stone
Iris Power
1 Westside Drive, Unit 2
Toronto, Ontario M9C 1B2

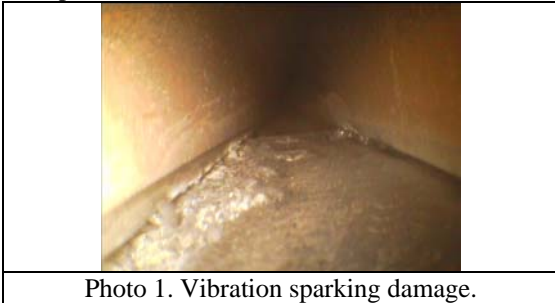
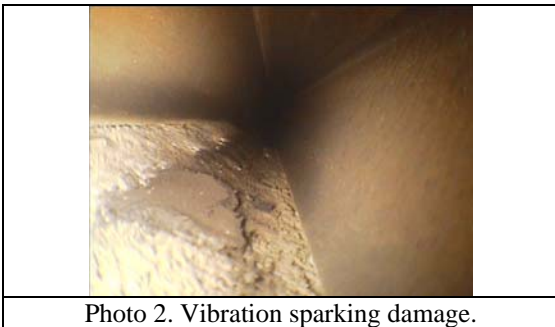
Vibration sparking is a relative fast deterioration mechanism and has caused service failure in a relatively short time. Photos 1 & 2 are borescope pictures of damage to a modern epoxy-mica groundwall insulation caused by vibration sparking. The stator winding of a generator of similar design failed in service after about 4 years of operation.

If vibration sparking is the result of radial looseness of the bar in the slot, rewedging can stop the vibration, unless the winding was a global vacuum pressure impregnated system. In this case, bonding may be the only option. If vibration is the result of side looseness, replacement of side packing with a side pressure springs should stop the vibration. This may not be possible, however, if the side packing is bonded to the core iron by the sparking or other bonding agent. Nor can side pressure springs be applied if the side clearance is insufficient to accept the spring.

Since vibration sparking tends to be an aggressive, relatively fast-acting phenomenon, if permitted to progress too far before being stopped, stator rewind may be the only viable option.

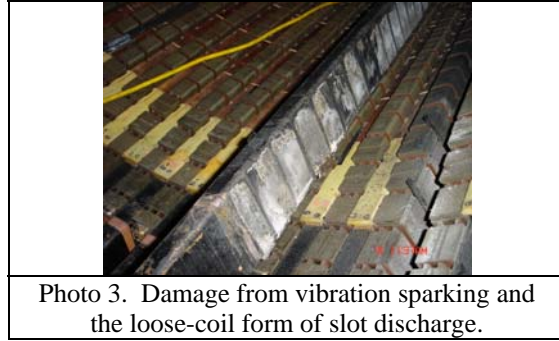
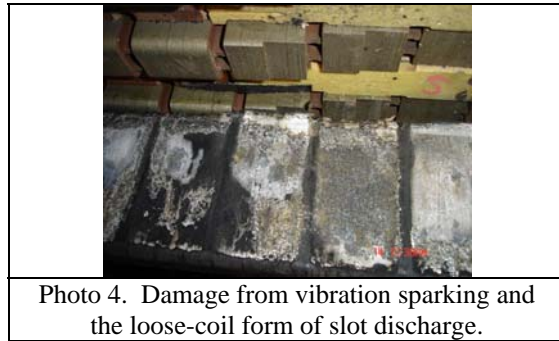
As previously stated, it may be difficult to distinguish the evidence of vibration sparking and partial discharge. If a bar is a high voltage bar, there may be no way to be certain, but if a deteriorated bar is from a low-voltage portion of the winding, it is certain to be vibration sparking. Photos 3 & 4 are of bars from an air-cooled turbine generator that appear to have both vibration sparking and partial discharge damage.

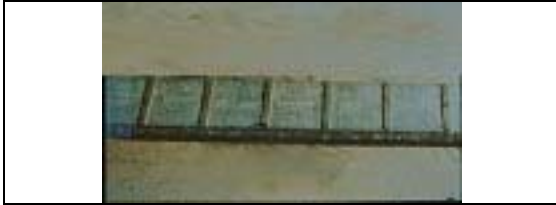
Photos 5 & 6 show examples of slot damage resulting from severe PD due to abraded insulation and due to poor conductive coating to ground.

Photo 5. Bar that has been abraded due to looseness in the slot.

Loose Windings. Bars that are allowed to vibrate in the slots will inevitably have worn insulation. Since the slot conductive coating is applied as the last coating on the outside surface of the bars, this coating will inevitably be damaged by vibration. The first priority of corrective action must be to stop the vibration. Rewedging, adding side pressure springs to the bars, and/or bonding the bars to the core iron can accomplish this. But the damage to the slot conductive coating that has resulted in the slot discharge cannot be easily or fully repaired. Thus if bar vibration has resulted in slot discharge, there probably will not be a permanent and complete fix. After the best repair possible, the level of partial discharge may be

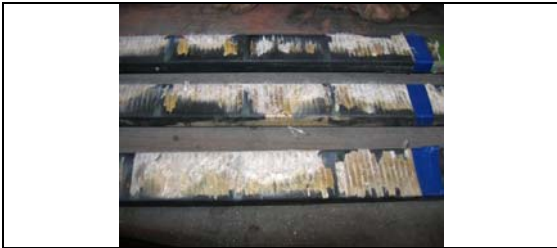
Photo 6. Slot discharge primarily due to poor slot conductive coatings.

Defective PD Suppression Coatings. When slot discharge is the result of a defective slot conductive coating, permanent and complete correction will probably not be possible, short of winding replacement. In-situ repair in the slot may include injection of conductive paints, silicon rubbers and epoxies. Defective slot grounding systems may be confined to isolated bars in the winding, and is only a problem in bars operating at

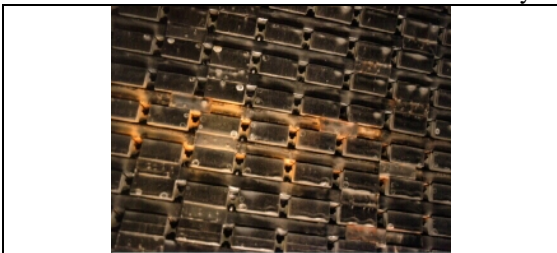
Two other forms of slot PD are shown in Photos 7 & 8. Both would be considered as serious, and corrective action would be considered necessary.

Photo 7. Wedges destroyed by slot PD.

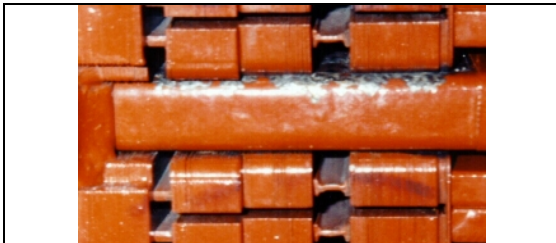
Photo 8. Major slot PD due to inadequate slot grounding paint system.

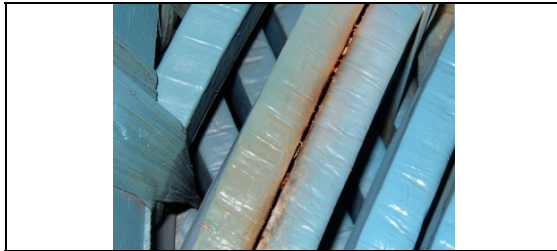
Photo 9. PD at a line-to-line phase break.

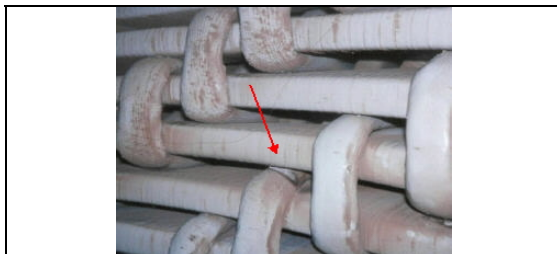
Photo 10. PD on a bar tie at a line-to-line phase break.

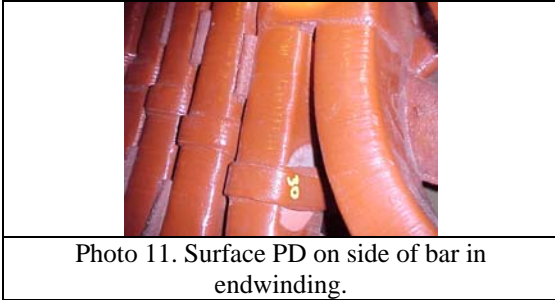
Also, localized partial discharge patterns may be seen on bars on windings that have been in operation for a period of time. Photos 11 & 12. The condition of Photo 12 would be of more concern than Photo 11, as Photo 12 suggests there will be significant partial discharge inside the slot.

Photo 11. Surface PD on side of bar in endwinding.

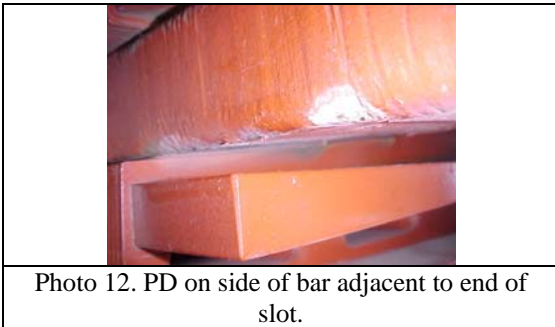
Photo 12. PD on side of bar adjacent to end of slot.

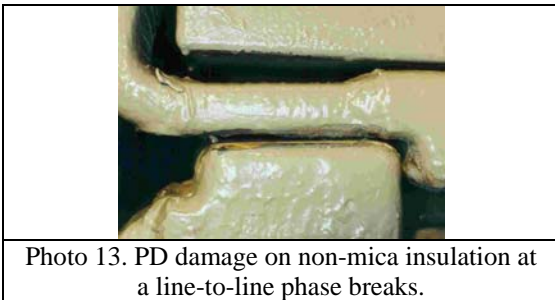
So long as the deterioration is purely partial discharge, e.g., without vibration or water contamination, the PD is unlikely to directly result in service problems. However, if the insulation is not mica-based, failure can occur in only a few months. Photos 13 & 14.

Photo 13. PD damage on non-mica insulation at a line-to-line phase breaks.

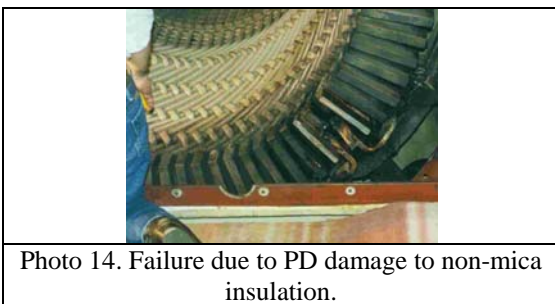
Photo 14. Failure due to PD damage to non-mica insulation.

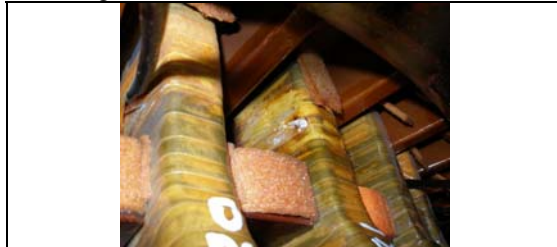
It was mentioned earlier that PD can only occur on higher voltage bars and that PD can be difficult to identify at times. These 2 simple and basic facts are sometimes overlooked by engineers performing inspection. To illustrate, the conditions shown in Photos 15 & 16 were observed on 2 duplicate air-cooled generators that had operated about 15 years. The appearance looks somewhat like partial discharge, yet these same conditions were observed randomly around the entire winding circumference on bars of high as well as low voltage. Thus the discolorations could not be indications of partial discharge.

Photo 15. Stator bar surface conditions misdiagnosed as partial discharge.

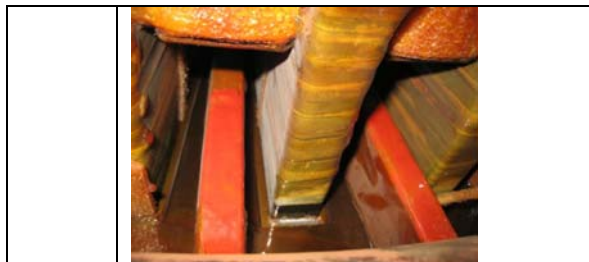
Photo 16. Stator bar surface conditions misdiagnosed as partial discharge.

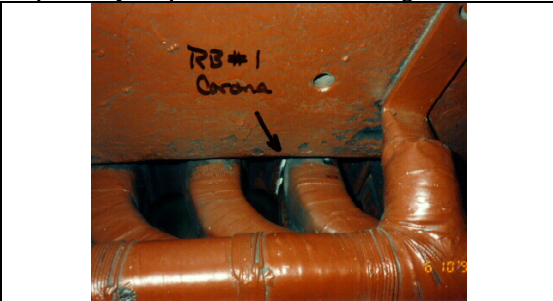
Junction Between End-arm Grading and Slot Grounding Paints. It is not unusual to observe distress at this junction, usually about 2" outside the slot. Photos 17 & 18. An adequate temporary repair may be possible on some designs.

Photo 17. Arcing damage at end-grading junction.

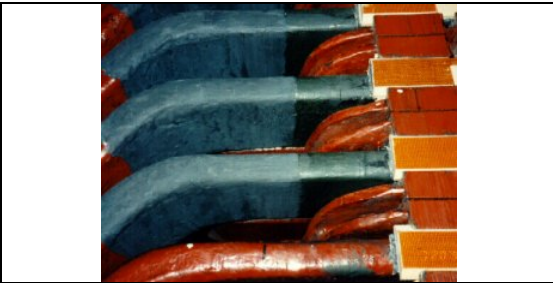
Photo 18. Repaired junction location.

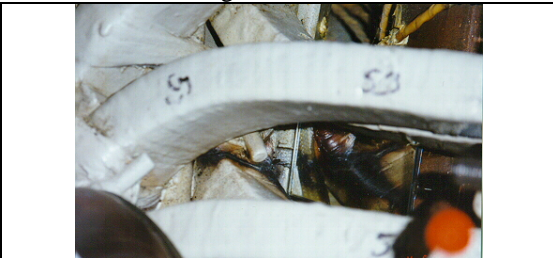
Electrical Arc Tracking. Two forms of this condition have been observed by the authors. One was the result of an endwinding grading system that was incapable of controlling the high voltage of factory winding high potential tests. Photo 19. Another apparently resulted from water dripping onto the endwinding. Photo 20.

Photo 19. Endwinding arc damage during shipping hipot.

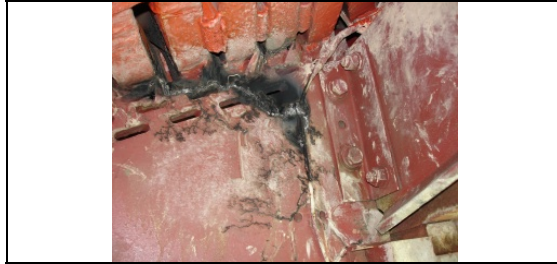
Photo 20. Arc resulting from water dripping onto endwinding. Outdoor unit.
