Experience with Directional Couplers in a High Noise Environment

Manitoba Hydro, Winnipeg, Manitoba R3T 1Y6 Canada

Abstract- Directional couplers have been used in Manitoba Hydro for on-line partial discharge measurements on rotating machines since 1981. This paper discusses experience with improved sensors and instrumentation in a high noise environment.

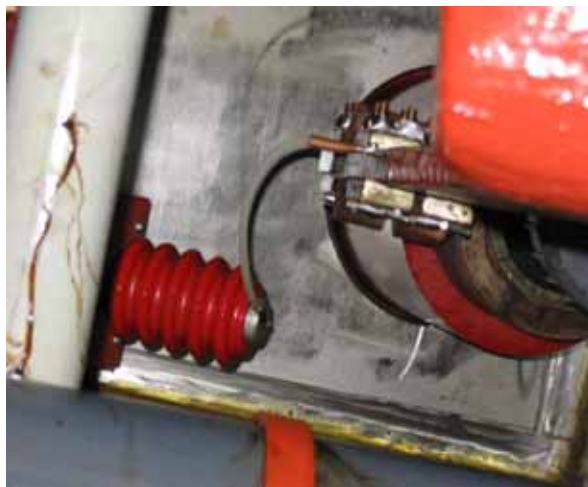
Fig. 1. 80 pF capacitive coupler inside housing of 300 MVA machine

Outages to re-wedge stator windings or to carry out related maintenance have provided opportunities to install compact 80 pF epoxy mica capacitive couplers. Fig. 1 shows one such coupler installed at the line end terminal of the stator winding of a 300 MVA synchronous condenser. High frequency grounding of the shield of the signal cable at the coupler is provided by means of a capacitor as is discussed in [3]. With the rotor removed there has been the opportunity to install a SSC under the wedge adjacent to the first air gap side bar from the line end of each circuit. In each of the small 160 MVA 17 kV synchronous condensers 6 SSCs have been installed, while the 300 MVA 13.8 kV machines have 12 SSCs. A SSC installed in a 160 MVA machine with a polyester mica winding is shown in Fig. 2. Each 160 MVA synchronous condenser is connected to the tertiary winding of a HVDC converter transformer. Each 300 MVA synchronous condenser has a separate 13.8/230 kV step-up transformer.

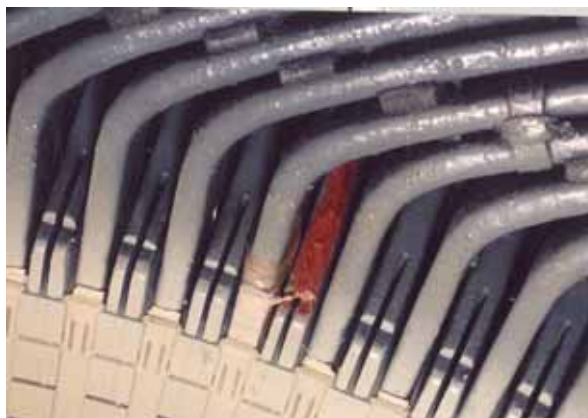
Fig. 2. Stator slot coupler installed under wedge in 160 MVA machine

wedges. In 1999 the unit was re-wedged with a radial ripple spring system. Also in 1999 stator slot couplers were installed and the earlier 80 pF XLPE cable type machine terminal couplers were replaced with 80 pF epoxy mica couplers that were installed inside the housing of the machine.

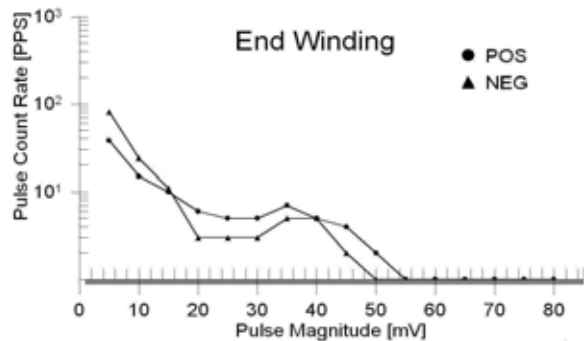
Fig. 3(b) SSC – PD Attributed to end winding at Slot 28 B-phase in air

In March 2000 with the machine running in air at 30 MVA 17.1 kV and a stator winding temperature of 72°C on-line PD measurements were made. Fig. 3(a) shows the PD attributed by the TGA-S to Slot 28 at the line end of one of two circuits in B-phase by means of the SSC that had been installed at the opposite connection end of this slot. Fig. 3(b) shows the PD that was attributed to the end winding at the same slot. The TGA-B data from the directional couplers on B-phase are shown in Fig. 3(c) for the machine and in Fig. 3(d) for power system “noise” including PD associated with the isolated phase bus.

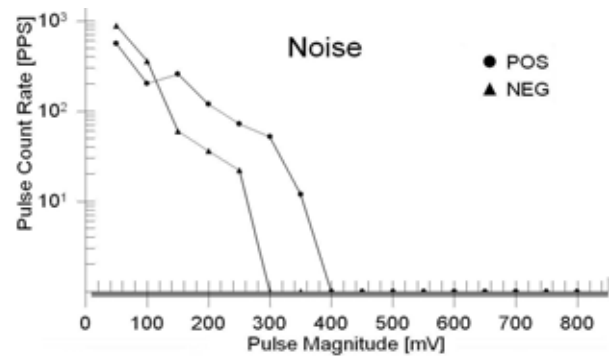
Fig. 3(d) 80 pF couplers – B-phase power system noise & IPB PD

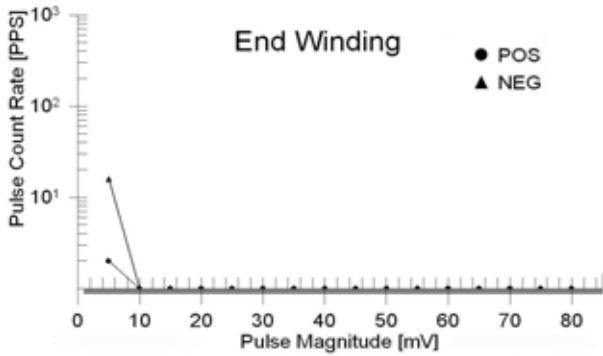
Fig. 4(b) SSC – PD Attributed to Slot 28 B-ph end winding in hydrogen

In January 2001 with the machine running in hydrogen at 207 kPa (gauge), loading at 38 MVA 17.0 kV and a stator winding temperature of 39°C, on-line PD measurements were made. The data will be found in Fig. 4(a) – Fig. 4(d). It will be noted that the PD measured from the sensors was reduced from that measured in air, with the exception of the power system “noise”.

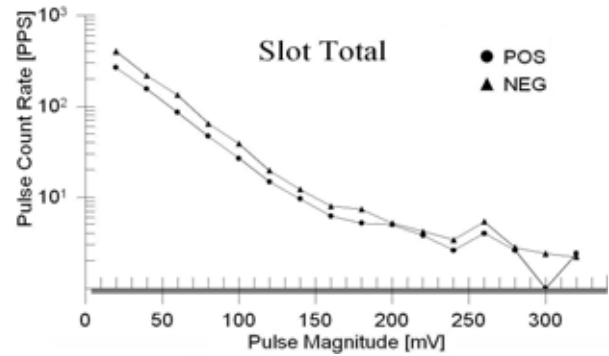
Fig.5(a) SSC – PD Attributed to Slot 13 B-phase line end in air

In October 1996 with the machine running in air at 26 MVA 17.0 kV and a stator winding temperature of 72°C, on-line PD measurements were made. Fig. 5(a) shows the PD attributed by the TGA-S to Slot 13 at the line end of one of the two circuit in B-phase by means of the SSC that had been installed at the opposite connection end of this slot. No PD was attributed to the end windings by the TGA-S analyzer. The PD data from the directional couplers on B-phase are shown in Fig. 5(b) for the machine and in Fig. 5(c) for power system “noise” including PD associated with the isolated phase bus. Figure 5(d) shows a phase plot of the PD attributed to the machine.

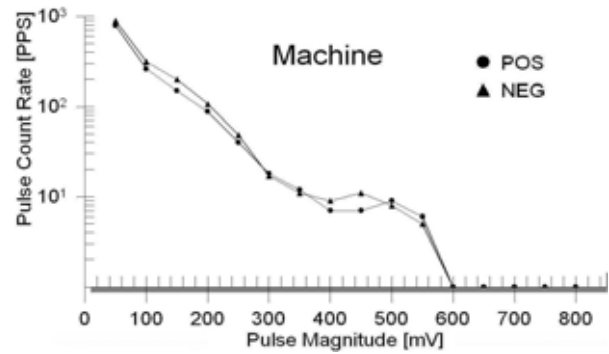
Fig. 5(b) 80 pF couplers – PD attributed to B-phase of machine in air

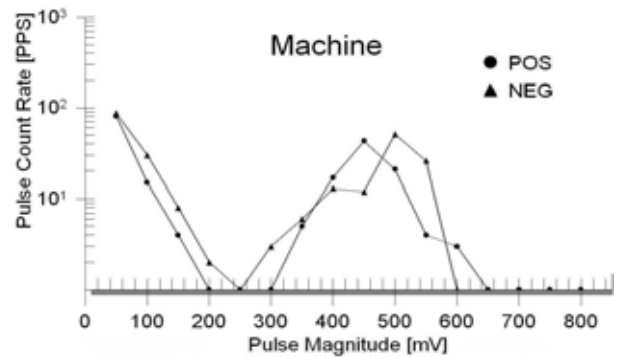
Fig.6 (b) 80 pF couplers – PD attributed to B-ph of machine in hydrogen

In February 1998 with the machine running in hydrogen at 207 kPa (gauge), loading at 19 MVA 17.0 kV, and stator winding temperature of 41°C, on-line PD measurements were made. The data will be found in Fig. 6(a) – Fig. 6(d). Note that the PD attributed to Slot 13 is less than what was observed with the winding operating in air, but the magnitudes are higher than for the previously discussed epoxy-mica winding in Fig. 3 and Fig. 4. As for the directional couplers, there was a reduction in pulses with a phase position typical of winding PD with the machine operating in hydrogen, but an increase in pulses that may reflect discharges external to the slot.

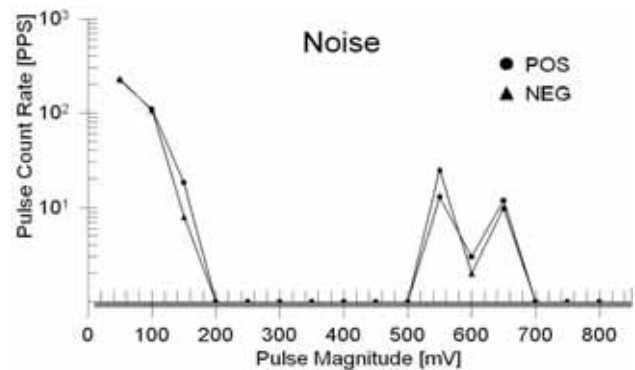
Fig. 6(c) 80 pF couplers – B-phase power system noise & IPB PD

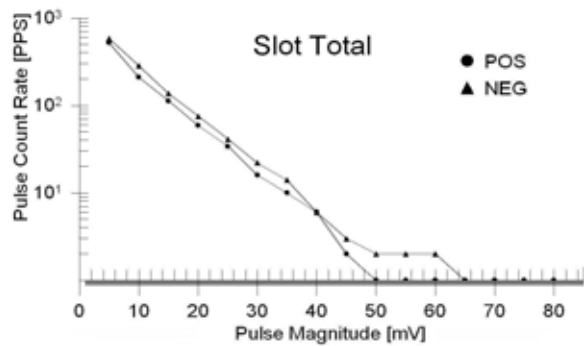
Fig.7 (a) SSC – PD Attributed to Slot 62 B-phase line end in air

In May 2005 with the machine running in air at 8 MVA 13.2 kV and a stator winding temperature of 52°C on-line PD measurements were made. Fig. 7(a) shows the PD attributed by means of a SSC to Slot 62. Virtually no PD was attributed to the end windings. The PD data from the directional couplers on B-phase are shown in Fig. 7(b) and Fig. 7(c). Fig. 7(d) shows a phase plot of the PD attributed to the machine. The predominance of positive polarity pulses suggests the external coating of the winding.

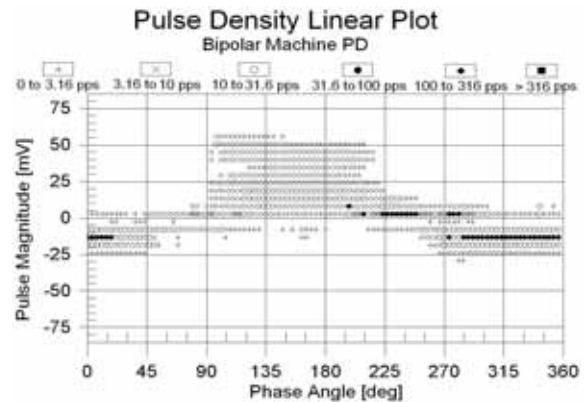
Fig. 7(d) 80 pF couplers – PD attributed to B-phase of machine in air

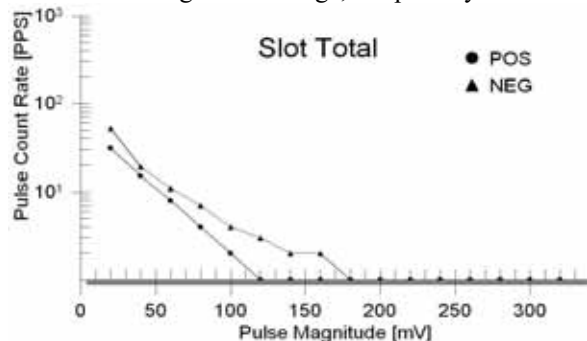
Fig.8 (a) SSC – PD Attributed to Slot 62 B-phase line end in hydrogen

In September 2005 with the machine running in hydrogen at 162 kPa (gauge), loading 10 MVA 13.8 kV at a stator winding temperature of 75°C, on-line PD measurements were made. As shown in Fig. 8(a) the PD attributed to Slot 62 by the TGA-S was significantly higher than had been measured with the machine operating in air and now showed signs of negative pulse predominance. The data from the directional couplers are shown in Fig. 8(b) - Fig. 8(e). The phase position of the PD attributed to the winding suggests end arms or circuit ring bus, but the magnitude is low. Pulses attributed to the IPB have the characteristic phase position for discharges related to line-to-ground voltage, but polarity is reversed.

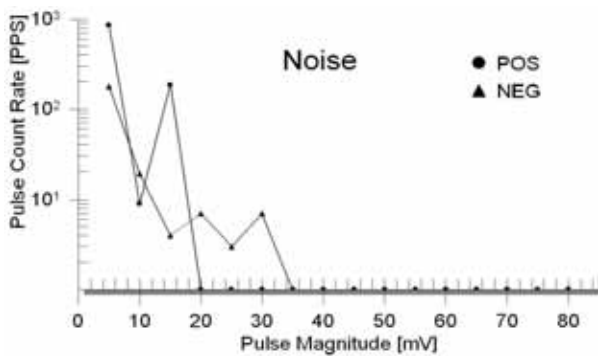
Fig. 8 (c) 80 pF couplers – B-phase power system noise & IPB PD

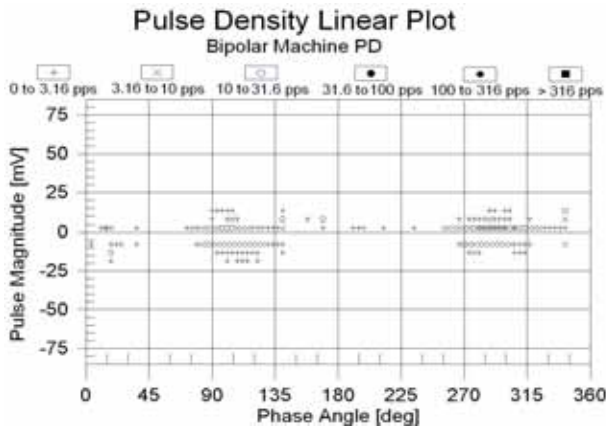
Fig. 8(d) 80 pF couplers – PD attributed to B-ph of machine in hydrogen

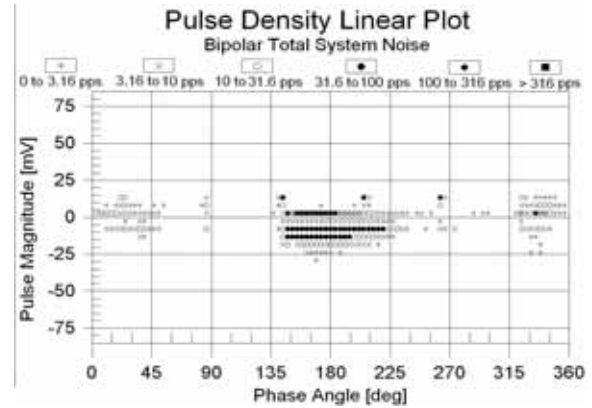
Fig. 8(e) 80 pF couplers – Pulses attributed to B-ph of IPB in hydrogen
