# Generator On-Line Monitoring and Condition Assessment

Partial Discharge and Electromagnetic Interference

1012216

Final Report, December 2006

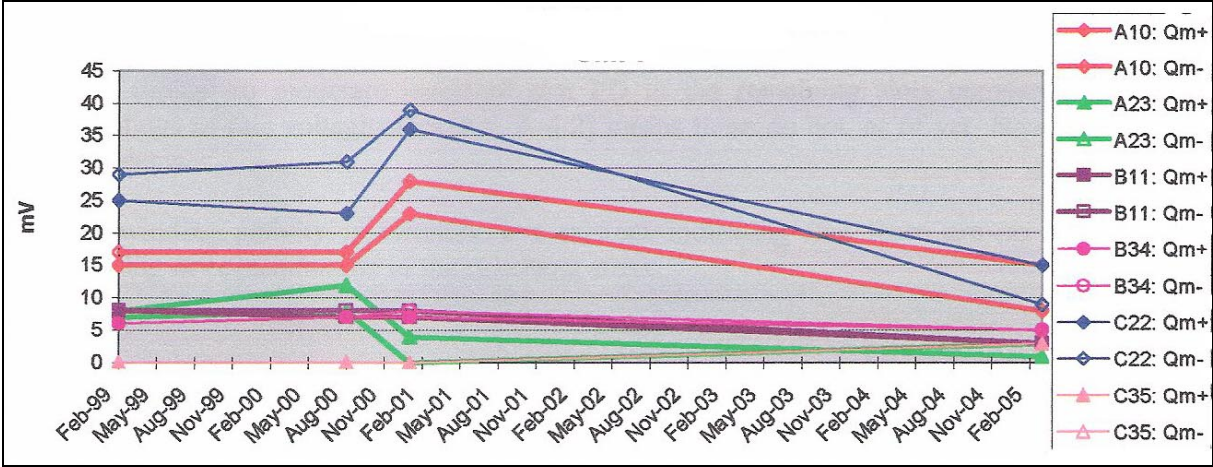
As with the results obtained from the bus couplers, it would appear that activity has changed little over the monitoring period. Indeed, Figure 2-3 would suggest that the activity had diminished slightly. Even though two of the sensors registered levels that would be regarded as higher than normal, the lack of deterioration over the time period would not suggest a major problem. Tester B concludes that the stator winding is suitable for service without restriction.

**Figure 2-3**  
**PD Activity over the Monitoring Period from the 6 Slot Couplers Installed in Sammis #6.**  
**Tester B**

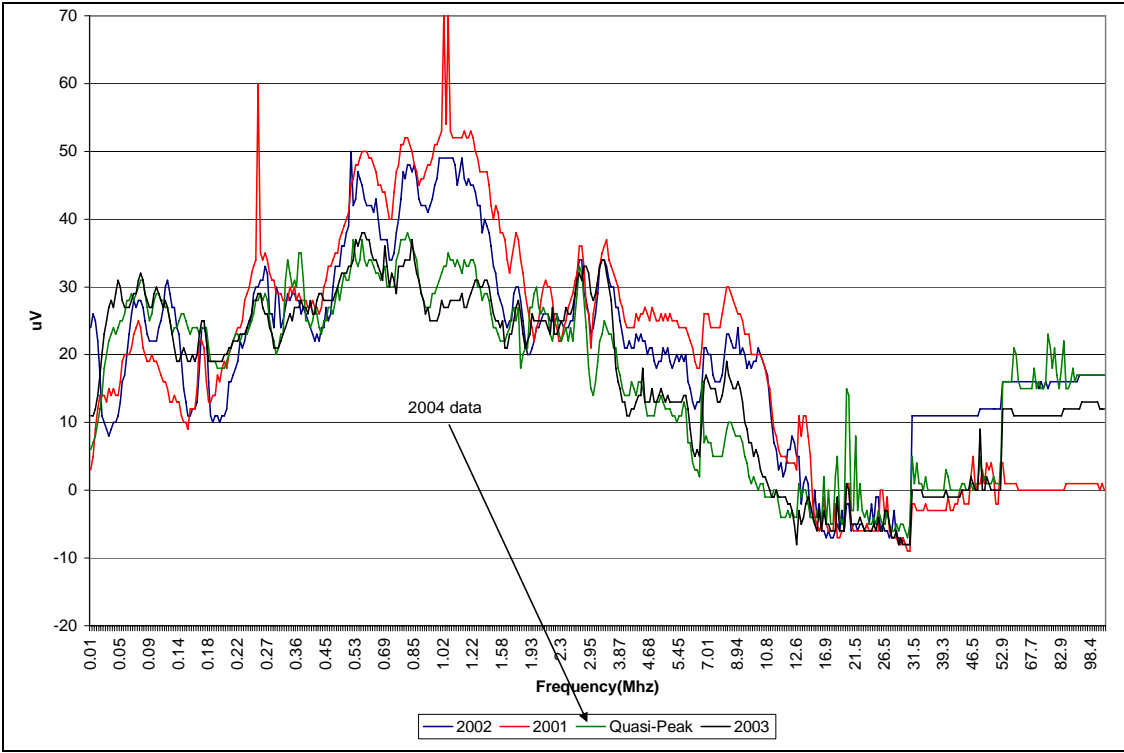
The last available EMI signature taken on this machine prior to the inspection is depicted in Figure 2-4.

**Figure 2-4**  
**EMI Signatures at Sammis #6 from 2001 to 2004. Tester D**

The latest result is shown in comparison to those taken in earlier years and clearly indicates that there has been little change in the overall spectrum. If anything the latest activity is somewhat less than in some prior years which is in agreement with the trending analysis available from the stator slot coupler results in the Stator Slot Coupler Tests Section. It should be recognized that, while the PD tests are made on the individual phases independently, the EMI measurements have been made through the use of a high-frequency current-transformer (HFCT see Figure 2-5) at the neutral of the machine. As a consequence, the results shown in Figure 2-4 represent an amalgamation of activity from all the phases. The use of an HFCT at the neutral is not a limitation of the EMI technique, but rather a practice that has been adopted as the technique has been developed. Indeed, in 2004, the EPRI program [2] undertook some comparative measurements using EMI derived from an HFCT and from line-end couplers on the same machine for comparison purposes.

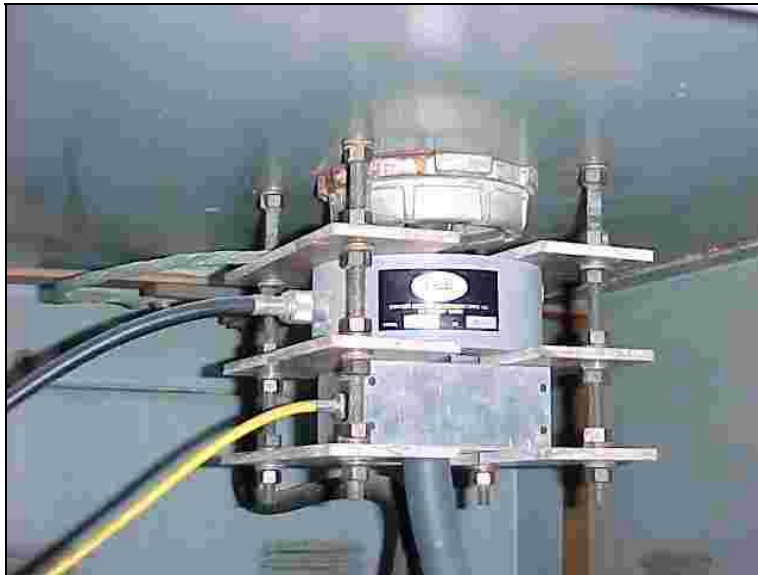
**Figure 2-5**  
**High-Frequency Current -Transformer at the Machine Neutral**

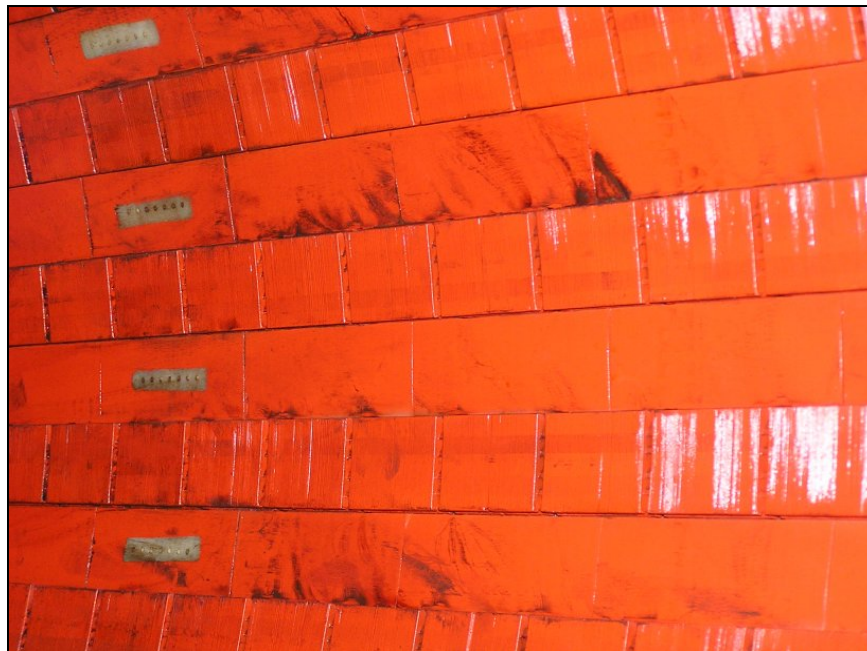
During the 1998 overhaul, radial springs and wedges with the 7-hole test system were installed by Westinghouse. While Figure 2-6 shows that there was considerable general contamination of the wedges, it is likely that this contamination is derived from wear products and dirt accumulation over the years of operation rather than individual wedge vibration or stator bar vibration. The wedges that were tested for tightness all sounded very tight, and First Energy reported that the 7-hole tests indicated satisfactory results.

**Figure 2-6**  
**“Greasing” Seen at the Slot Wedges**

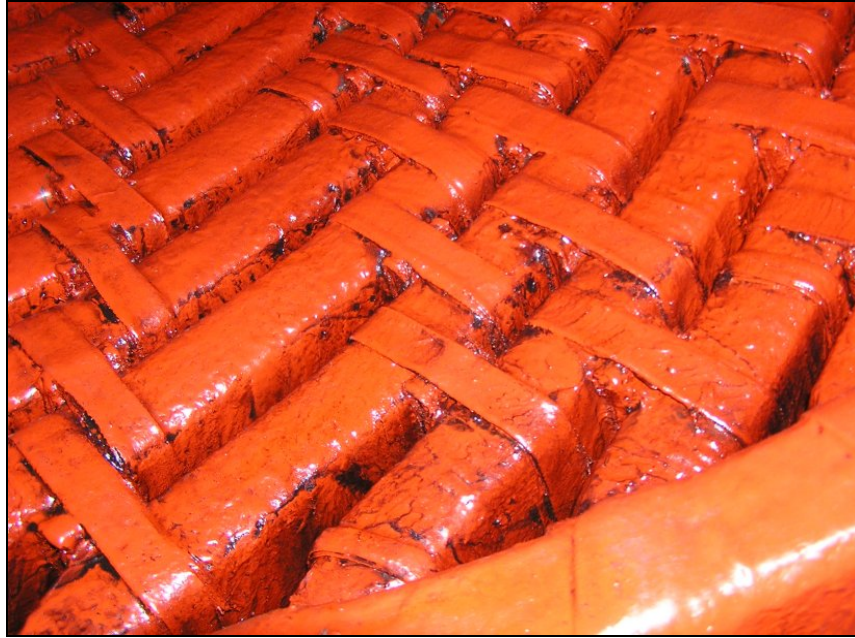
Again there was wide-spread “greasing” as seen in Figure 2-7. The so-called “grease” is a mixture of oil with the dust generated by insulation wear (and general contaminating dirt). Oil ingress is common on generators, particularly hydrogen-cooled units. This generator was particularly contaminated with oil. Recently, the amount of oil removed from the generator was reported to be many gallons per day. Generally, oil contamination is not considered to be a serious degradation mechanism to the metallic and insulation components of modern generators, but it does make inspection problematical.

**Figure 2-7**  
**Contamination Collecting from Endwinding “Greasing”**

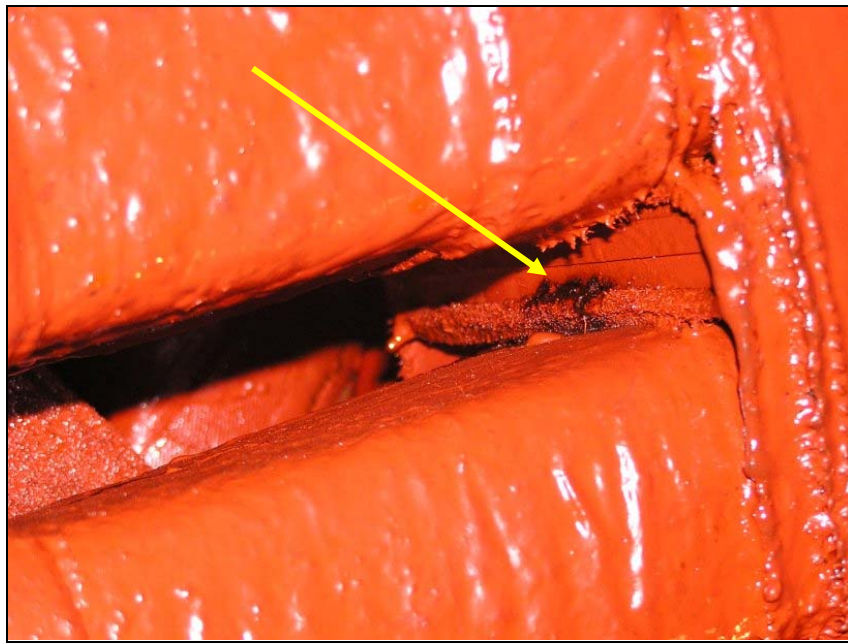
Careful inspection of the phase breaks in the endwindings revealed little indication of any PD activity. Figure 2-9 is the only block on which confirmed indications were seen (shown arrowed). While this looks very much like the widespread contamination found all over the endwindings (see Figure 2-7), the physical properties were different, and in line with that normally seen from phase-break partial discharge. Whereas the grease deposits were easily removed by wiping with a cloth, the material in Figure 2-9 was hard and dry, typical of PD deposits. This activity was not obviously picked up by any of the installed stator slot couplers whose output is shown in Figure 2-3.

**Figure 2-9**  
**Probable Partial Discharge Activity on Blocking at Phase Break**

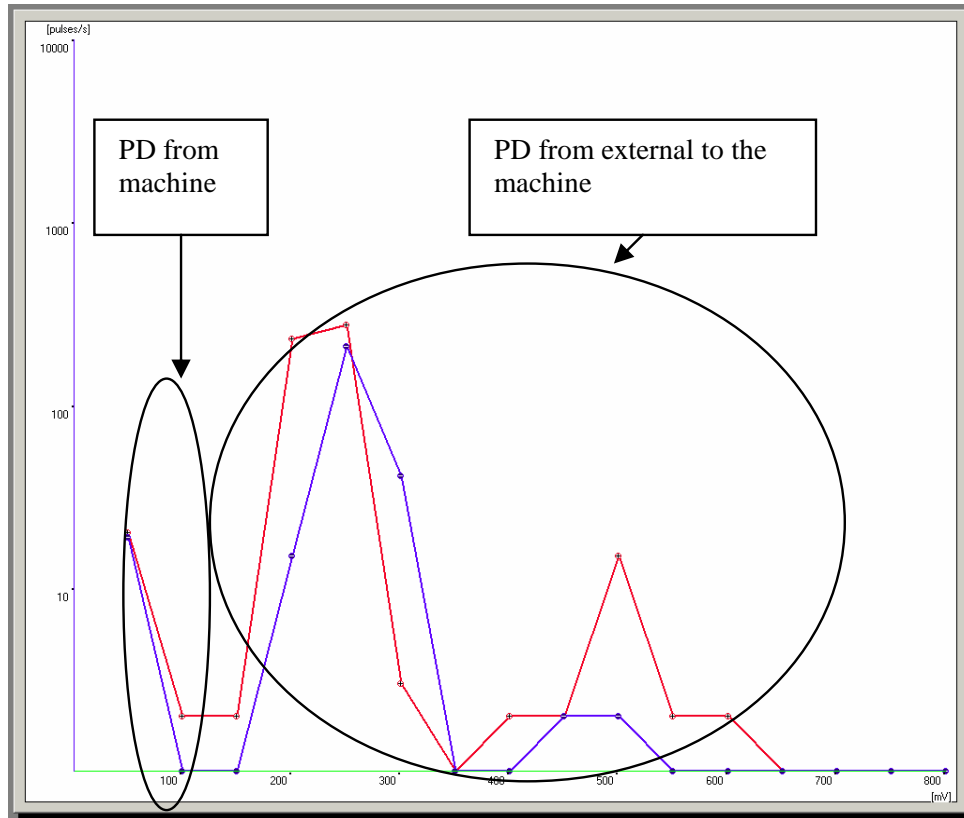
The EMI data is reported in the EMI Assessment Section. The signal from the PD coupler of each phase is connected to an HP 8591E Frequency Response Analyzer together with an antenna-derived ambient noise signal for use as a noise baseline reference. The frequency window used is 100 kHz - 500 MHz. The peak and average amplitudes of the spectrum of each phase are recorded, and used for a combined phase-resolved PD test, and also for data interpretation -- in comparisons with trended data.

**Figure 3-2**  
Pulse Height Analysis for Marshall #3 (HF Technique) Tester A

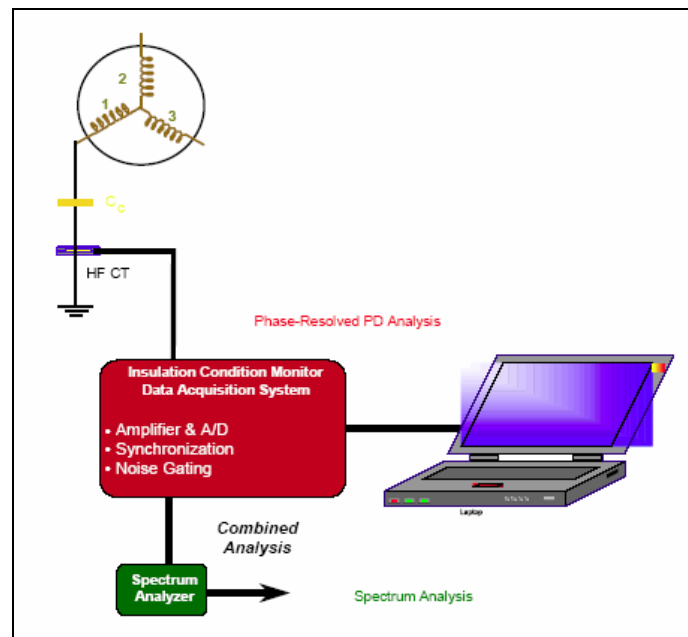
**Figure 3-3**  
Schematic Representation of the PD Measurement System Used by Tester C

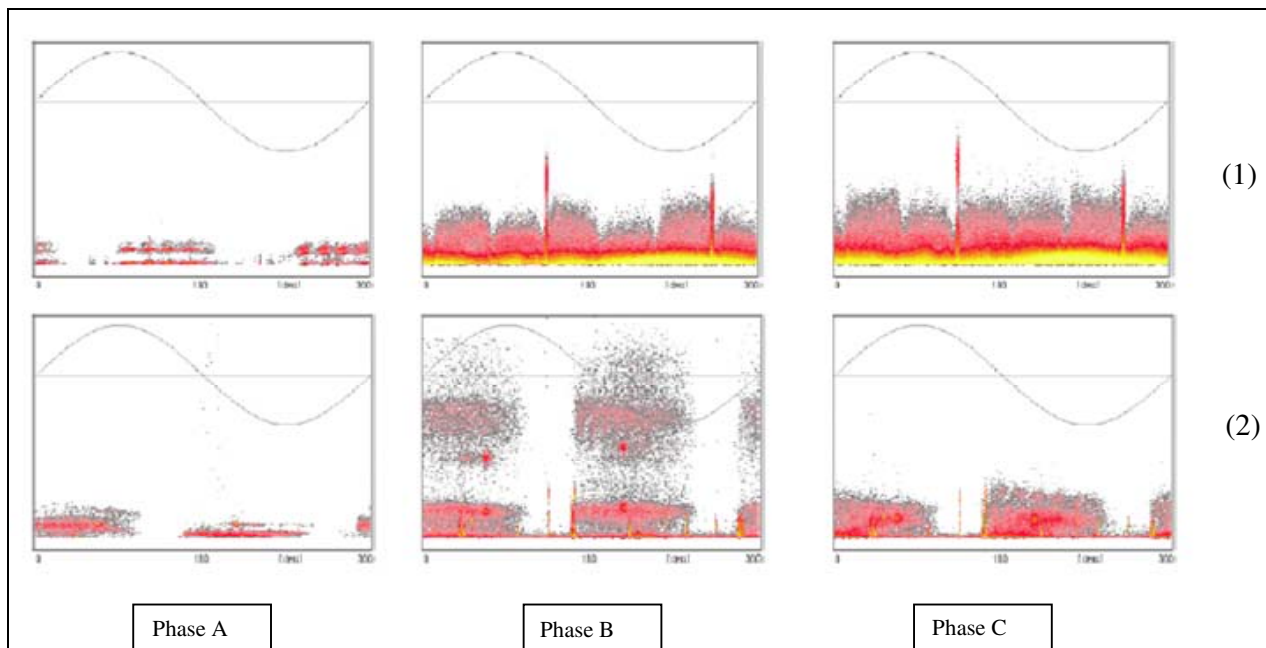
In a combination analysis, the frequency response analyzer can be used as a “narrow” bandwidth filter set to individual peaks of interest identified in the previous EMI scan. This “filtered” signal is connected to the PD data acquisition system to provide information related to the specifics of the PD pattern at each notable frequency. This has been done in Figure 3-5 where a frequency window centered on 1.29 MHz has been used. The frequency is based on the EMI spectrum given below in Figure 3-6.

**Figure 3-5**  
**Phase-Resolved PD Analysis at a Frequency of 1.29 MHz. Marshall Unit #3. Tester C. (1)**  
**July 2004, (2) Nov 2005**

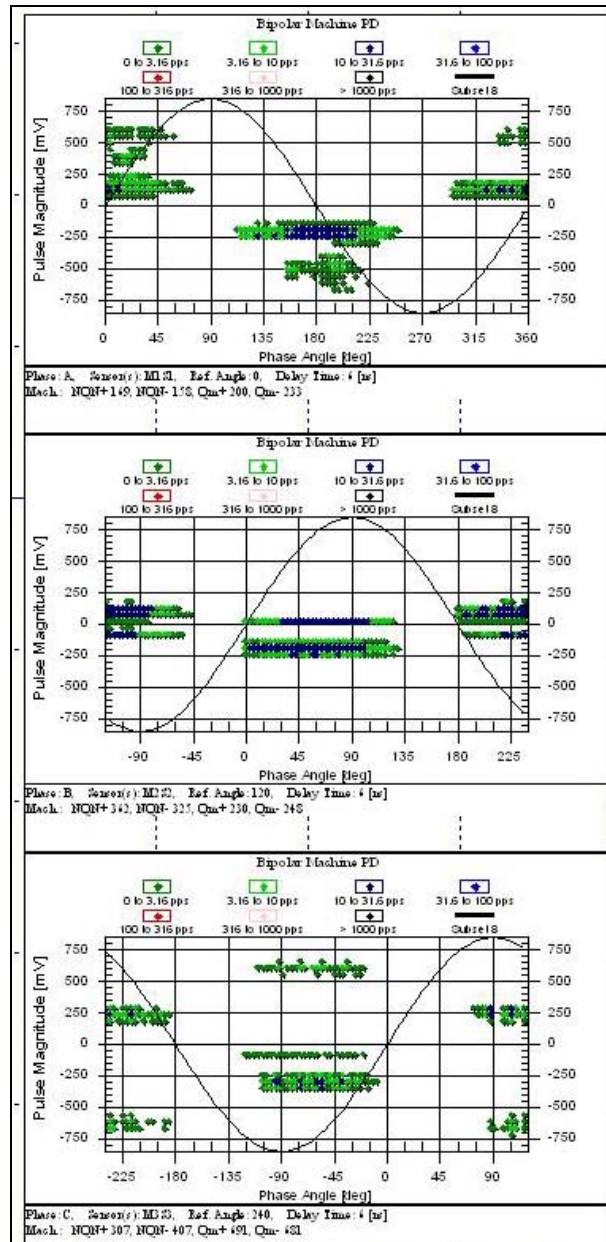
It is immediately apparent that the signals have increased dramatically during the intervening 18 months for all phases. This increase should be interpreted as a cause for concern. Figure 3-7 provides the associated phase-resolved discharge plot which shows that, in C phase, the activity is near to the center on the peaks of the AC cycle, with the usual polarity relationship for PD or corona (i.e. the pulse polarity opposite to AC voltage polarity). Assuming correct assumptions have been made on the phase shifts from the reference in each phase, then the pattern in C phase is typical of conventional corona on the surface of a conductor. This usually only occurs on the output bus of the generator. Thus because of the phase relationship and the subjective similarity to past patterns seen – the most likely source of this activity is the isolated phase bus of C phase. The cause may be sharp conductive points on the bus, weld splatter, a contaminated rag, etc.

Such patterns are not likely within the stator – and in fact there appears to be little conventional stator winding PD within this machine.

**Figure 3-7**  
**Marshall Unit #3 Phase Resolved PD Analysis. Tester B**

With the assumptions about the phase reference and RFCT polarization – it may be that the high signals in A and B phases are just cross-coupled signals from C phase. (If the assumptions are incorrect – then the iso-phase bus sparking may be occurring on these other phases instead.) Iso-phase bus sparking/corona rarely leads to unit failure, but Tester B recommended that it would be prudent to examine the bus when possible (i.e. at the time of the scheduled rewind).

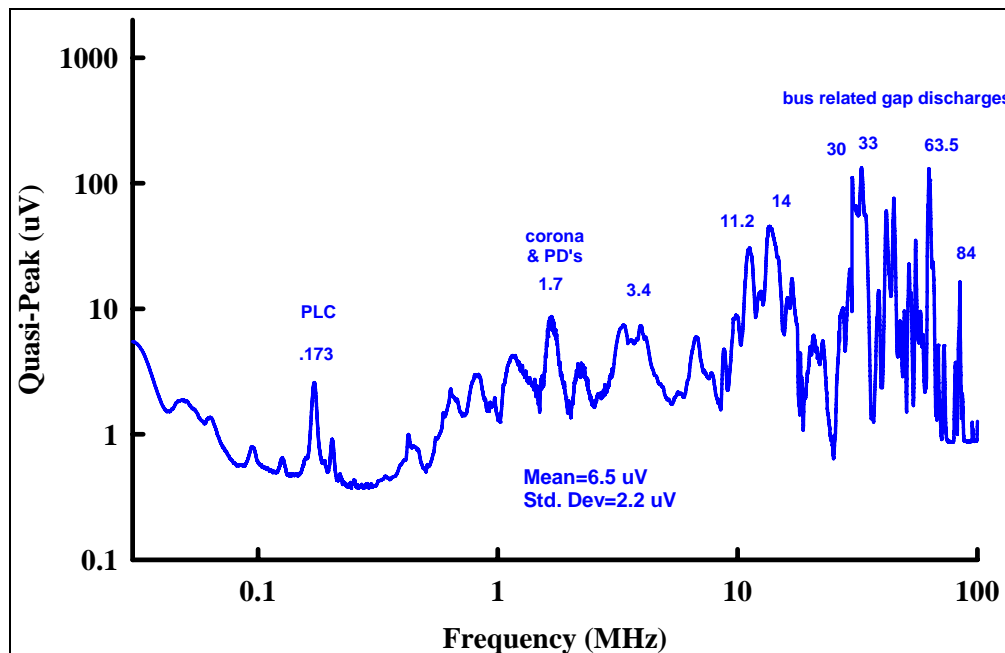
An EMI test was conducted on February 10<sup>th</sup> 2006 when the load was 705 MW and the hydrogen pressure 0.39 MPa (56.8 psi). Figure 3-9 provides a plot of the resulting spectrum captured with a quasi-peak detector. The previous EMI measurement on this machine [2] had indicated anomalous sparking in early 2004 and a bushing CT shorted turn in 2003. These features are no longer evident in Figure 3-9, but the resonances seen above 25 MHz provide an indication that there still may be external busbar-related discharge problems persisting. These high level discharges were tracked with a hand-held EMI “sniffer” and isolated to the bus duct area under the unit. All phases showed high levels, although Phase B appeared to be the worst. Figure 3-10 provides a time domain plot of the activity taken at a frequency window centered on the peak at 63.5 MHz identified in Figure 3-9. Those skilled in the “art” of interpreting such signatures might interpret the unstable nature of the discharge pattern as due to vibration in the bus which causes changes in the discharge location. The occasional discharge having a longer time constant (i.e. having width) might also suggest that significant current was involved with this process. Tester E ascribes this signature to defective enclosure insulation or deteriorated conductor shunts.

Figure 3-9  
EMI Spectrum Taken at a Neutral CT of Marshall Unit #3. Tester E

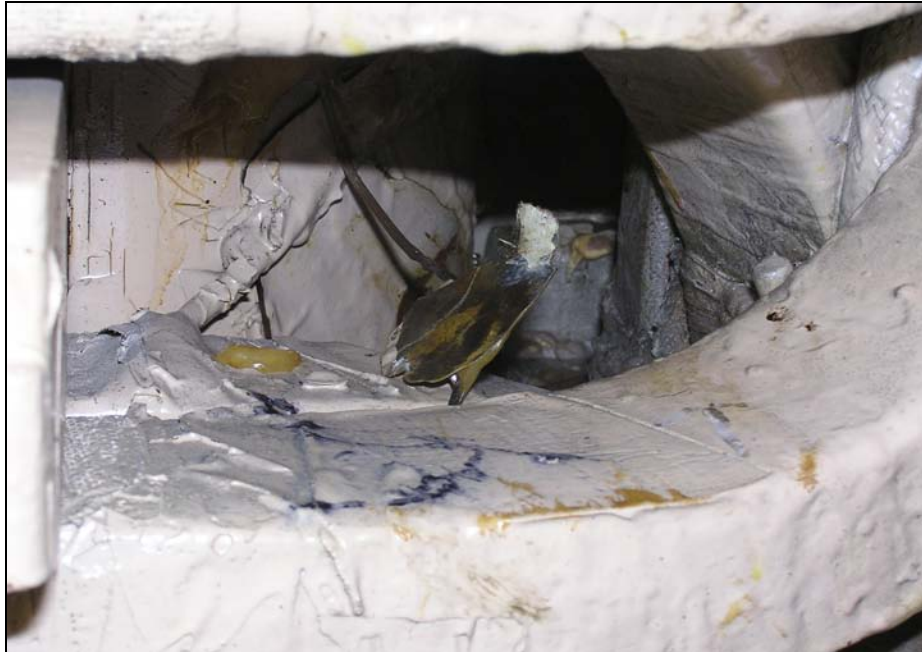
The wedges appeared tight. Although such vibration would not necessarily be regarded as serious, it was clearly sufficient to cause some abrasion products at the end of the slot (resulting in the observed greasing after absorption of oil particles entrained in the gas flow). This abrasion will tend to wear away the slot grounding paint/tape, and thus create a potential PD origin site. Indeed, there was evidence of some abrasion associated with the ripple springs (shown removed in Figure 3-12) which is consistent with the other signs of vibration. The wire from the flux probe was bonded to the flux shield and also to the outer axial winding support structure and had been severed between these two locations – see Figure 3-13. It is likely that the wires broke due to low cycle fatigue associated with the approximately 2.5 mm axial movement of the support during load change from light to full load, although it is possible that the wire debonded from the flux shield, and the wire then broke due to vibration associated with gas flow.

**Figure 3-13**  
**Debonded and Severed Flux Probe Wiring (See Text)**

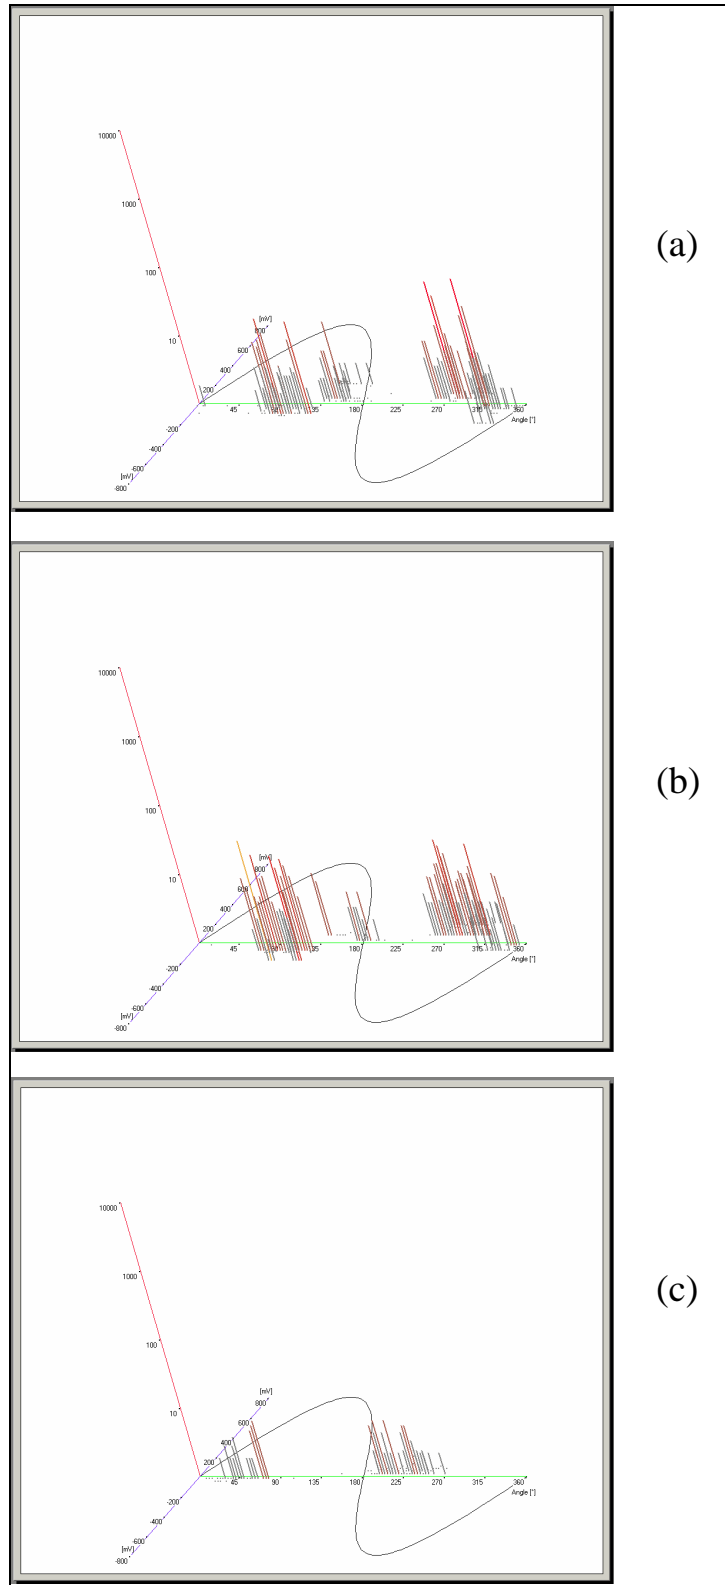
**Figure 4-1**  
**High-Frequency PD Phase-Resolved Analysis of Marshall Unit #4 by Tester A. (a) - (c)**  
**Correspond to Phases A – C**

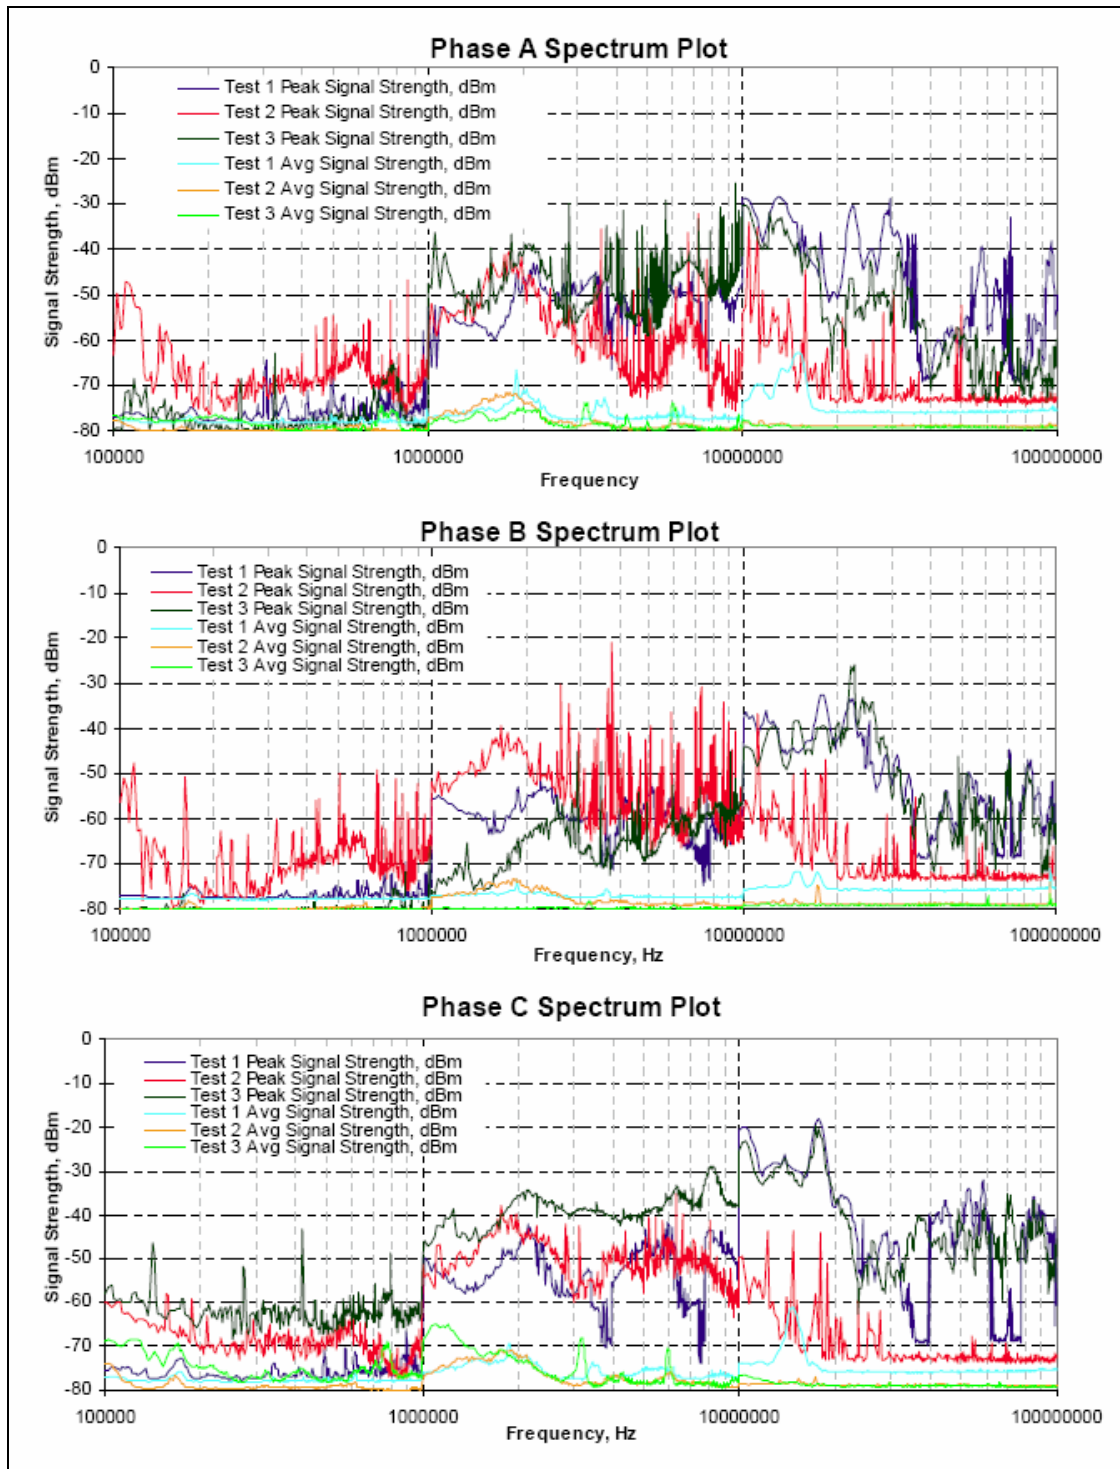
The EMI spectra of Marshall Unit #4 for all three phases (top to bottom) is provided in Figure 4-4. A particular feature of these spectra is the lack of activity seen in the region below 1 MHz. This is the part of the frequency band in which discharges in the slot area usually become visible [2].

**Figure 4-4**  
**EMI Spectra for All 3 Phases of the Stator of Marshall Unit #4. Tester C**

This feature would tend to reinforce the view that the groundwork of this machine is still in good condition. In contrast, the copious activity evident in the higher frequency regions is consistent with arcing conductions at the busbars or corona discharges in the external circuit.

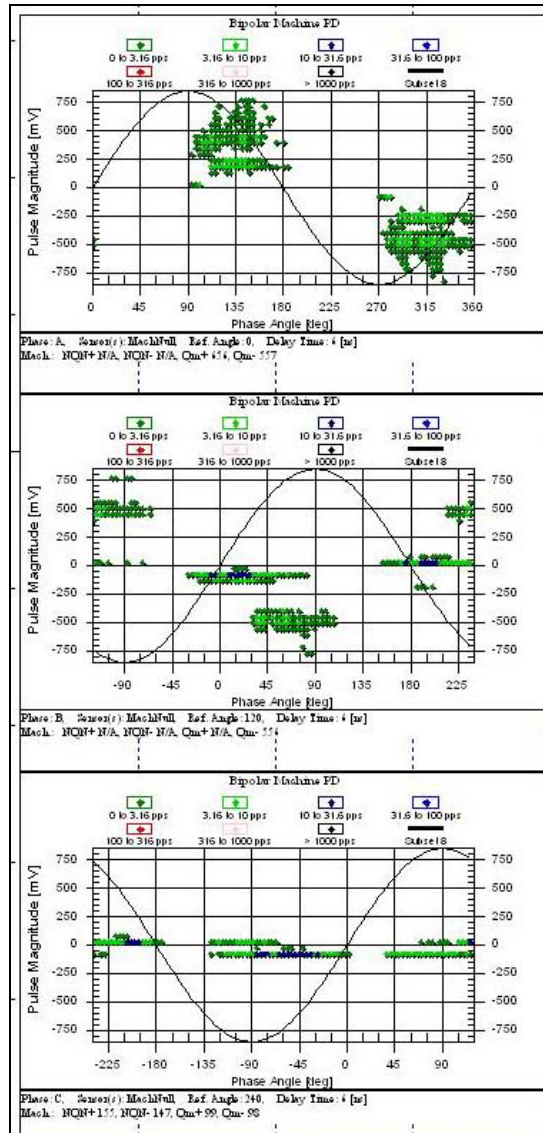
It would appear that there has been a substantial increase in activity over the intervening 18 months; particularly for Phases B and C. However, examination of the phase-resolved plots in Figure 4-5 makes it clear that the pattern depicted does not have the phase relationships expected of activity either in the slot area or in the end-windings. As a result one must yet again question the validity of the reference signals used particularly as the signals are derived from the couplers through radio-frequency current transformers of unknown connection. Tester B, based on the similar anomalous increase also seen in Unit #3, concludes that the source of the increased signals measured is likely to result from problems in the isophase bus duct and not from the stator itself.

**Figure 4-5**  
**Marshall Unit #4 Phase Resolved PD Analysis. Tester B**

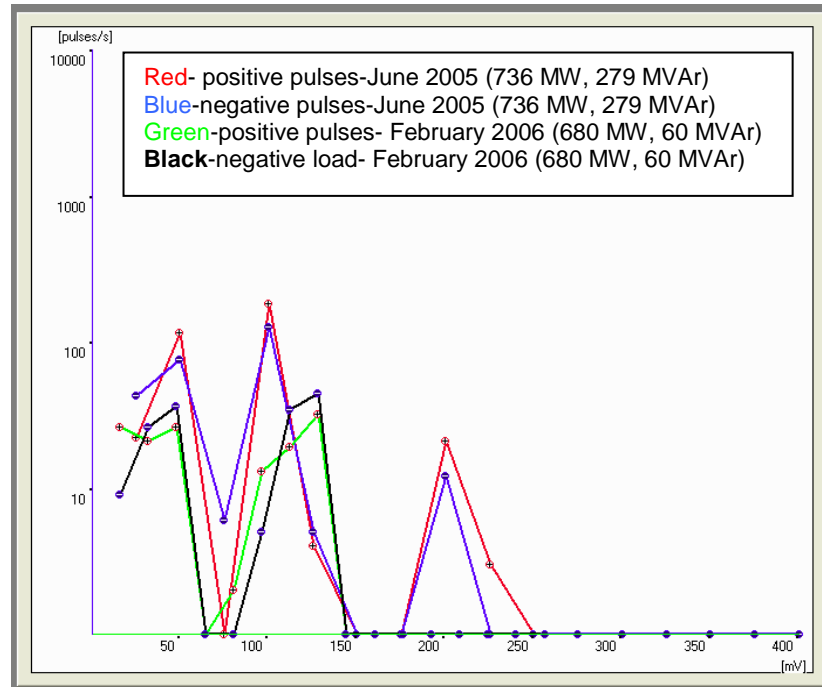
The second PD evaluation was conducted on February 2<sup>nd</sup> 2006 by Tester A when the load was 680MW (60 MVar). The stator temperature was recorded at 55°C and the H<sub>2</sub> pressure at 0.41 MPa (59 psi). Since the same tester evaluated Unit #4 in June 2005, a direct comparison can be made, although it must be recognized that the reactive power delivered in the 2005 test was much higher, resulting in a higher winding temperature; presumably as a result of the associated cross flux. Such a comparison is made in Figure 4-6 on the basis of a pulse height analysis applied to Phase A. This illustrates both that the method appears reproducible and that the machine is stable with no significant change in condition over the intervening period. A similar conclusion could be drawn for the other two phases (not pictured here).

**Figure 4-6**  
**PD Pulse Height Analysis for Phase A of Marshall Unit #4. Tester A Comparison Over a 7 Month Period**

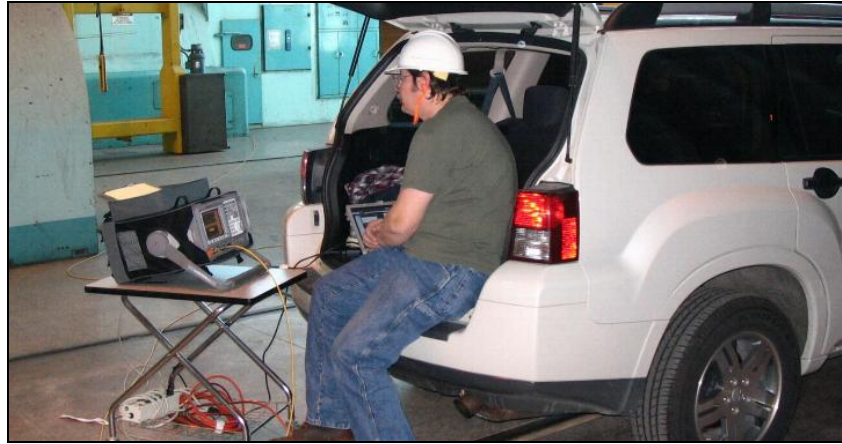
An EMI analysis was conducted on Unit #4 on February 9<sup>th</sup> 2006 at a load of 703 MW, and hydrogen pressure of 0.40 MPa (58.7 psi). The signals were captured using a split-core RFCT placed around a ground connection to the generator neutral grounding transformer. Previous measurements made by Tester E have used an Electro-metrics™ EMI3115A EMI Analyzer/Receiver, but these measurements were taken with a new instrument - Agilent E7405A EMC Analyzer coupled to a PC to provide the necessary data processing. The mobile set-up is illustrated in Figure 4-7. In addition Tester E also derived measurements from the installed 9 nF couplers on the isophase bus at the line end for comparison.

**Figure 4-7**  
**EMI Measurements in Progress at Marshall**

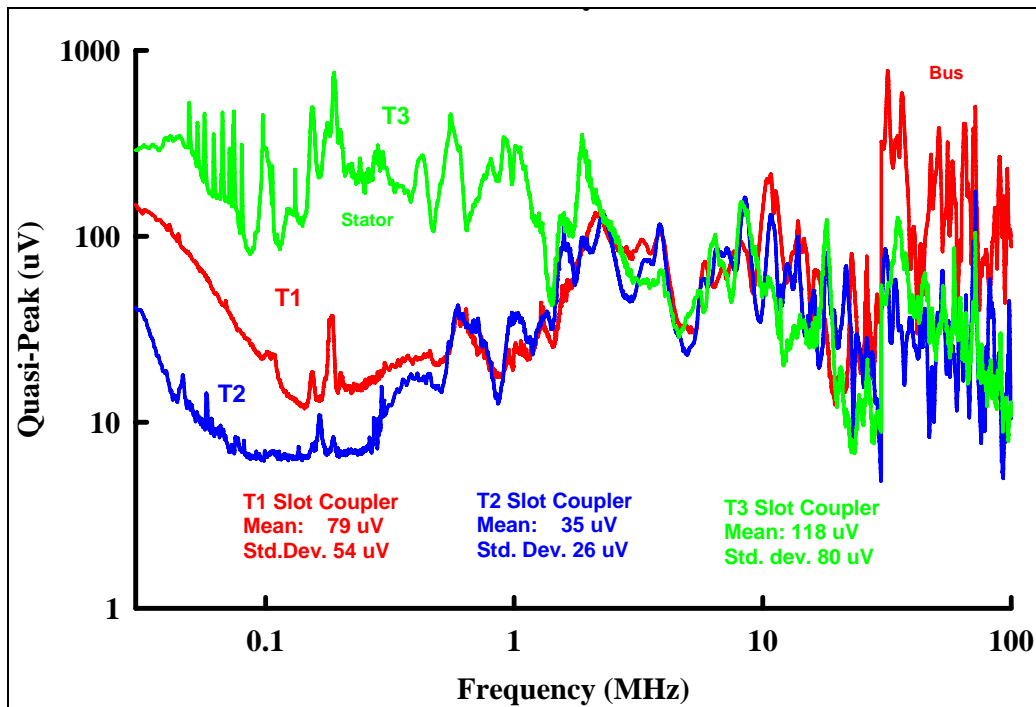
The activity seen between 2 and 4 MHz is identified with the stator winding, while that above about 20 MHz likely originates from the buswork external to the generator. It is also speculated, on the basis of this result, that there may be some core edge discharges as the result of stator bar movement. Figure 4-9 documents the same result, taken on a phase-by-phase basis, from the line-end bus couplers. As would be expected, the sensitivity is greater since the sensors are closer to the top end of the winding where most of the discharge is expected. Figure 4-6 would indicate that the T3 coupler (Phase C) is registering significantly more activity than Phases A and B. Measurements taken with a portable EMI detector [2] at the lower frequency range were identified with slot related deterioration, particularly at the core edges. In comparing the characteristics of Figures 4-5 and 4-6 using different sensors on the same machine, it is also clear that the marked peaks shown in Figure 4-9 are the result of resonances which are excited to a much greater extent than is visible for the neutral CT connection.

**Figure 4-9**  
EMI Signatures from the 3 Bus Couplers on Marshall Unit #4. Tester E

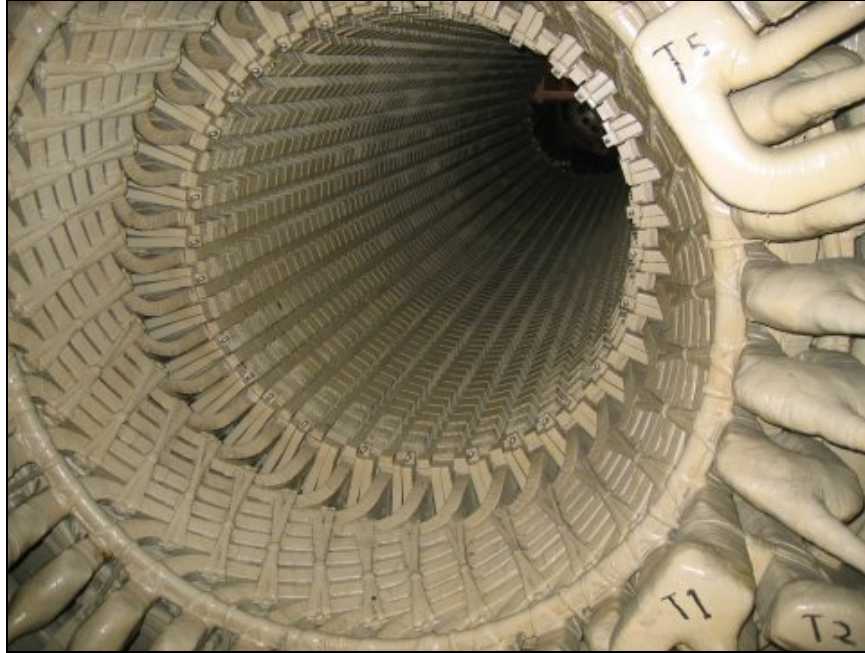
The March 3<sup>rd</sup> 2006 inspection of this unit revealed that, overall, this 30-year-old winding appeared to be in good condition despite the fact that this is a very large GE unit with high electromagnetic bar forces. Figure 4-11 shows an overall view of the end-winding region, and there were no indications of discharges at the phase breaks. The close-up shown in Figure 4-12 indicated that the machine was only slightly oily. This winding was in stark contrast to the SW Sammis #6 winding which was the age of this generator when first inspected in 1998 as part of the EPRI PD project. A comparison may be made by looking at Figure 2-7 in Chapter 2. Wedges were generally tight. With the exception of very minor greasing at the ends of a few slots, there were no indications of bar vibration, either in the slots or, more particularly, at the ends of the core – see Figure 4-12. There were no visible deposits relating to partial-discharge at the line-to-line voltage phase breaks on the top bars at either end of the winding. We were unable to find any evidence of partial discharge occurring anywhere on the endwinding of this machine. The conductors are set very deep in the slot, thus it was not possible to examine for partial discharge without use of a borescope. Since the winding was about to be removed, the Duke Energy personnel were requested to examine the bars as they were removed from the slots and to record and photograph any indications found.

**Figure 4-11**  
**Overall View of the End-Winding Region of Marshall Unit #4**

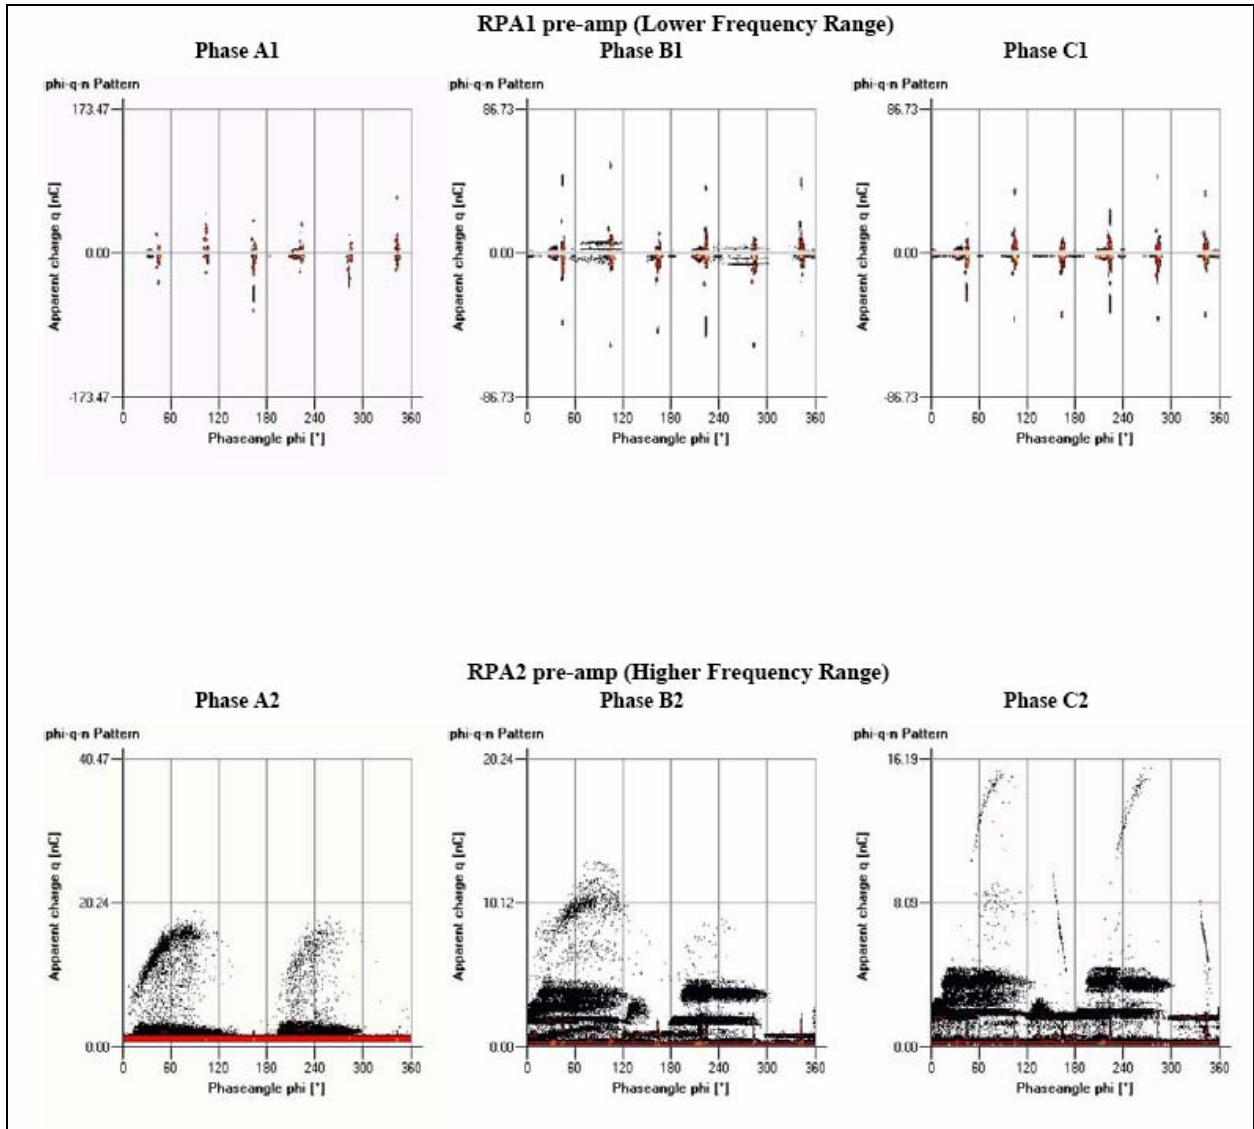
**Figure 5-3**  
Phase Resolved PD Analysis for Lake Road Generating Unit #3. Upper: Low Frequency Analysis, Lower: High Frequency Analysis. Tester F

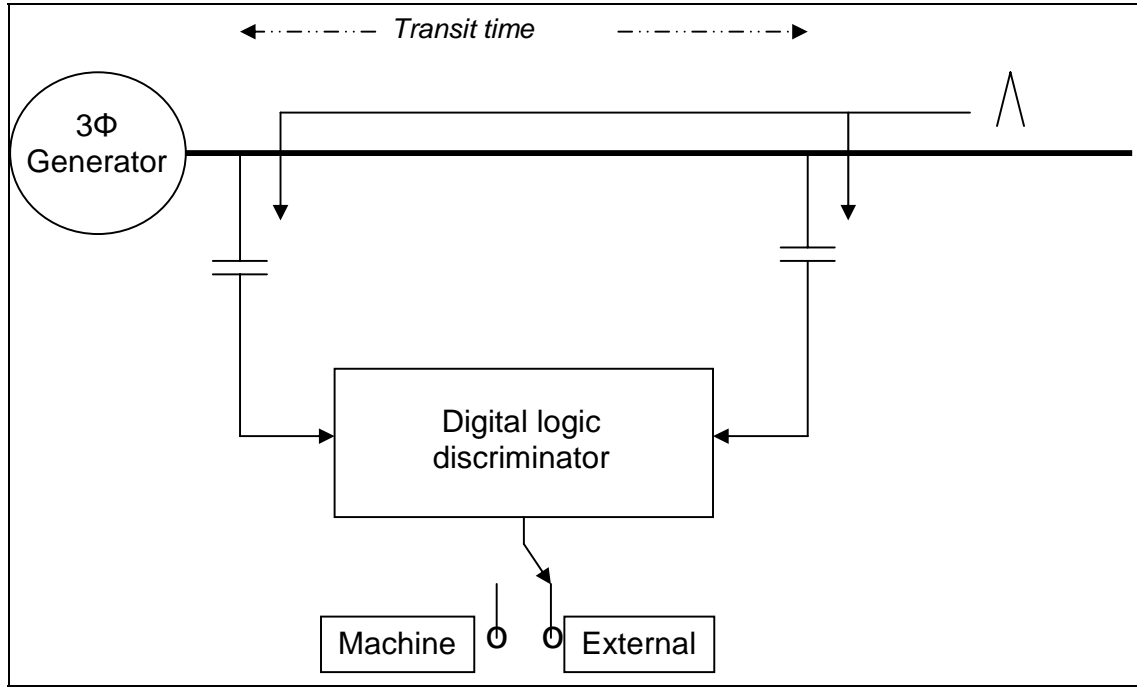
**Figure A-1**  
**Schematic of Discriminator Circuit for Differentiating Between Machine-Related PD and External Signals**

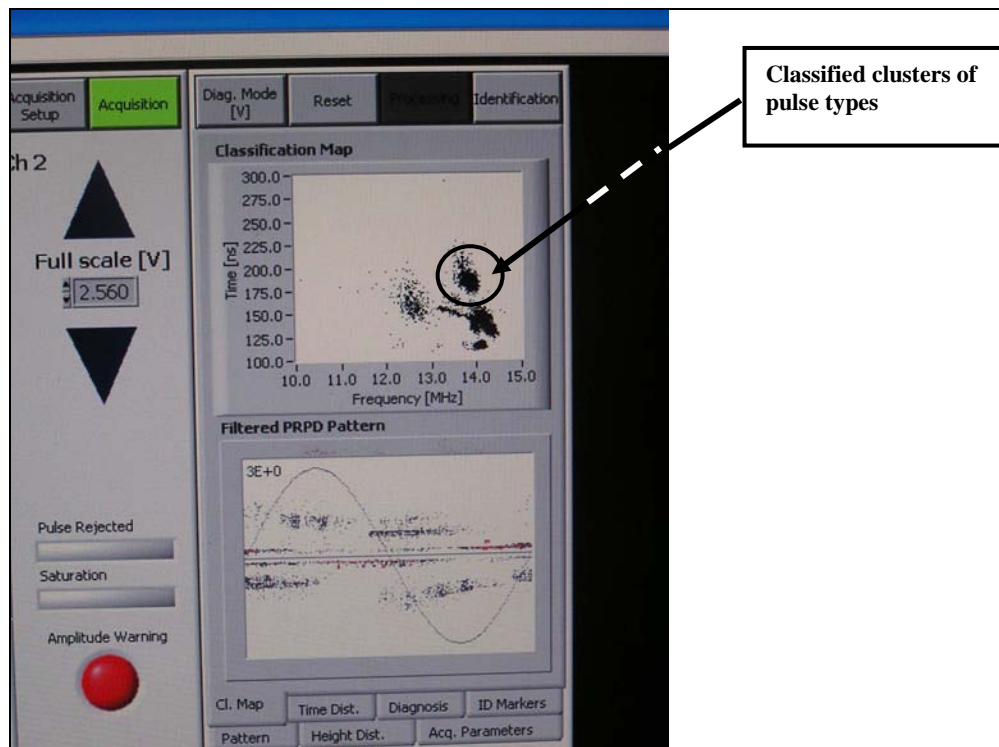
**Figure B-1**  
**Classification of Captured Pulses on the Basis of Duration and Bandwidth Attributes**
