Find the fault

Comprehensive diagnosis of a hydropower generator

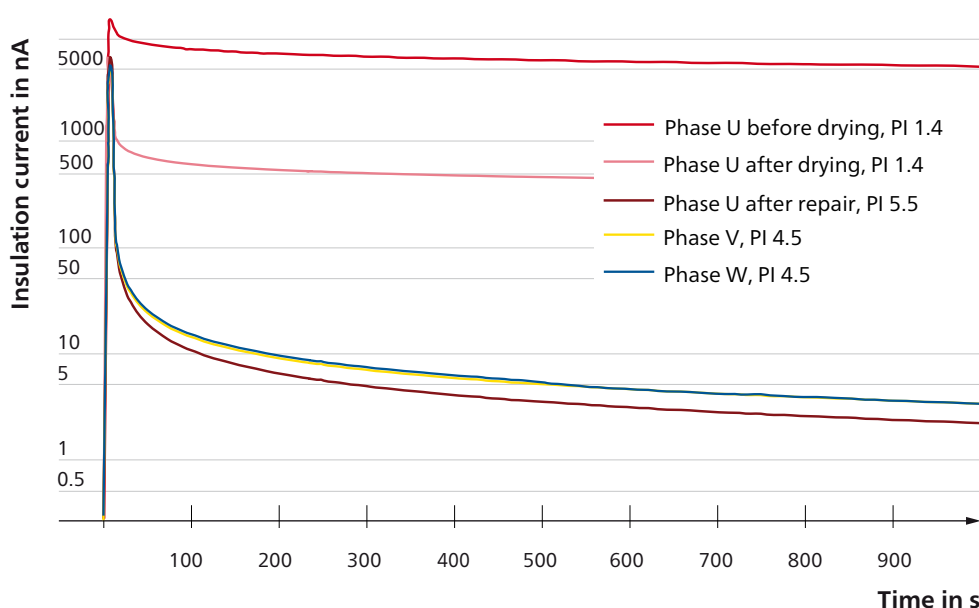
DIRANA was first used to measure the insulation currents and the PI. With phase U, after 10 minutes the insulation current was almost 1 000-times higher than with phases V and W. The PI of phase U was just 1.4, whereas the PI of the other phases was around 4.5. The low PI of phase U

Insulation currents of the phases U, V and W.

In addition to this, the insulation resistance and PI measurements were repeated. At 513 nA after 600 seconds, the insulation current was more than 10-times lower than the value recorded before the drying process. However, the PI of phase U remained the same at the low value of 1.4.

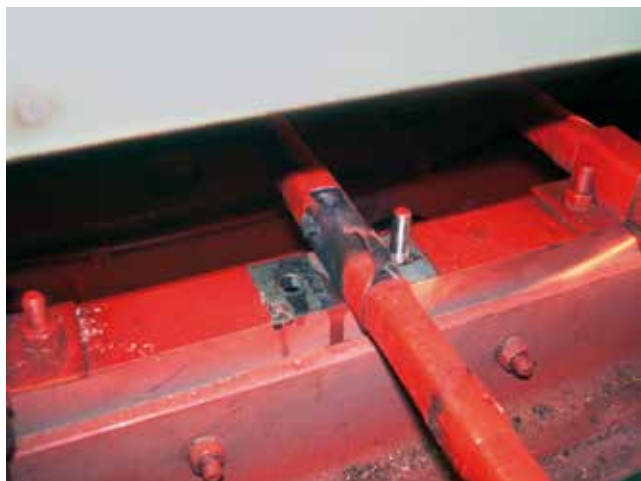
At a voltage of 2.5 kV, very severe partial discharges of more than 100 nC occurred at the star point. They could be localized acoustically using an ultrasonic detector. The picture on the left shows the fault location: a sharp-edged mounting clamp on the output to the star point.

PD fault location on the output to the star point.

However, the actual fault had still not been eliminated, which became obvious when the insulation current measurement was repeated using the DIRANA. Therefore, the windings were tested at their rated voltage (6400 V). During this test, an arc occurred in phase U after about 10 seconds. The insulation resistance that was measured afterwards was so low that a current of 2 A could be fed into the fault location using the CPC 100. Thereby, the feed point of the current was alternated between the high-voltage side and the star point. The defective rod could be found using a clip-on ammeter. The winding was repaired by disconnecting the defective coil and connecting the ends of the remaining winding to one another. The insulation current was tested again. It was found to be at a similar level with the other two phases. The PI was 5.5 following the repairs, well above the critical value of 2.

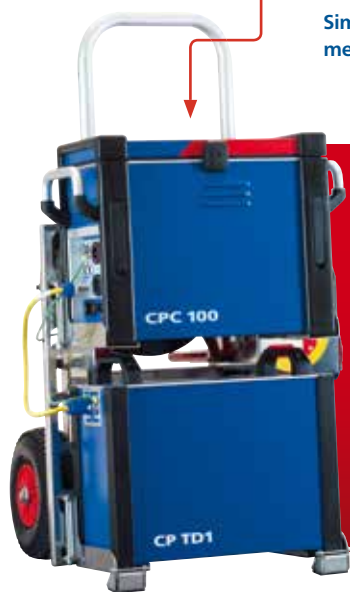
CPC 100 + CP TD1

- > Improved insulation diagnostics thanks to variable frequency testing
- > Lightweight and easy to transport thanks to trolley
- > Automated testing with testing templates
- > Reporting: detailed analyses with trend displays and graphics
