CORONA PROBE MEASUREMENTS TAKEN ON HYDRO MACHINES
AT
GRAND COULEE DAM

T. A. Goodwin
U. S. Bureau of Reclamation

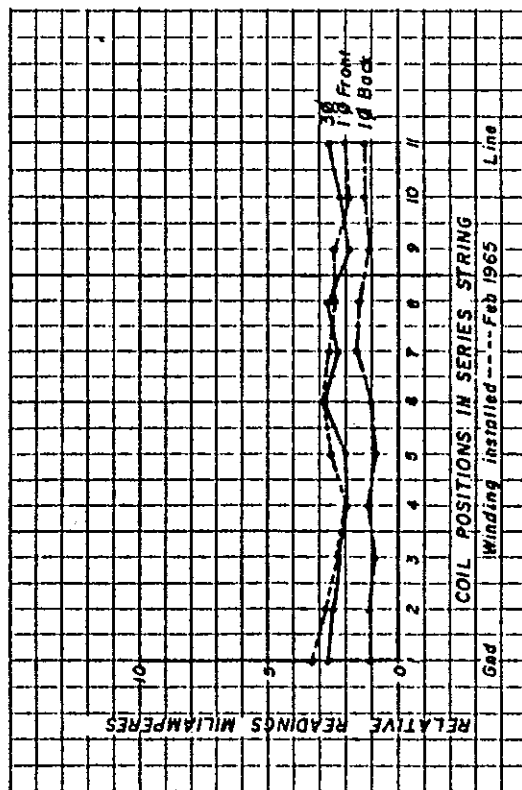
USBR, COULEE DAM
G-6 STATOR WINDING

PEAK-PULSE CORONA TEST MADE AT 7.5 KV USING 5 MEGAHERTZ PROBE
3" BELOW TOP OF IRON IN AIR GAP. ROTOR IN PLACE.

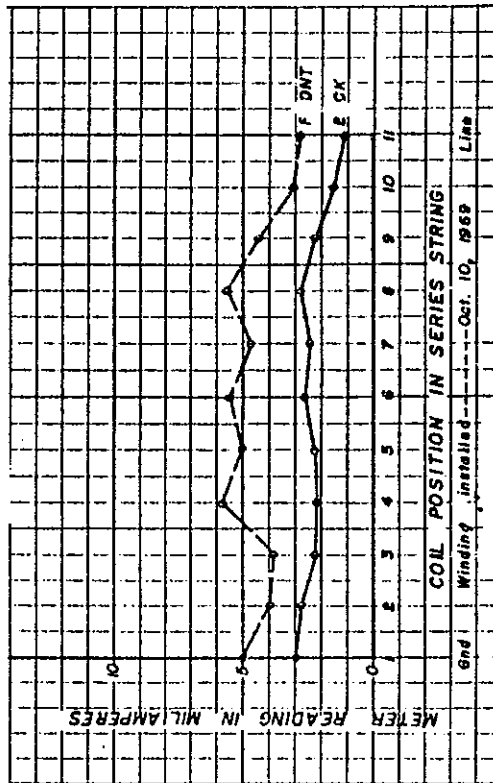
USBR, COULEE DAM
G-7 STATOR WINDING

PEAK-PULSE CORONA TEST MADE AT 5KV USING 5 MEGAHERTZ PROBE
3" BELOW TOP OF IRON IN AIR GAP.

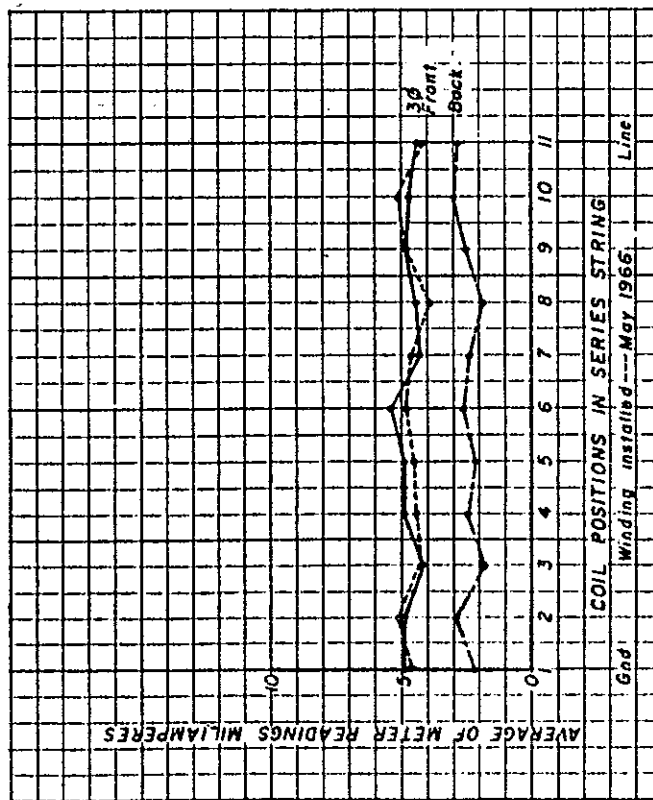
USBR, COULEE DAM
G-8 STATOR WINDING

PEAK-PULSE CORONA TEST MADE AT 5KV USING 5 MEGAHERTZ PROBE 3"
BELOW TOP OF IRON IN AIR GAP.

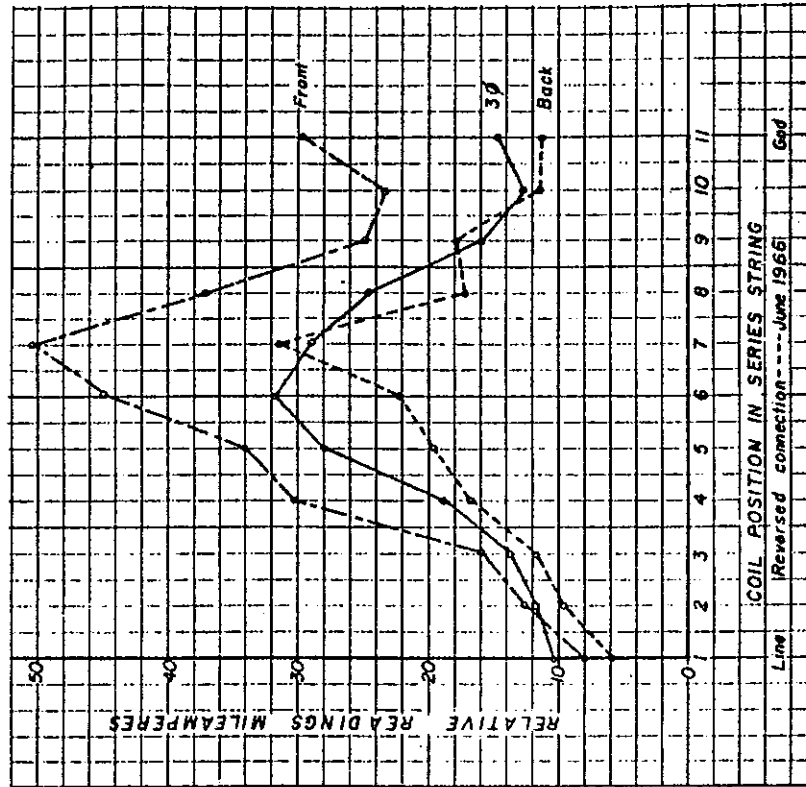
USBR, COULEE DAM
G-8 STATOR WINDING
Asphalt Bonded Mica Insulation

PEAK-PULSE CORONA TEST MADE AT 7.5 KV USING 5 MEGAHERTZ PROBE
3" BELOW TOP OF IRON IN AIR GAP ROTOR IN PLACE.

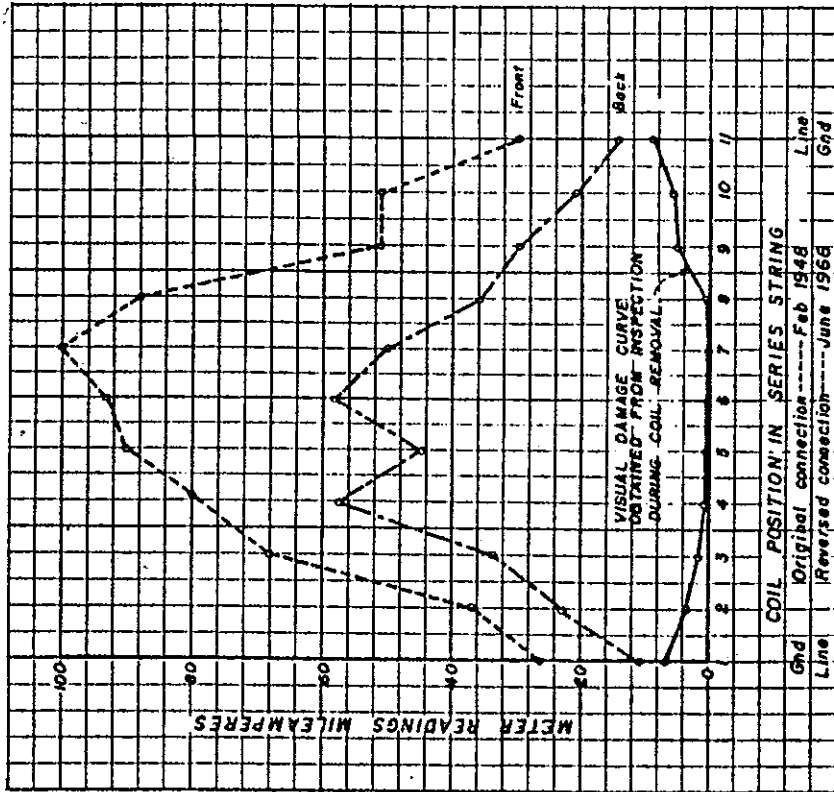
USBR, COULEE DAM
G-8 STATOR WINDING
Asphalt Bonded Mica Insulation

PEAK-PULSE CORONA TEST MADE AT 7.5 KV USING 5 MEGAHERTZ PROBE
3" BELOW TOP OF IRON IN AIR GAP ROTOR IN PLACE.
THIS CURVE SHOWS THE CLOSE SIMILARITY OF THE CORONA PROBE
CURVE AND THE "CORONA DAMAGE" CURVE WITH ITS ORDINATE
REVERSED.

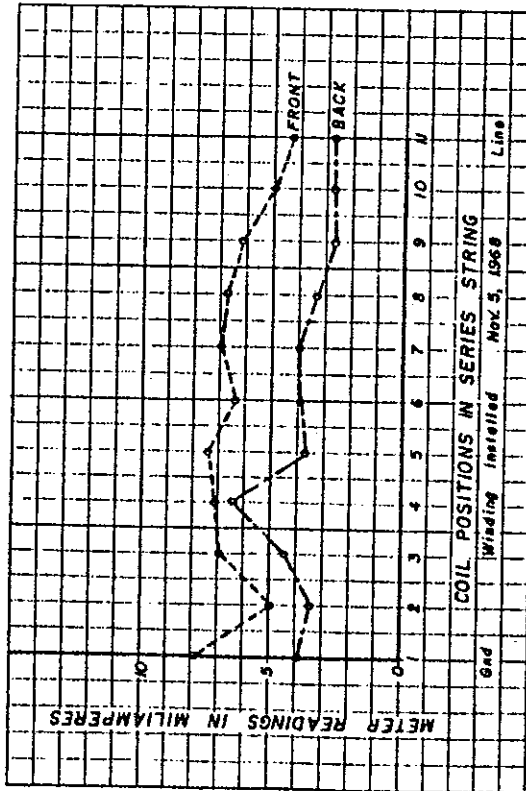
USBR, COULEE DAM
6-9 STATOR WINDING

PEAK-PULSE CORONA TEST MADE AT 75KV USING 5 MEGAHERTZ PROBE
3" BELOW TOP OF IRON IN AIR GAP. ROTOR IN PLACE.

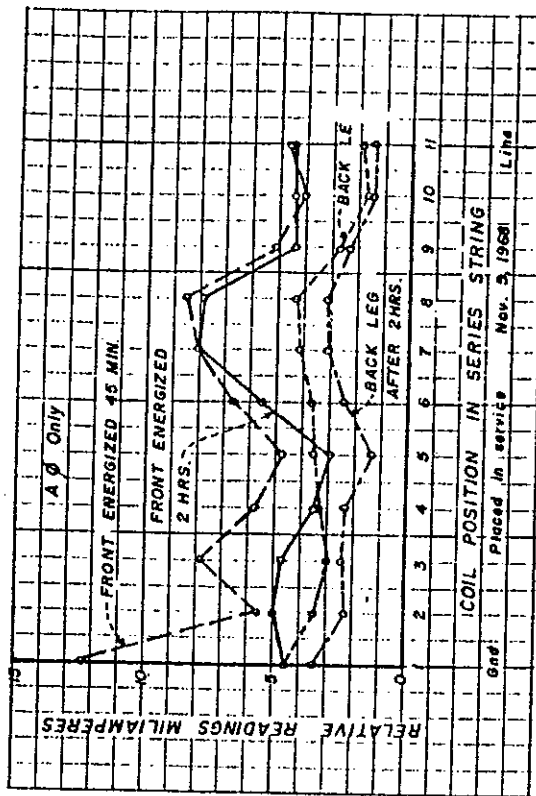
USBR, COULEE DAM
 6-10 STATOR WINDING
 Asphalt Bonded Mica Insulation

PEAK-PULSE CORONA TEST MADE AT 75KV USING 5 MEGAHERTZ PROBE
 3" BELOW TOP OF IRON IN AIR GAP. ROTOR IN PLACE.

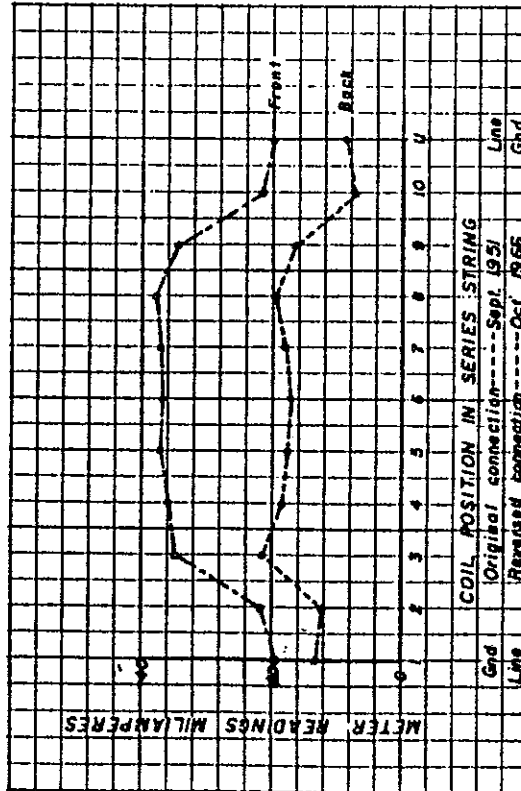
USBR, COULEE DAM
 G-11 STATOR WINDING
 Asphalt Bonded Mica Insulation

PEAK-PULSE CORONA TEST MADE AT 75 KV USING 5 MEGAHERTZ PROBE
 3" BELOW TOP OF IRON IN AIR GAP. ROTOR IN PLACE.

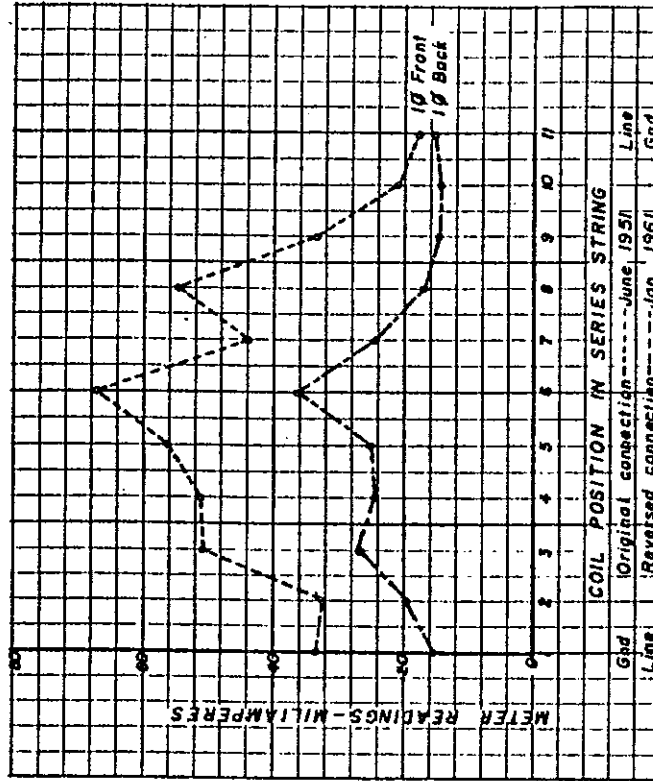
G-12 STATOR WINDING

PEAK-PULSE CORONA TEST MADE AT 7.5KV USING 5 MEGAHERTZ PROBE
3" BELOW TOP OF IRON IN AIR GAP. ROTOR IN PLACE.

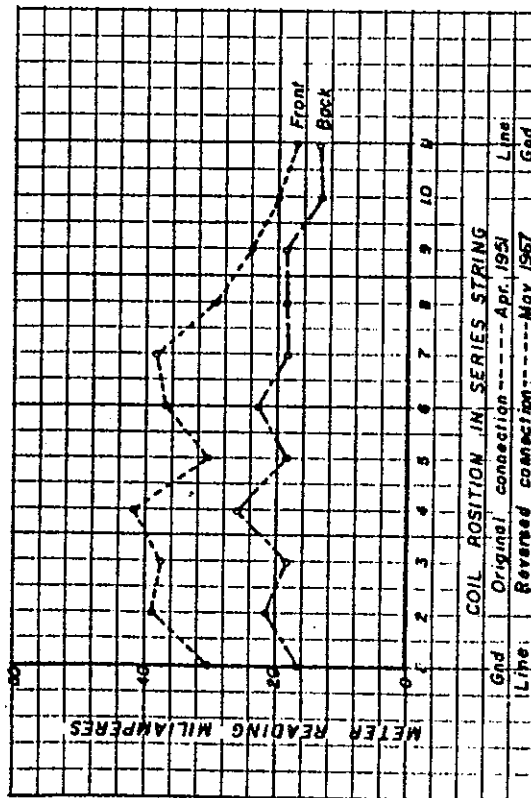
G-16 STATOR WINDING

PEAK-PULSE CORONA TEST MADE AT 6KV USING 5 MEGAHERTZ PROBE
3" BELOW TOP OF IRON IN AIR GAP. ROTOR IN PLACE.

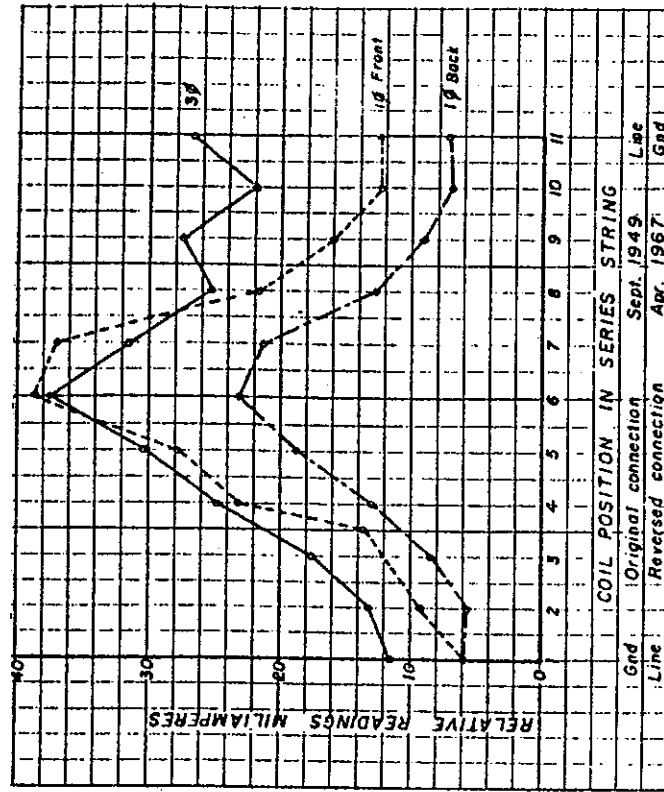
USBR, COULEE DAM
 6-16 STATOR WINDING
 Asphalt Bonded Mica Insulation

PEAR-PULSE CORONA TEST MADE AT 6KV WITH 5 MEGAHERTZ PROBE
 3" BELOW TOP OF IRON IN AIR GAP. ROTOR IN PLACE.

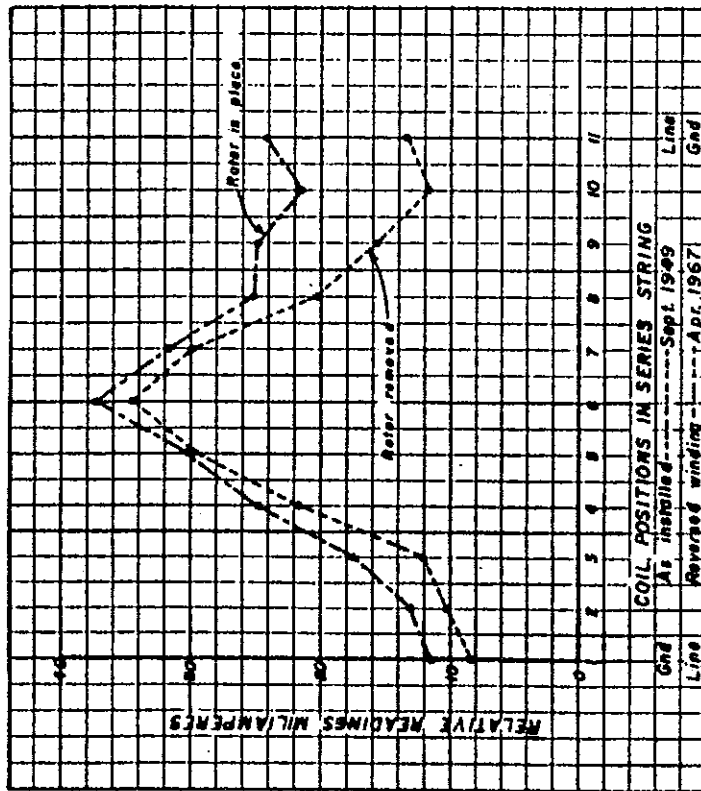
USBR, COULEE DAM
 6-18 STATOR WINDING
 Asphalt Bonded Mica Insulation

PEAR-PULSE CORONA TEST MADE AT 6KV USING 5 MEGAHERTZ PROBE
 3" BELOW TOP OF IRON IN AIR GAP. ROTOR IN PLACE.

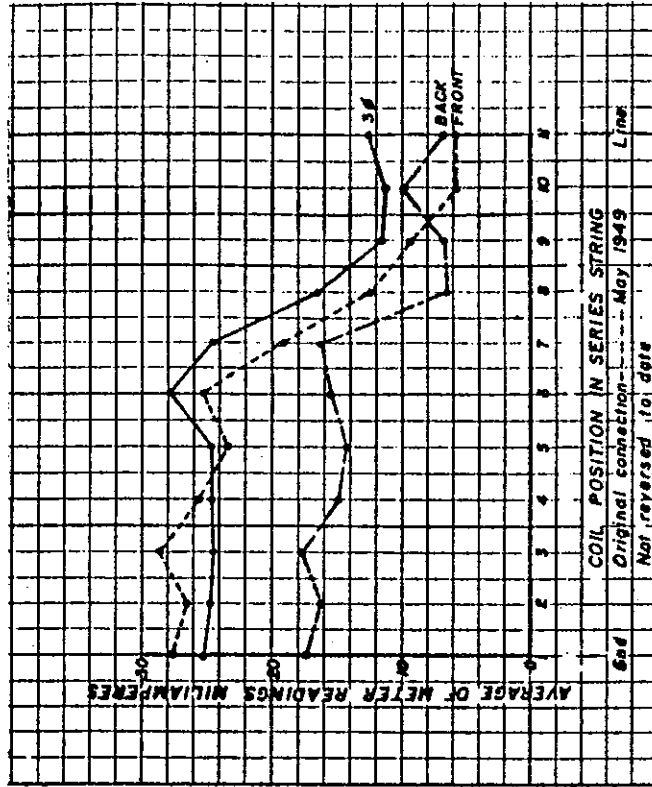
USBR, COULEE DAM
G-18 STATOR WINDING
Asphalt Banded Mica Insulation

PEAK-PULSE CORONA TEST MADE AT 8KV USING 5 MEGAHERTZ PROBE
 3" BELOW TOP OF IRON IN AIR GAP. ROTOR IN PLACE.
