EXPERIENCE WITH DIAGNOSTIC TESTING TO EVALUATE THE REMAINING USEFUL LIFE OF A HYDROGEN-COOLED GENERATOR

Dan Huynh and Terry Hill
PacifiCorp

Hugh Zhu
Adwel International

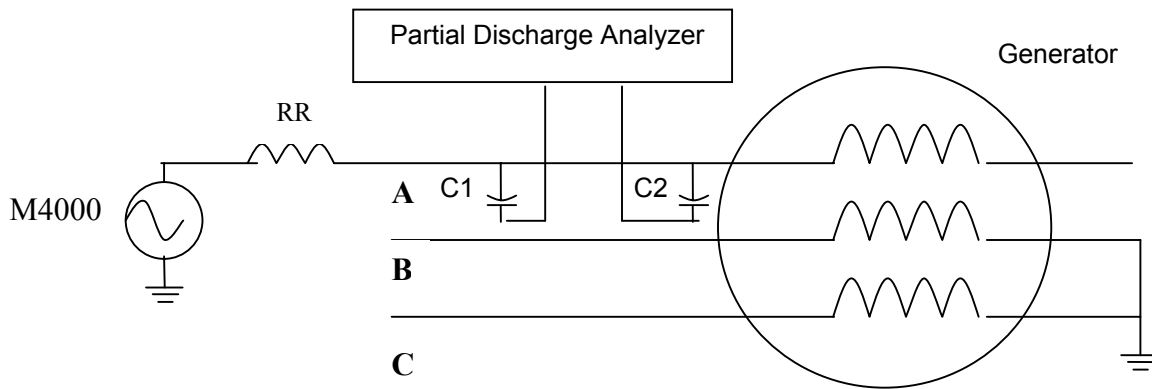
Fig. 3 Set-up of the off-line partial discharge test.

The set-up of the off-line PD test is shown in Fig. 3. A Doble M-4000 tester was used to apply 8 kV line-to-ground voltage to the stator winding, the low voltage lead and the test-set ground lead were connected to the machine ground. A resonant reactor (RR) was used to neutralize the capacitive current of a 255 MVA generator. Using the ground-specimen test mode, each phase was tested with the other two phases grounded.
