# IEEE standards may not sufficiently address grounding issues in rotor, stator windings

Clyde V Maughan, [clyde@maughan.com](mailto:clyde@maughan.com), [Maughan Generator Consultants](#)

There are two, unfortunately common, generator-winding failure modes that the IEEE standards overlook: the fracture of a rotor (field) conductor and the fracture of a stator conductor. This article describes these types of failures, discusses associated negative impacts of them, and recommends corrective actions.

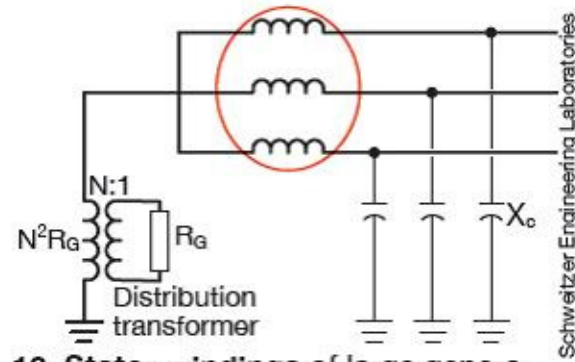
The stator windings of power station generators are typically Y-connected, and high-impedance grounded through a distribution transformer. The impedance is controlled by the magnitude of the resistor connected across the transformer. This impedance is selected to allow a maximum of about 3-10 amps to flow in the event of a ground at the high-voltage end of the stator winding (Fig 12).

**12. Stator windings** of large generators typically are wye-connected and high-impedance-grounded through a distribution transformer

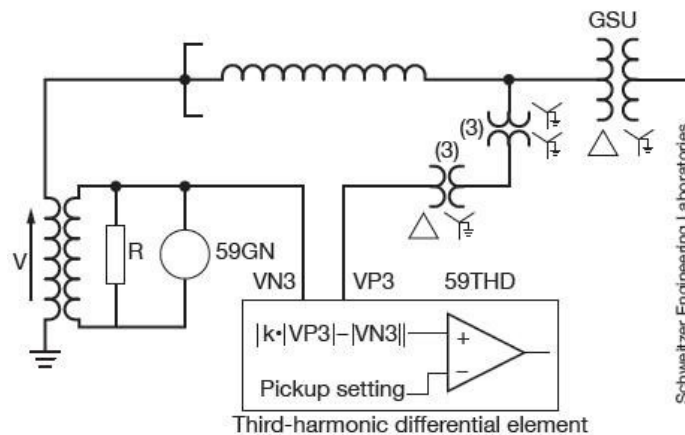
Historically, an electromechanical relay (59GN) is placed across the resistor, which is powered by the voltage of the stator winding. The characteristics of this electrical circuit and relay are such that the relay does not respond to the voltage of the bottom 5% of the stator winding.

This weakness of the electromechanical relay has been recognized for many years. By the early 1970s, in Europe, most generators larger than 100 MW also were protected by a third-harmonic relay (59THD). Third-harmonic relay protection was first applied in the US in 1980. The combined relay system protects 100% of the winding (Fig 13). But most generators in North America apparently are still protected only by the 59GN relay.

**13. Combining electromechanical (59GN) and third-harmonic (59THD) relays** protects 100% of the winding

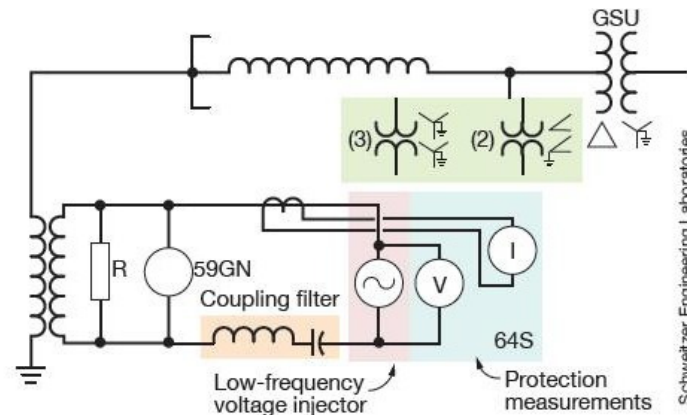
Because of these concerns, there is a trend toward developing and installing voltage-injection relay systems (64S). With the injection relay system, ground-fault protection can be functional when the generator is shut down (at standstill or turning gear), during startup, and at-speed offline or online (Fig 14).

**14. Voltage-injection** ground protection can be functional when the generator is shut down (standstill or turning gear), during startup, and at speed offline or online

A subharmonic sinusoidal voltage is injected continuously, typically at 15 or 20 Hz on 60-Hz systems. The resultant sub-harmonic current is measured via the 64S relay and, if a ground fault occurs anywhere in the three phases of the stator winding, the current in the relay increases and causes the relay to operate.

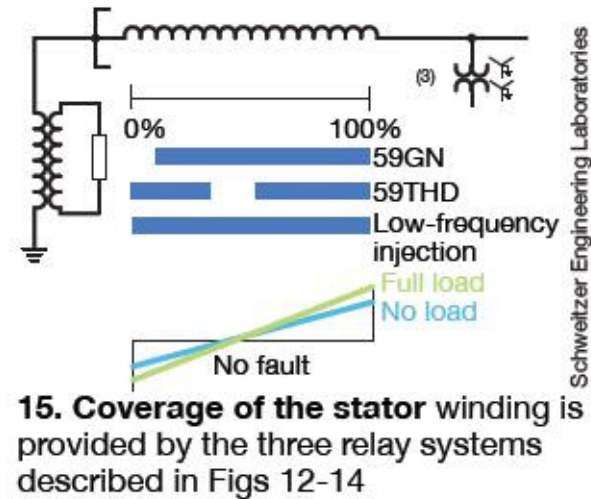
Coverage of the stator winding provided by the three relay systems is shown graphically in Fig 15. The 59GN relay gives reliable protection, but only on the top 95% of the winding. The bottom 5% remains completely unprotected. In some cases, this has proven to be a near-fatal deficiency, based on the experience discussed earlier.

The 59THD relay does not protect a mid-portion of the winding and must be used in conjunction with an additional relay system. Thus even if fully reliable, the third-harmonic system could not be considered as adequate protection by itself.

The cost of the signal generator is a disadvantage of the injection relay system (64S), but this system can reliably protect the entire winding, by itself. It has these further advantages: It can detect open circuits in the grounding transformer primary or secondary and is self-protecting for a grounding-relay system problem or loss-of-injection voltage source.
