Partial Discharge Activity vs. Operating Temperature Investigation

Jeffery Nofsinger
Power Production Engineering
Idaho Power Company

DC Ramp Testing on 6.9 kV Generators

Cable Testing at the Lower Salmon Plant

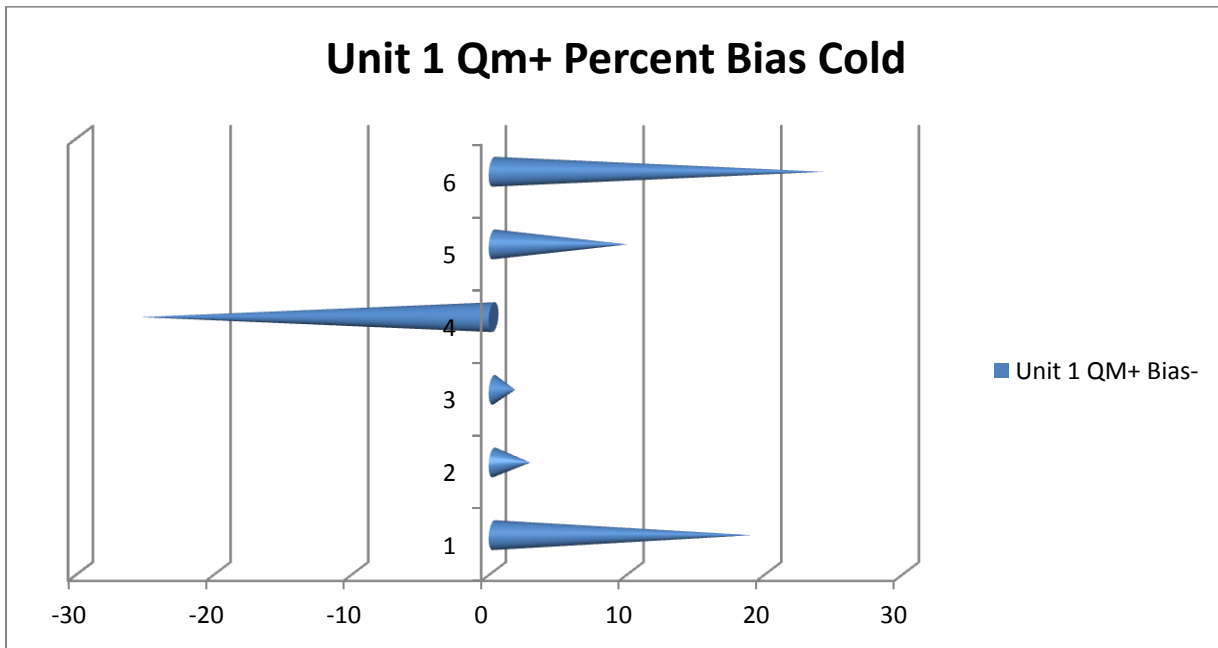
As shown in the charts, Unit 1 Qm levels rose significantly when the power level and temperature was reduced in the unit. To see if any predominance occurred in the unit when cold, the following chart depicts the change in Qm with a shift toward the Qm+ as a positive number to the right. The chart shows a slight shift to Qm+ but not substantial. The results for this unit show that overall PDA levels increase in this unit when cold and at low power and that the PDA remains in the bulk of the insulation.

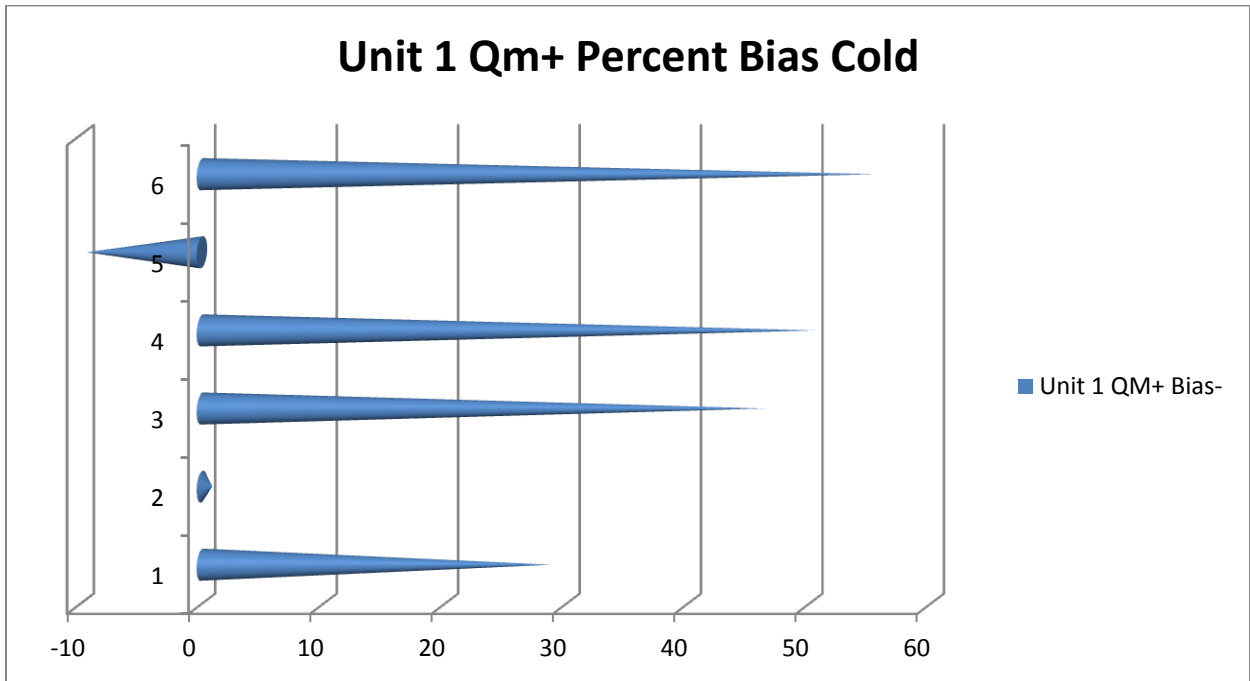
The above charts show that the PDA in Unit 1 has changed from going down to going up on a change from full load hot to low load cold. The bias chart below shows that the bias has shifted from a surface to a bulk insulation PDA. This could be attributed to better control of surface PD by the maintenance crews.

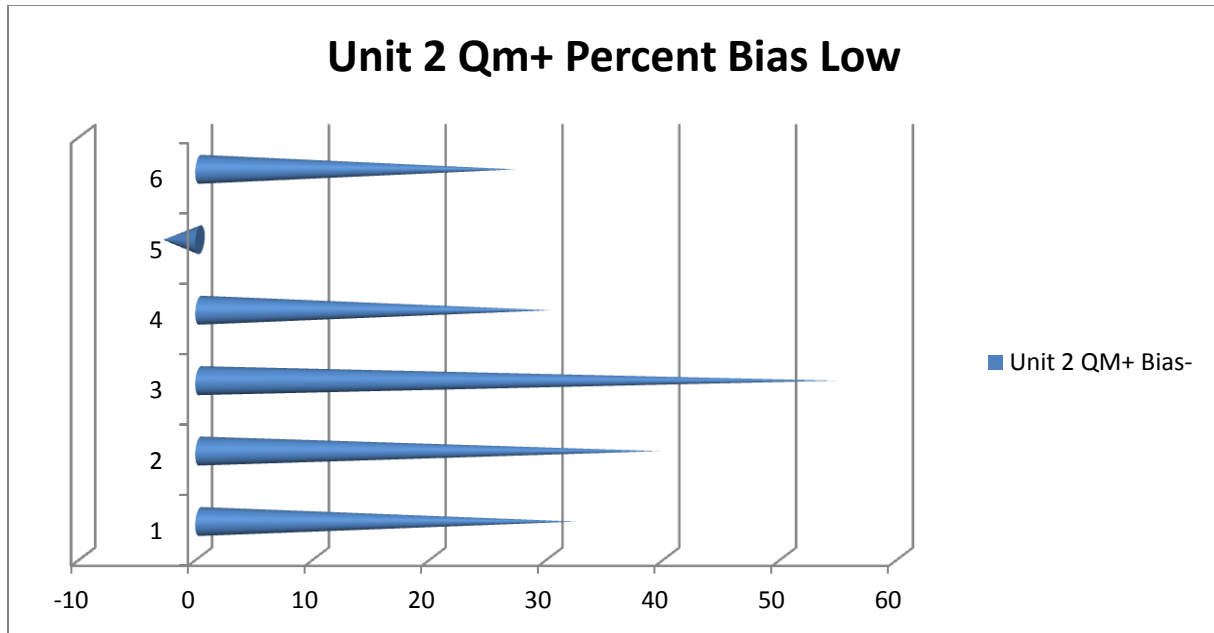
Unit 2 has also shifted toward more PDA at the lower temperatures. The Qm+ all decreased in 2002. In 2012, only one decreased. In 2002, Qm- decreased a minimum of 63%. In 2012 the maximum decrease was 54%. The chart below compared to 2012 shows that the bias has increased in Unit 2 towards surface PD at the lower temperatures.

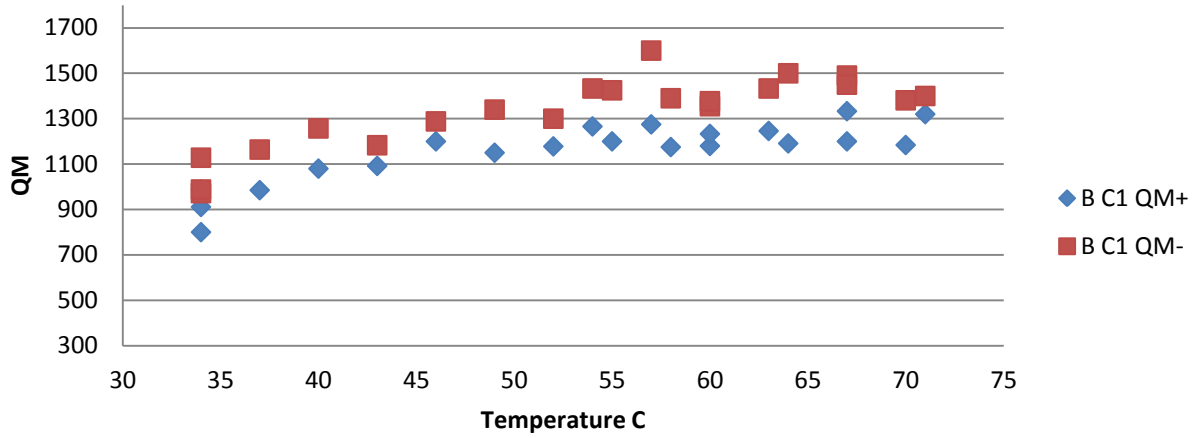
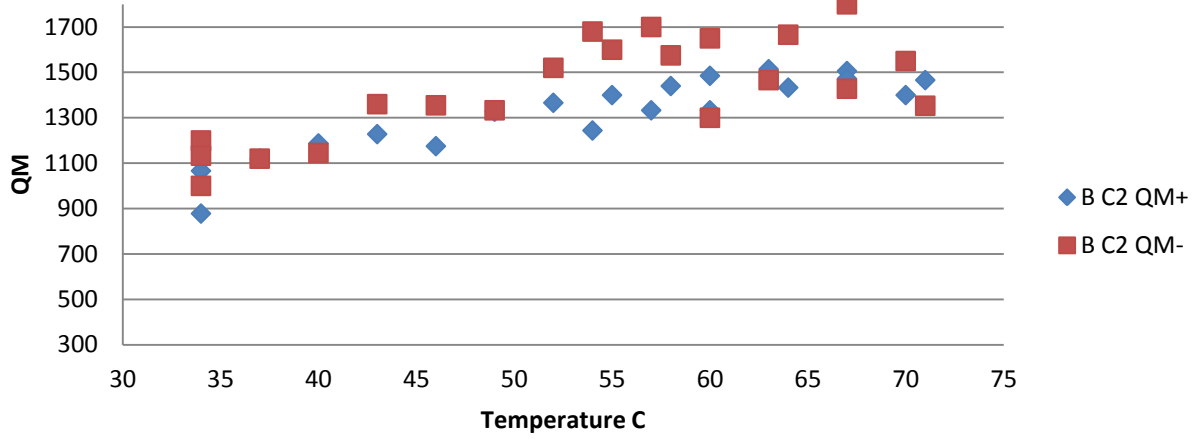
AFPR 11 MW

The phase A C1 results show a decrease in Qm+, which is consistent with loose windings. Qm- remains constant. C2 remains constant but what is of note is how low the PDA is on that coupler.

Both couplers on B phase increase with temperature. The only failure mechanism that normally increases with temperature is PD in the Semicon/Grading coating interface (SGCI). However it normally has a positive predominance and this phase has a negative predominance.

If the SGCI is severely deteriorated this may show up as pulses at 0 and 180 degrees. (1) This also could be a combination of contamination, inadequate spacing, and SGCI.

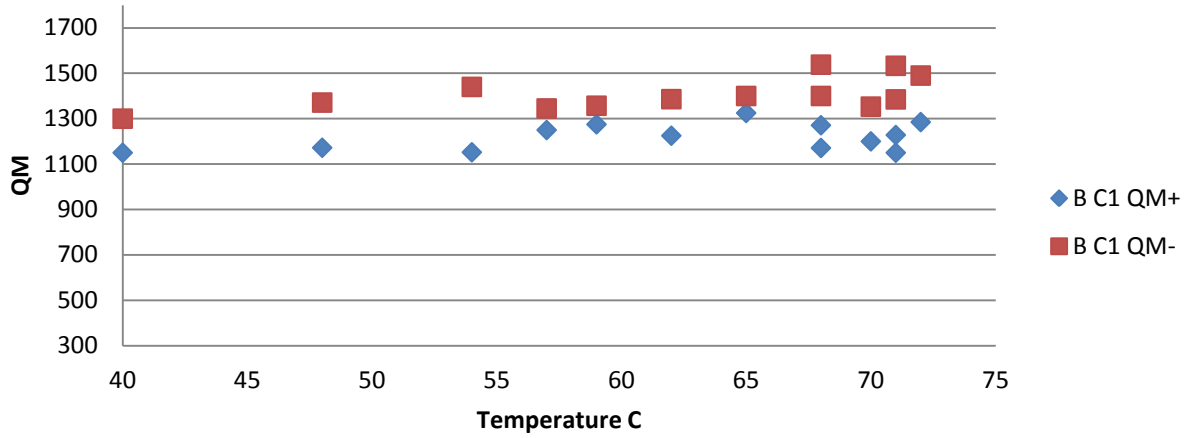
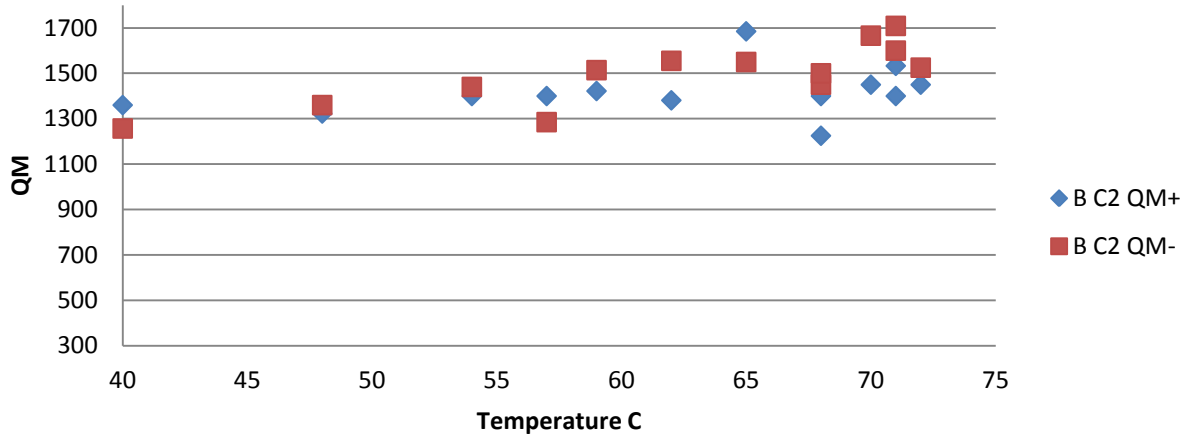
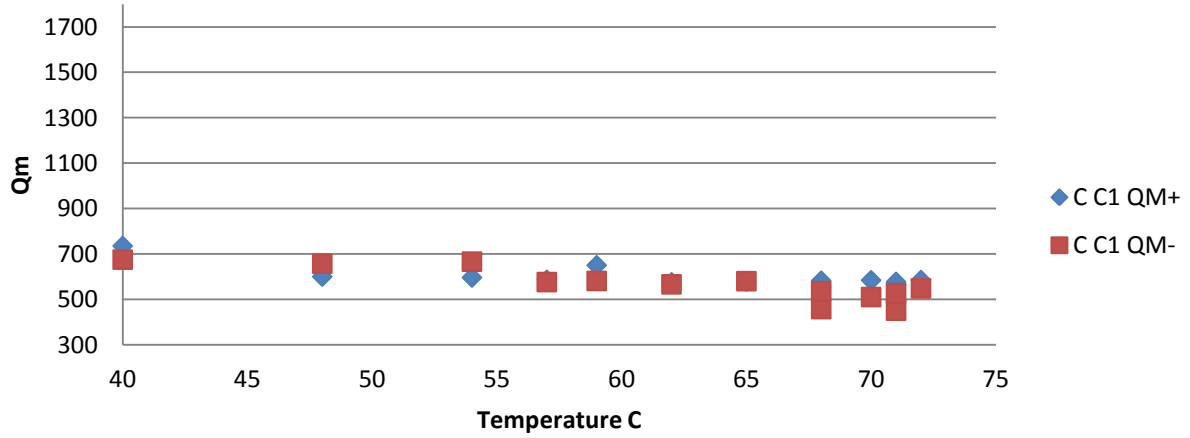
AFPR 1, 33MW

Under high load A C1 now has an increase with temperature. C2 remains constant, which is interesting with the load change.

Phase B still increases with temperature but starts at a higher initial level.

On this unit loading is not a major factor on the level of PDA. Temperature is a major factor only on phase B with more of an influence at low loading levels. This phase shows severe SGCI at low loading levels. There is indication of loose windings on several couplers at low load conditions. There is probably a combination of failure mechanisms occurring in this unit.

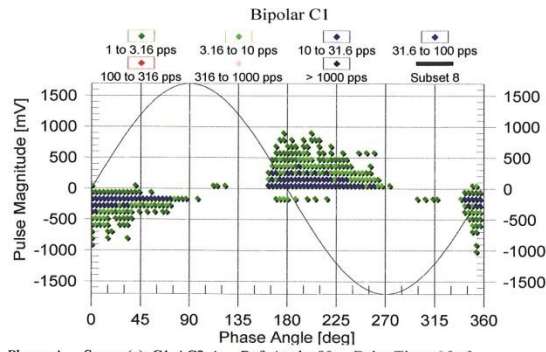
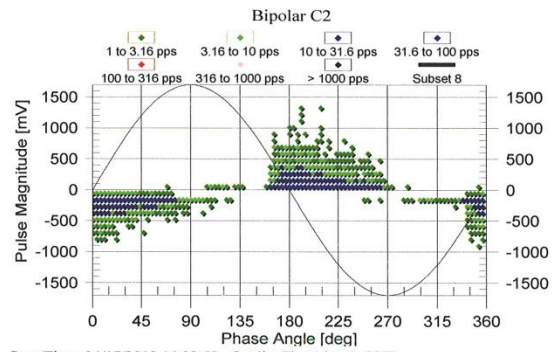
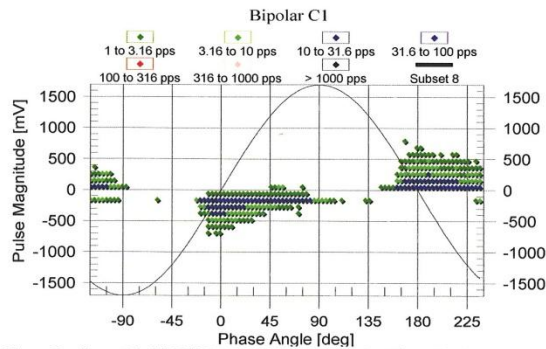
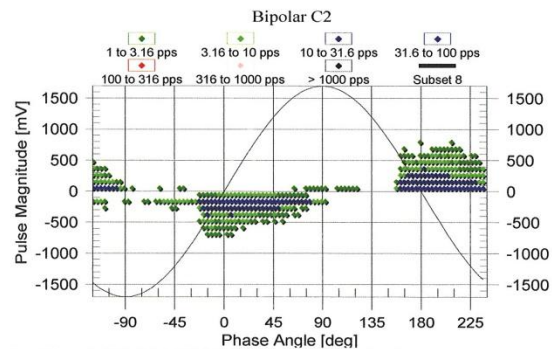
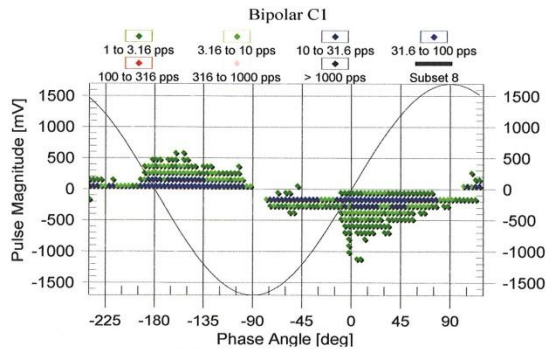
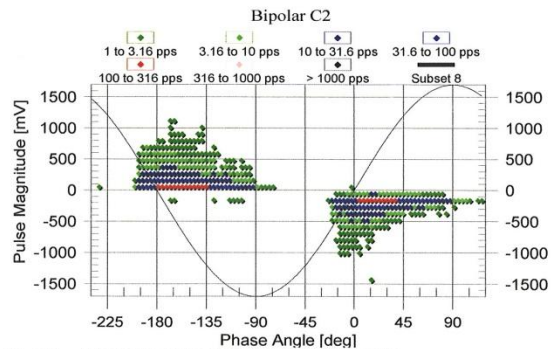
Phase: A, Sensor(s): C1-AC2-A, Ref. Angle: 90, Delay Time: 6 [ns]
 C1: NQN+ 1808, NQN- 1412, Qm+ 925, Qm- 700

Start Time: 04/17/2013 14:32:50, Quality Flag (short): OVR
 C2: NQN+ 2198, NQN- 1628, Qm+ 1037, Qm- 775

Phase: B, Sensor(s): C1-BC2-B, Ref. Angle: 90, Delay Time: 6 [ns]
 C1: NQN+ 1500, NQN- 1139, Qm+ 740, Qm- 580

Start Time: 04/17/2013 14:33:34, Quality Flag (short): Good
 C2: NQN+ 1928, NQN- 1372, Qm+ 833, Qm- 664

Phase: C, Sensor(s): C1-CC2-C, Ref. Angle: 90, Delay Time: 6 [ns]
 C1: NQN+ 1357, NQN- 1580, Qm+ 650, Qm- 725

Start Time: 04/17/2013 14:34:18, Quality Flag (short): OVR
 C2: NQN+ 2427, NQN- 1854, Qm+ 1000, Qm- 887

The above data would seem to correspond to the failure mechanism at the SGCI at most of the couplers. This failure mechanism has positive polarity predominance. Phase C coupler C1 was the only one that had a negative predominance. The other 5 couplers had a positive predominance. All couplers had an increase in both Qm's as temperature increased. This failure mechanism is one of the few that has a positive increase with temperature. Loading did increase the PDA but only by 10 or 20 percent. As with unit 1, this also could be a combination of contamination, inadequate spacing, and SGCI.

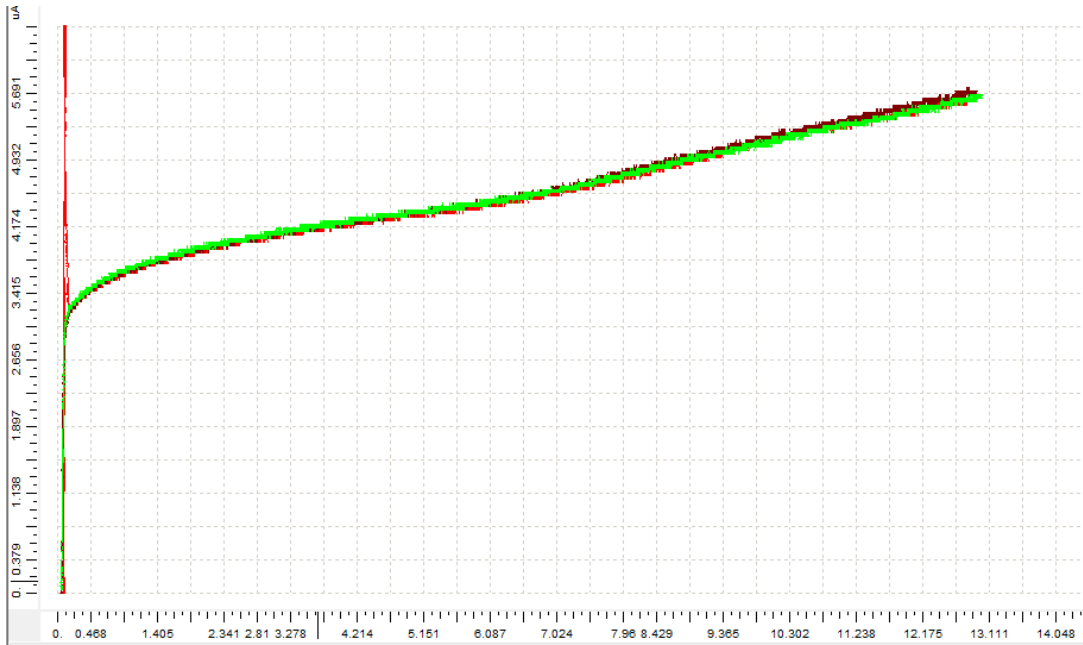
As can be seen, the unit had some issues. This type of result is indicative of a crack in insulation. This unit has had a troubled life and had recently burned up a set of main cables to the transformer as well as had a fire in the lightning arrester compartment. The only external component that not had been recently replaced were the neutral leads and the insulation was known to be in bad shape on them. Since the results up until the point of flash over were consistent with little noise, it was felt that the neutral leads were indeed the problem. It was then planned to replace the neutral leads at the next outage. When the old leads were removed, the DC Ramp test would be run before the new leads were installed to isolate the windings as much as possible. The below results are from the second test.
