PARTIAL DISCHARGE AS A STATOR WINDING EVALUATION TOOL

Clyde V. Maughan P.E.
Maughan Engineering Consultants
Schenectady, New York 12306 USA
Email: clyde@maughan.com Web: clyde.maughan.com

Abstract: This paper has been prepared to illustrate the value of partial discharge (PD) testing in assessing the condition of stator windings on operating generators and motors. The database of one particular PD system vendor was chosen for this study because of the magnitude of data accumulated by this company over the last 15 years. It was felt that sufficient data had been accumulated to allow useful statistical analysis of the capabilities of PD testing.

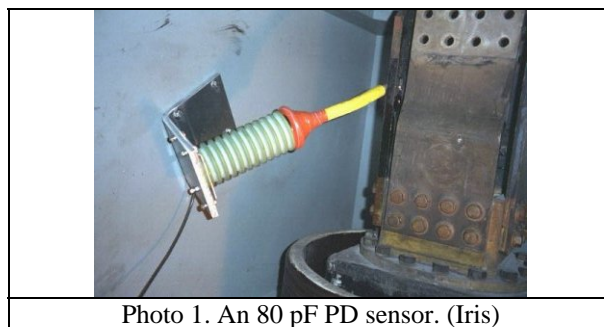
Most of the PD data analyzed in this paper was collected either with 80 pF couplers, Photo 1, or antenna-like sensors – called stator slot couplers (SSCs). Photo 2.

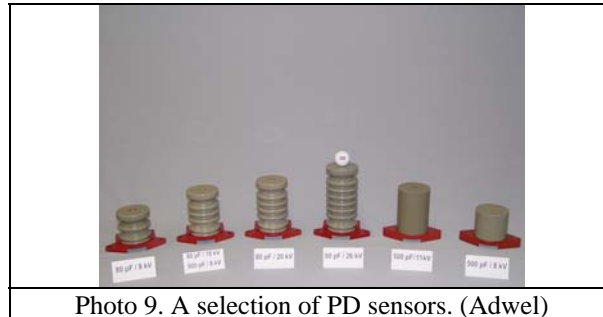
pickups may detect PD signals that are not seen with the smaller 80 pF pickups. Adwel has tended to use 500 pF sensors on lower voltage machines, and 80 pF sensors on units of higher than 11 kV (Photo 9). Adwel has conducted many PD tests on generators and large motors; in some cases, machines have been shut down due to high, or increasing, PD readings, and problems have been found that correspond to the PD indications. Local repairs, e.g., cleaning and repainting a PD source, have resulted in lower PD readings upon return to service.

Photo 9. A selection of PD sensors. (Adwel)

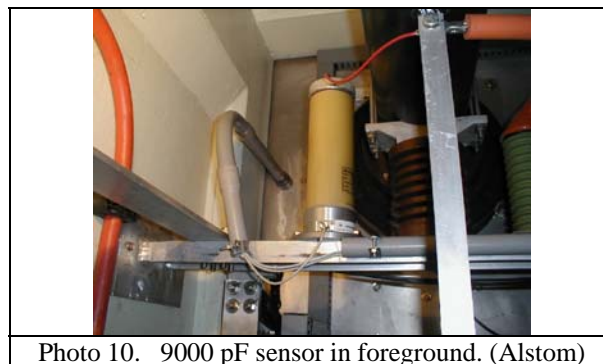
Photo 10. 9000 pF sensor in foreground. (Alstom)

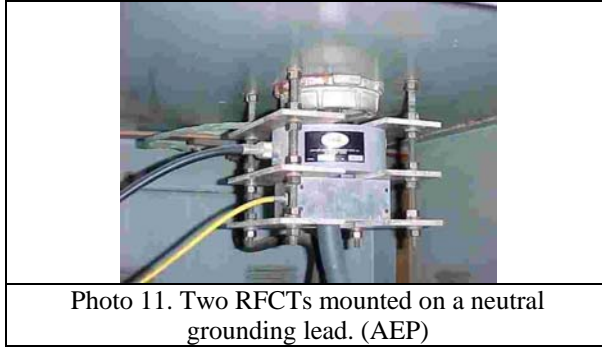
The test RFCT sensor can be mounted permanently on a neutral grounding lead during a brief shutdown. Photo 11. But a temporary RFCT can be installed without the need to remove the generator from service.

Photo 11. Two RFCTs mounted on a neutral grounding lead. (AEP)
