# A NEW IEEE STANDARD FOR VOLTAGE ENDURANCE TESTING of HYDROGENERATOR STATOR COILS

G.C. Stone	S. Cherukupalli
Iris Power Engineering	B.C. Hydro

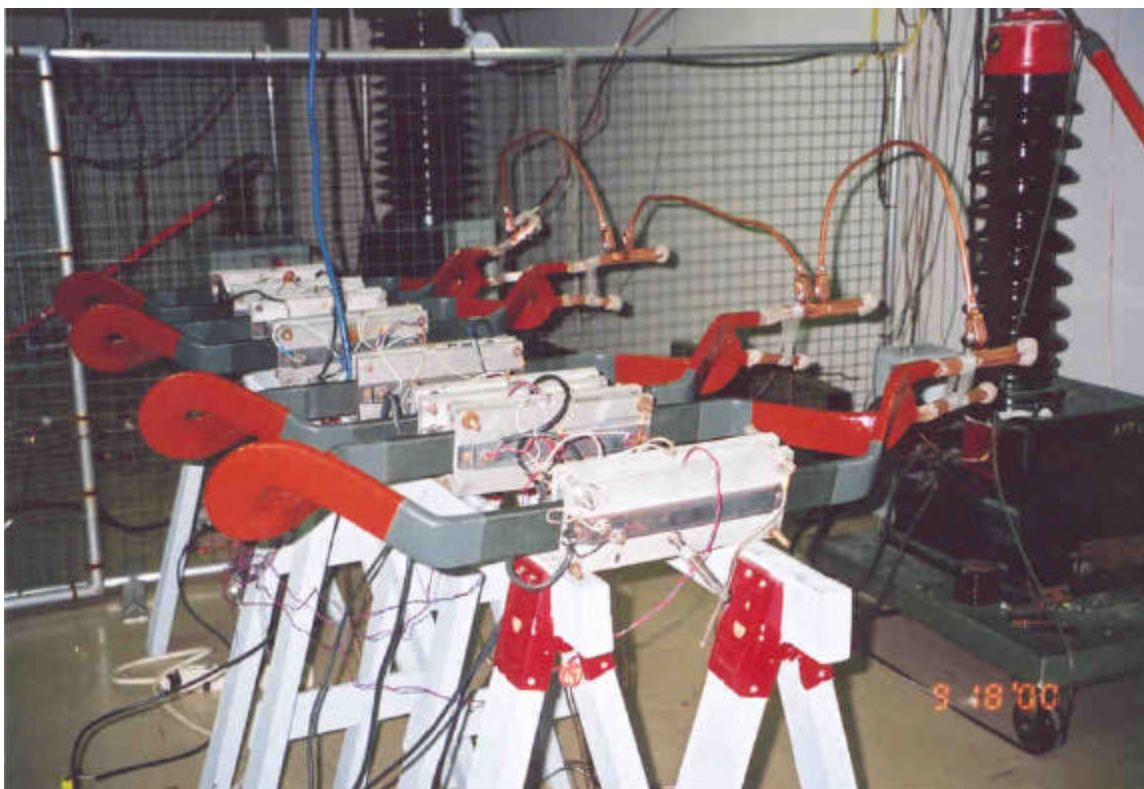
Figure 1: Typical voltage endurance test set-up.

In a voltage endurance test on coils, usually two or more coils or 4 or more stator bars are randomly drawn from a production batch. The coils are placed in a special stand where the slot portions of the coils are encased in metal heater plates, which raise the surface to a specified temperature ("the test temperature") -Figure 1. At the same time, a 50 or 60 Hz ac voltage ("the test voltage") is applied between the heater plates and the coil copper conductors. The coil is subjected to this high voltage and temperature for a minimum time. If the coil or bar does not puncture in the specified time, then the insulation is considered "good", i.e. suitable for service. The test is sensitive to the following design or manufacturing problems:
