PARTIAL DISCHARGE: PD, common in air-cooled stator windings, is not well understood at the plant level

By Donald Selkirk, PE, SaskPower

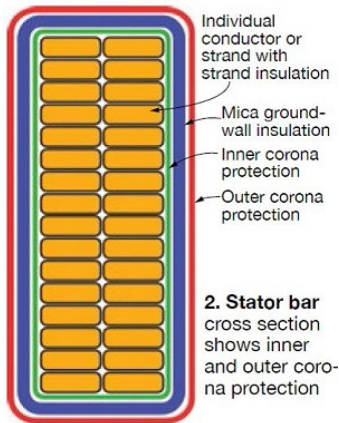
1. Copper strands are Roebel together to form modern mica ground-wall generator bars

The bar usually is wound with a layer of semi-conductive tape to provide inner corona protection. Mica-based, ground-wall tape then is applied. This tape creates a wall between the energized bar copper and the grounded stator core and frame. A second layer of semi-conductive tape is applied on top of the ground wall to provide outer corona protection.

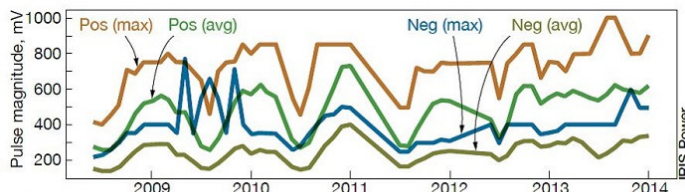
3. Two-dimensional trend plot gives plant personnel a general indication of the level of PD in a stator winding

PD detection can provide simple, two-dimensional PD monitoring and data logging accessible to plant personnel, or three-dimensional PD monitoring done by trained technicians using specialized equipment. The former delivers PD pulse-height analysis plots, which provide plant personnel with a general indication of the level of PD in the stator winding and data trending that indicates whether any changes have taken place in the amount of PD in the winding (Fig 3).

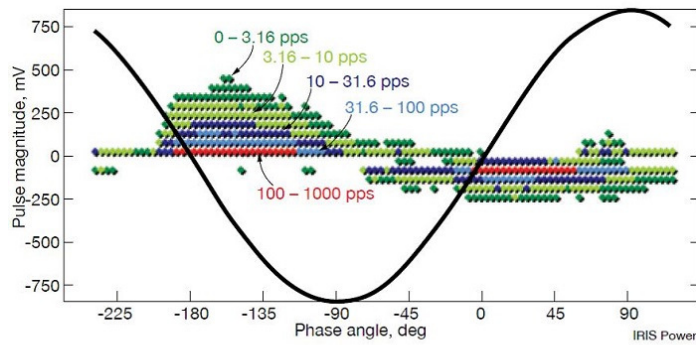
4. Three-dimensional plots can provide the user with information on the nature of the PD in the stator winding

Three-dimensional PD monitoring delivers pulse-height analysis plots and phase-resolved plots of stator winding PD activity and can provide the user with a great deal of information about the nature of the PD in the stator winding (Fig 4). It also can provide information on the location of the PD (slot, end winding), relative size of the worst insulation defects, quantity of insulation defects, and whether the PD may be related to vibration sparking.
