Applying new technology in the upgrading or uprating of generators

W-D. Blecken, Power Generation Group (KWU), Siemens AG, Germany

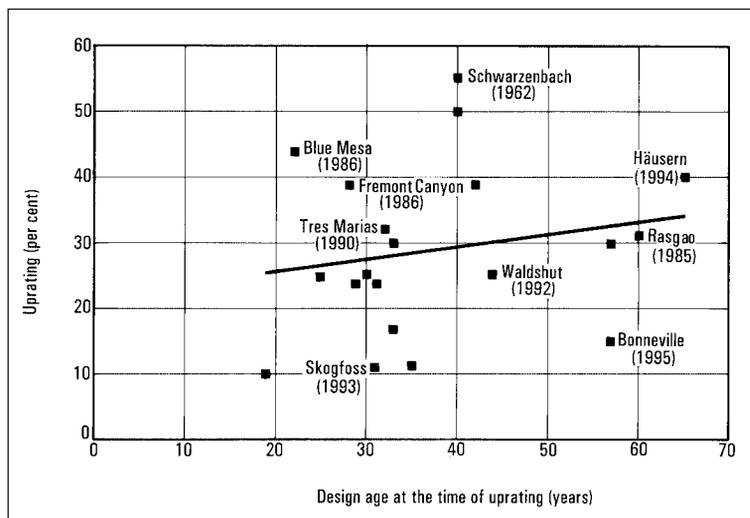
Fig. 1. Some examples to show a range of recent generator uprating projects, carried out by Siemens.

This explains the wide generator uprating range of actual projects shown in Fig. 1.

Fig. 1 demonstrates that actual uprating projects virtually start at a design age of 20 years, with a certain peak for hydro generators with an average age of about 30 years. This fact is self-explanatory, as shown in Fig. 3. The reduction of ground wall insulation for the 1957 to 1967 decade alone (starting with an asphalt-mica thickness level of 5 mm = 100 per cent in 1957, when this insulation system has been replaced by the Micalastic insulation) amounts to 27 per cent. The total reduction, to date, is 41 per cent.

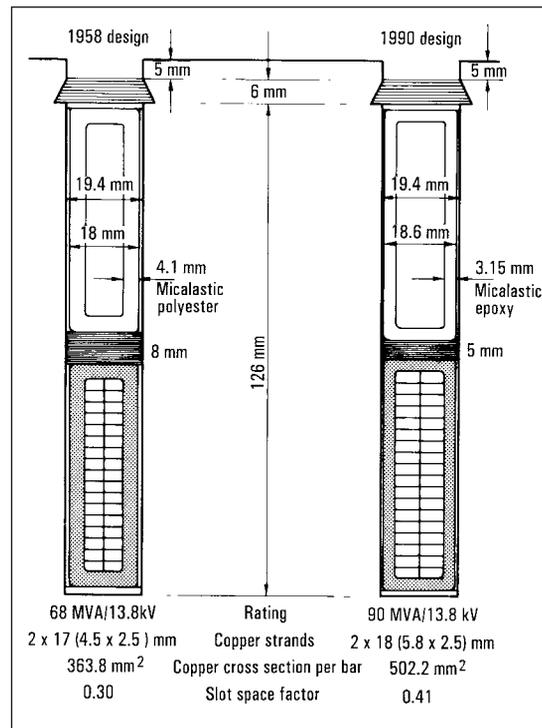
Fig. 2. Stator slot cross section of the Tres Marias uprating project.

The original design of this plant dates back to 1958 when the 68 MVA run-of-river units were ordered. In 1990, an uprating programme was initiated and new stators were delivered. The number of slots and slot dimensions remained unchanged. Improvements in the insulation technique permitted an increase of slot space factor from 30 per cent to 41 per cent (Fig. 2). The rated load was increased to 80 MVA with a permissible continuous overload of 90 MVA. The new stators were designed by incorporating various modern features. The lack of core joints considerably improves the mechanical stability of the new stator.

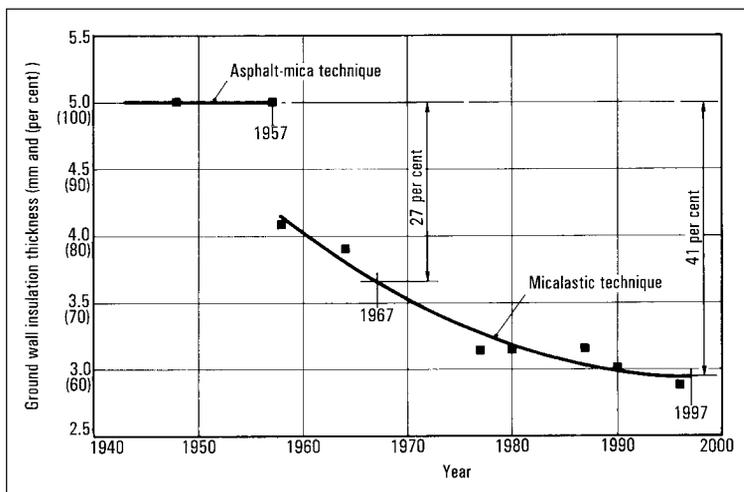
Fig. 3. Development of ground wall insulation thickness for 13.8 kV stator windings of actual projects.

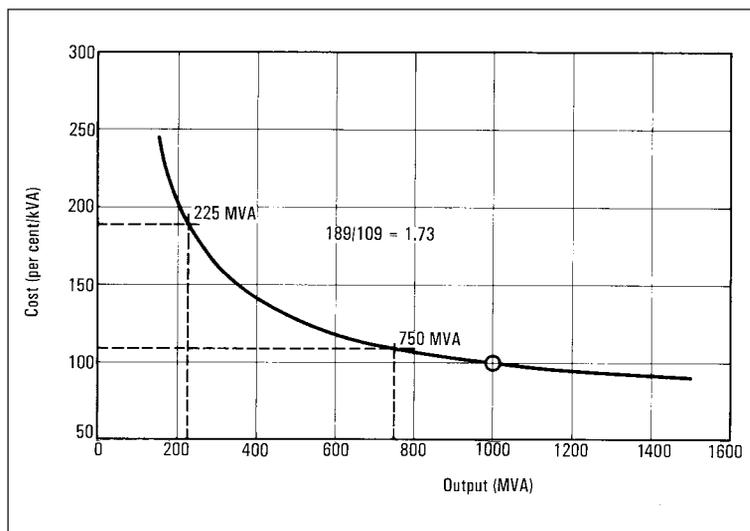
Fig. 4. Average electrical components cost curve for a number of hydro projects.

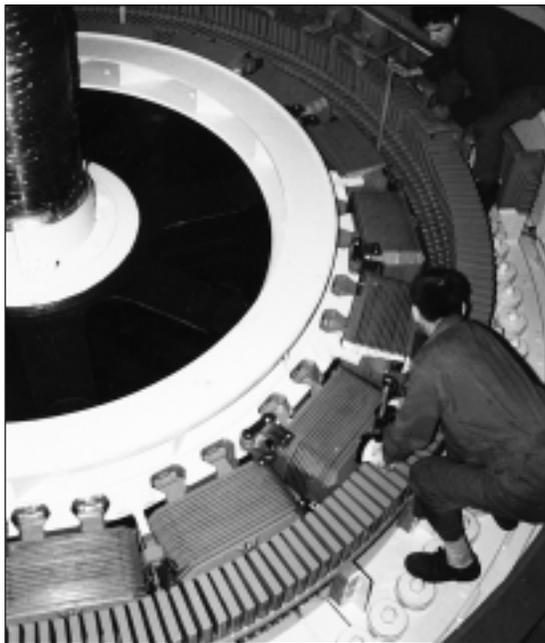
Photo 1. Rotor assembly of the uprated Häusern unit.

free design of the new stator winding and the spring elements of the stator core are clearly visible in Photo 1.

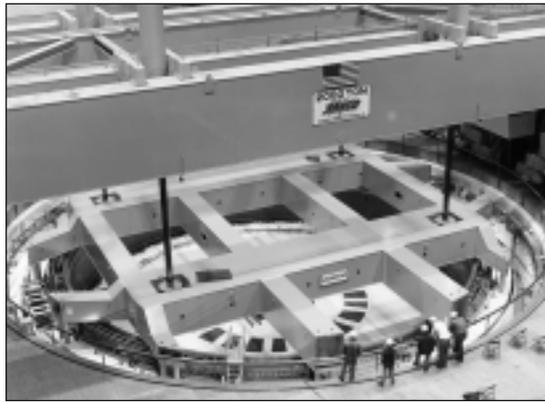
Photo 2. Refurbished stator of Grand Coulee unit G-24 being lowered into the pit.
