KEEPING STATOR AND ROTOR WINDINGS CLEAN

**Greg Stone and Earl Goodeve
Iris Power Engineering**

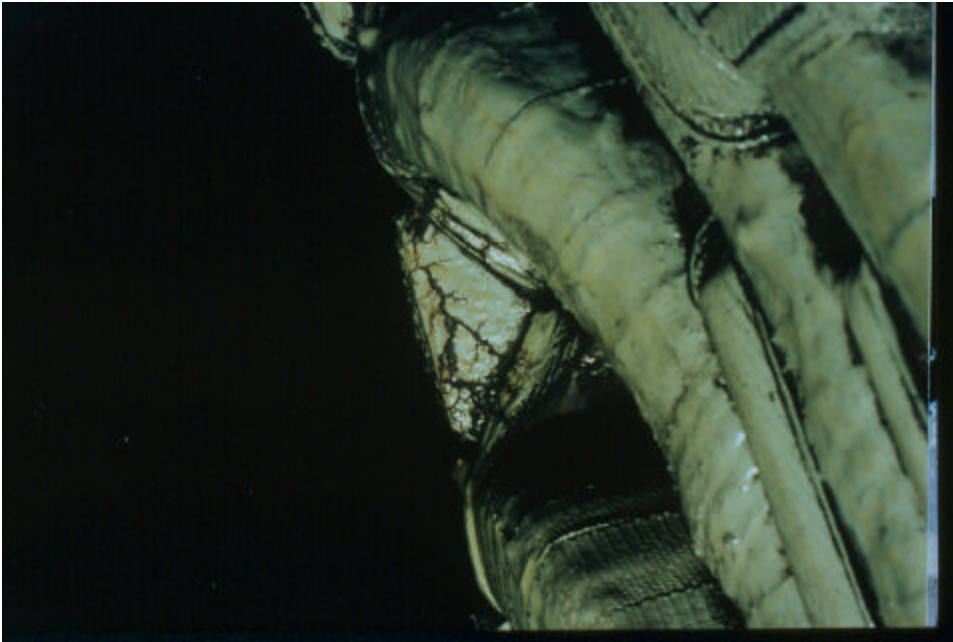
Figure 1 (see 8-7 in Visio file): Cross section of two adjacent stator coils that are the phase end coils in two different phases, with electrical equivalent circuit.

The problem normally only occurs in the endwindings of stators. If the contamination has some conductivity, say less than a few tens of megohms per square, then currents can flow if a potential difference exists. Figure 1 shows the cross-section of two adjacent coils in the endwinding, together with an equivalent circuit. Assume the coils are in two different phases. The contaminated surface of the A phase coil will have a tendency to float up to the voltage of the copper within the coil, by capacitive coupling. Similarly, the B phase coil surface will tend to float up to the B phase voltage. Blocks and ties used for stiffening the endwinding structure and for electrically separating the coils bridge these surfaces. The surface of the block represents an “electrical resistance” of the contamination across the block. The equivalent circuit in Figure 1 shows the results. If the two coils are phase-end coils in two different phases, then during normal operation the full phase-to-phase voltage is applied to the equivalent circuit, and current will flow. If the contamination resistance is high compared to the capacitive impedance of the coils in the contaminated area, then the surface of the coils is almost at the same voltage as the underlying copper conductors, and nearly full phase voltage is applied across the block.

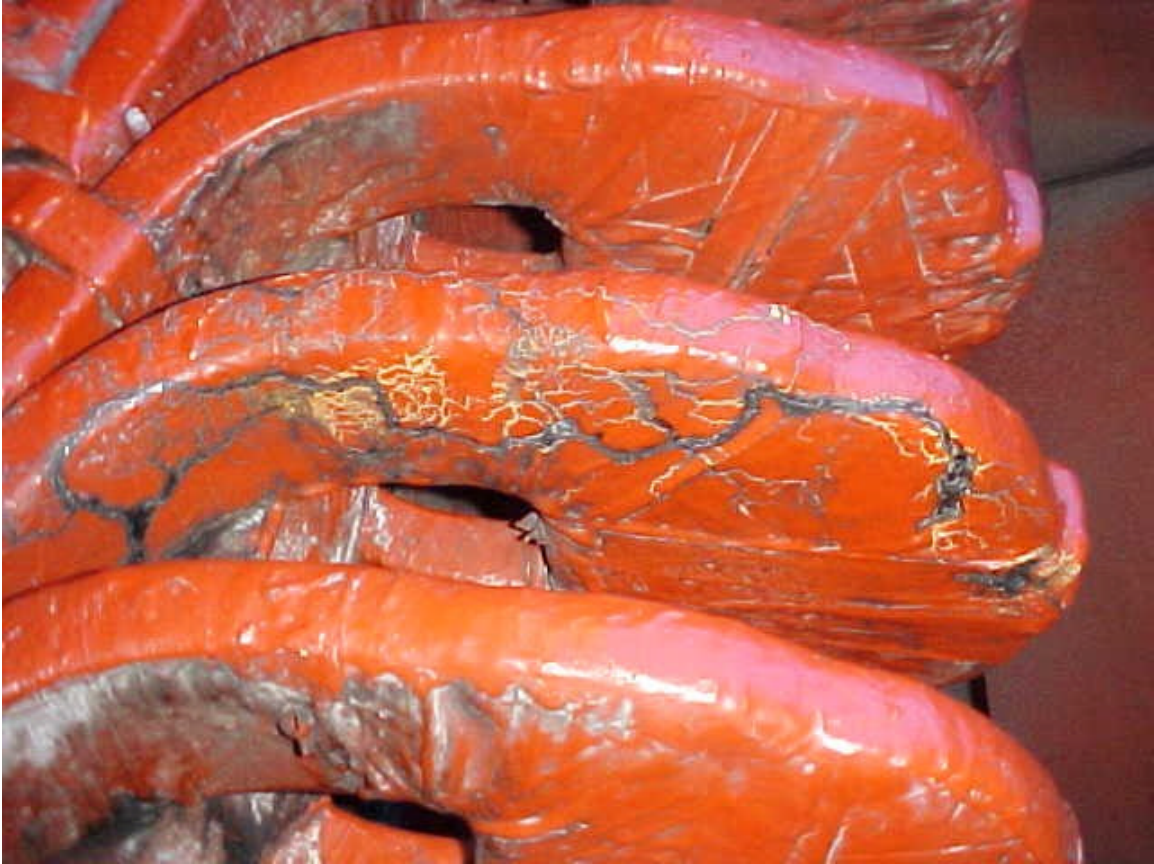
Figure 2: Electrical tracking (the carbonized, lightning-like lines) over an insulating block between two phases caused by electrical currents flowing in surface contamination.

resistance is much higher than the general resistance of the contamination. In this case, virtually the entire voltage will then appear across the small dry band, causing electrical breakdown of the adjacent air. The discharge degrades and may carbonize the underlying organic resin and tapes. This small area is eventually left very conductive. The electrical stress then transfers to another region of high resistance, where discharges ensue. The result is an electrical track, which slowly grows across the insulation (Figure 2). The track often has many branches, and appears as a carbonized, black network across the blocking. Given time, the discharges will also start boring into the groundwall. If the track is between coils in different phases, a phase-to-phase failure results, which allows extremely large fault currents to flow. Alternatively, tracks can appear between coils in the same phase, if one coil is near the phase end, and the other is near neutral. Similarly, tracking can occur along a coil between the core and further into the endwinding (Figure 3).

When a machine has been completely or partly disassembled, it is usually easy to detect that there is severe contamination which may lead to any of the above problems. That is, the cooling ducts will be partly or completely plugged, the spacing between the endwindings may be closed off, and/or there is an oily film over the endwindings. If one investigates the stator endwindings more closely, then one may also see the formation of electrical tracks (Figures 2 and 3), if they are present.
